**CITY OF ALBANY
PARKS AND RECREATION COMMISSION
STAFF REPORT**

Agenda date: May 19, 2011

TO: Parks and Recreation Commission
FROM: Penelope Leach, Recreation and Community Services Director
SUBJECT: Dartmouth Tot Lot Improvements

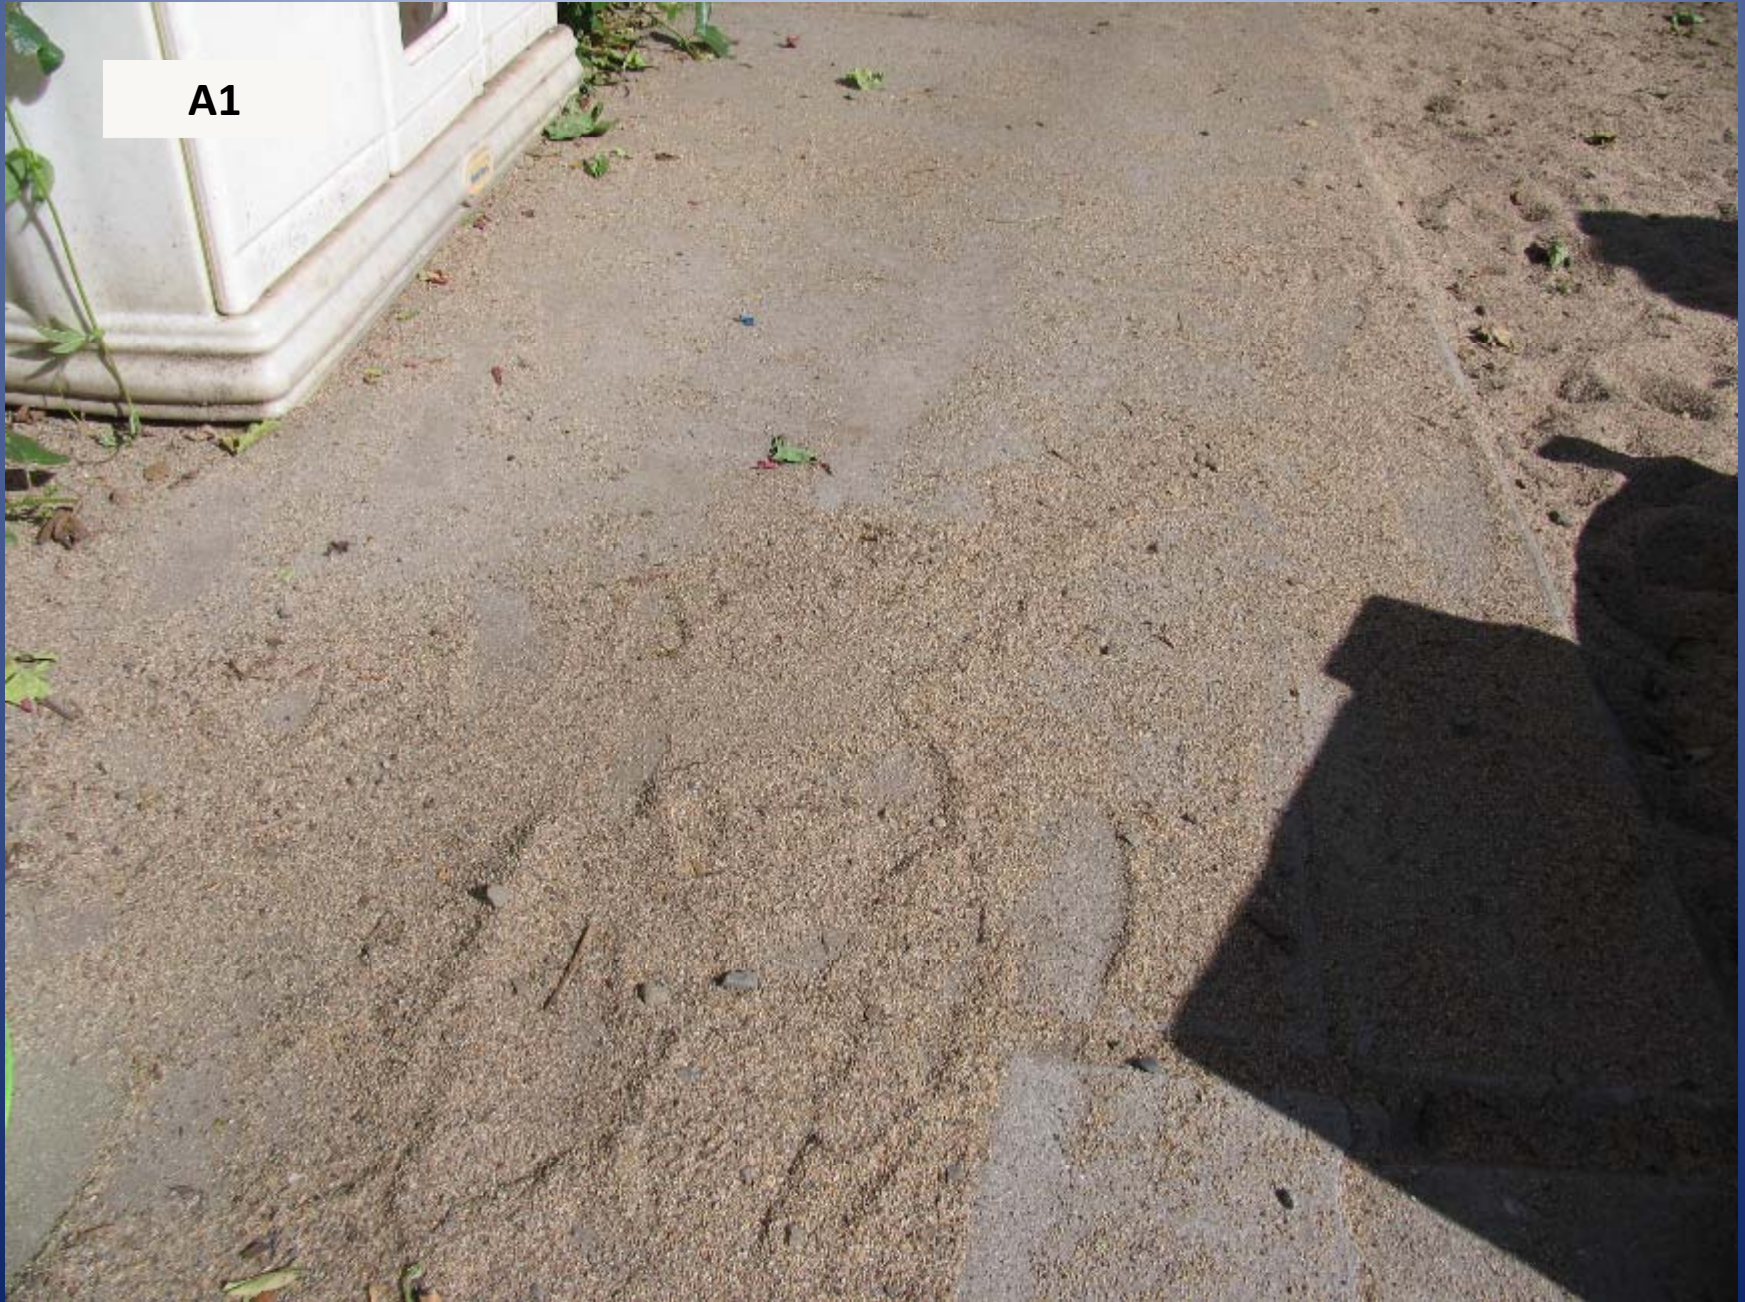
A1

Staff continues to have three major concerns with the current condition of the Dartmouth Tot Lot: (1) the sand creates a slippery surface when it spills onto the surrounding concrete walkway (please see attached pictures **A1 and A2**); (2) the amount of sand that is getting into the nearby storm drains creating sediment and potential clogging; and (3) improved ADA access (please see attached pictures **B1 and B2**). A fourth concern does not have to do with the design, but with the number of toys left at the park. Please see pictures **C1-C4**.

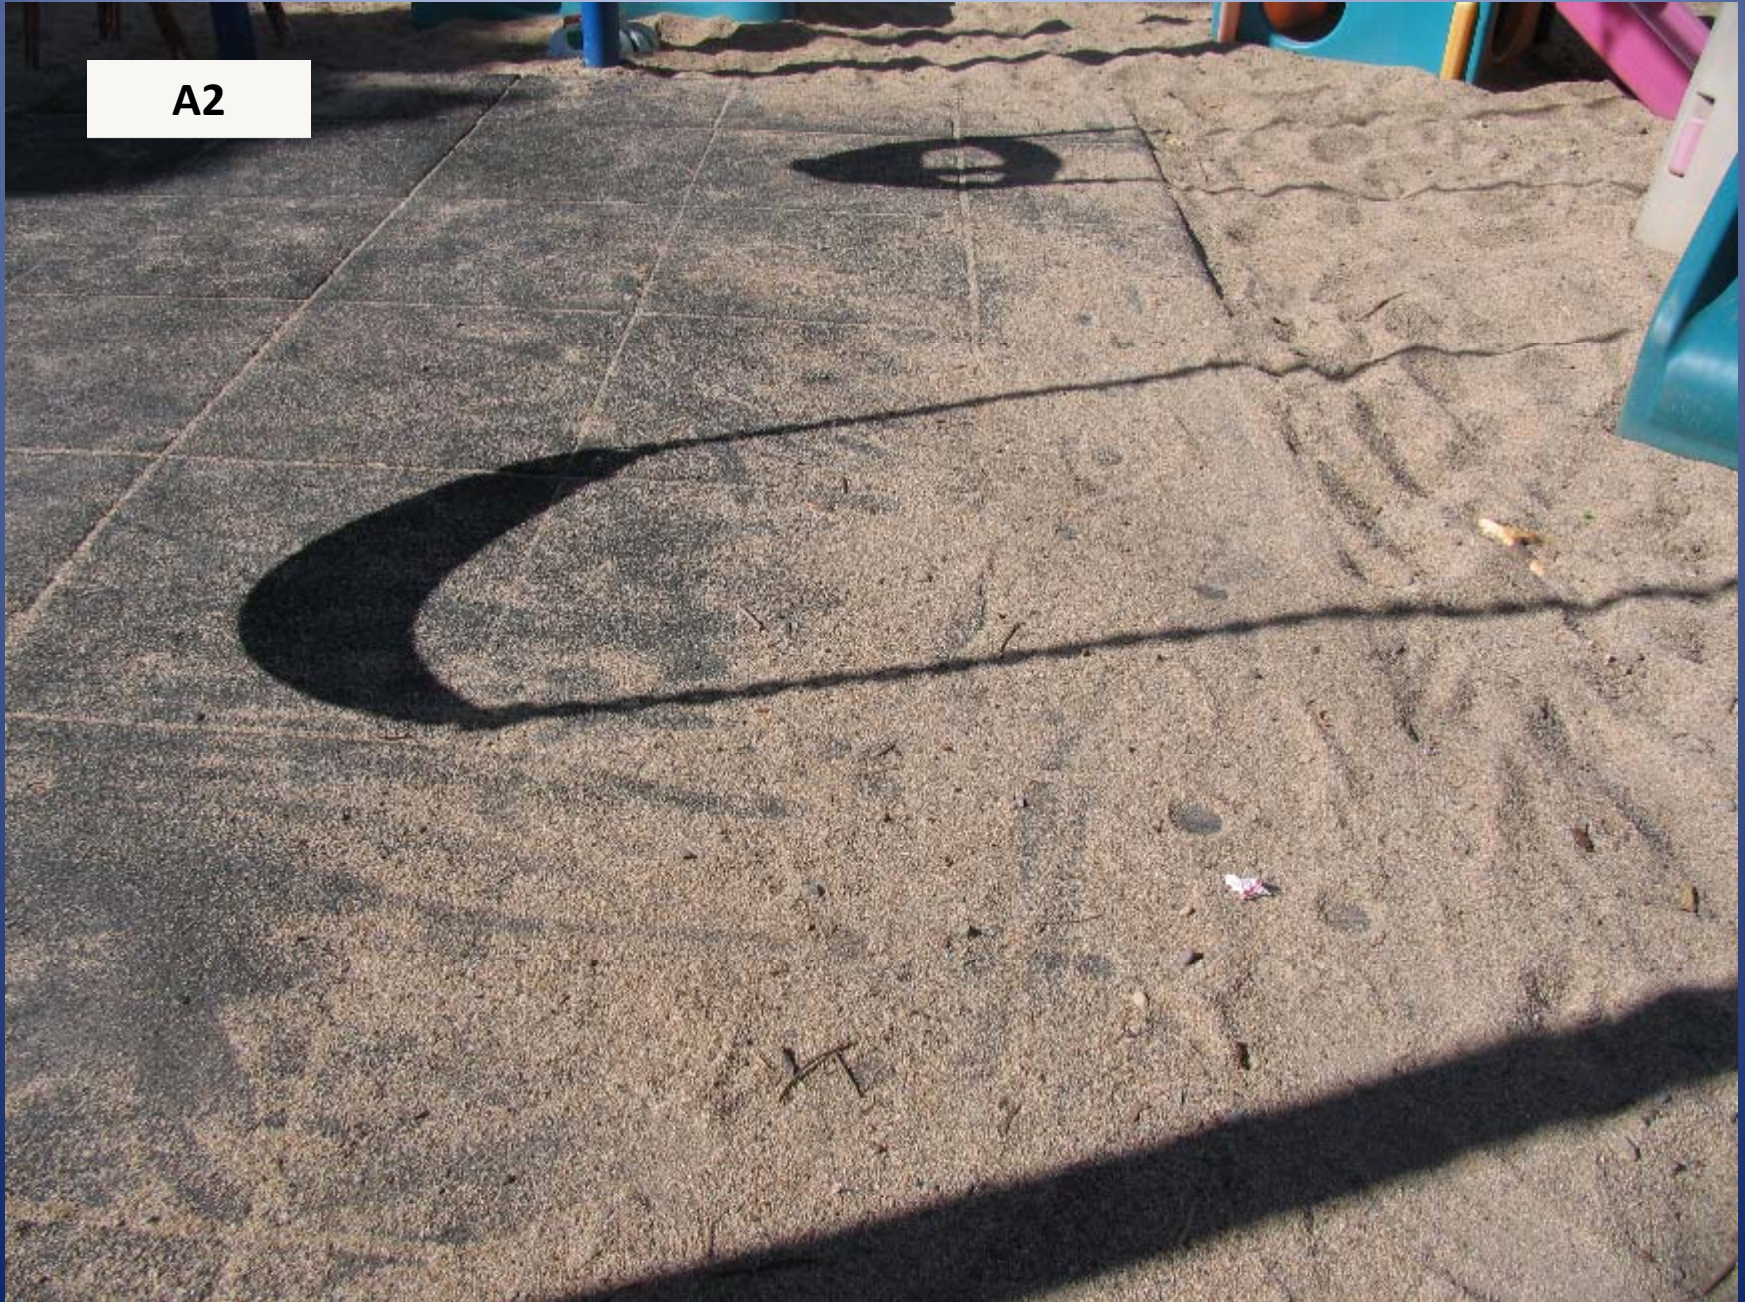
A2

Regarding the sand on the concrete walkway, a suggestion was made to cover the concrete walkway with rubber surface. This may not address the slippery surface sufficiently. As can be seen by picture **A2**, once the rubber surface is covered with sand, it too can be slippery. The cost of the rubber surfacing on top of the concrete, which would be \$9,470, compared to its benefit may not have the desired impact of creating a less slippery surface.

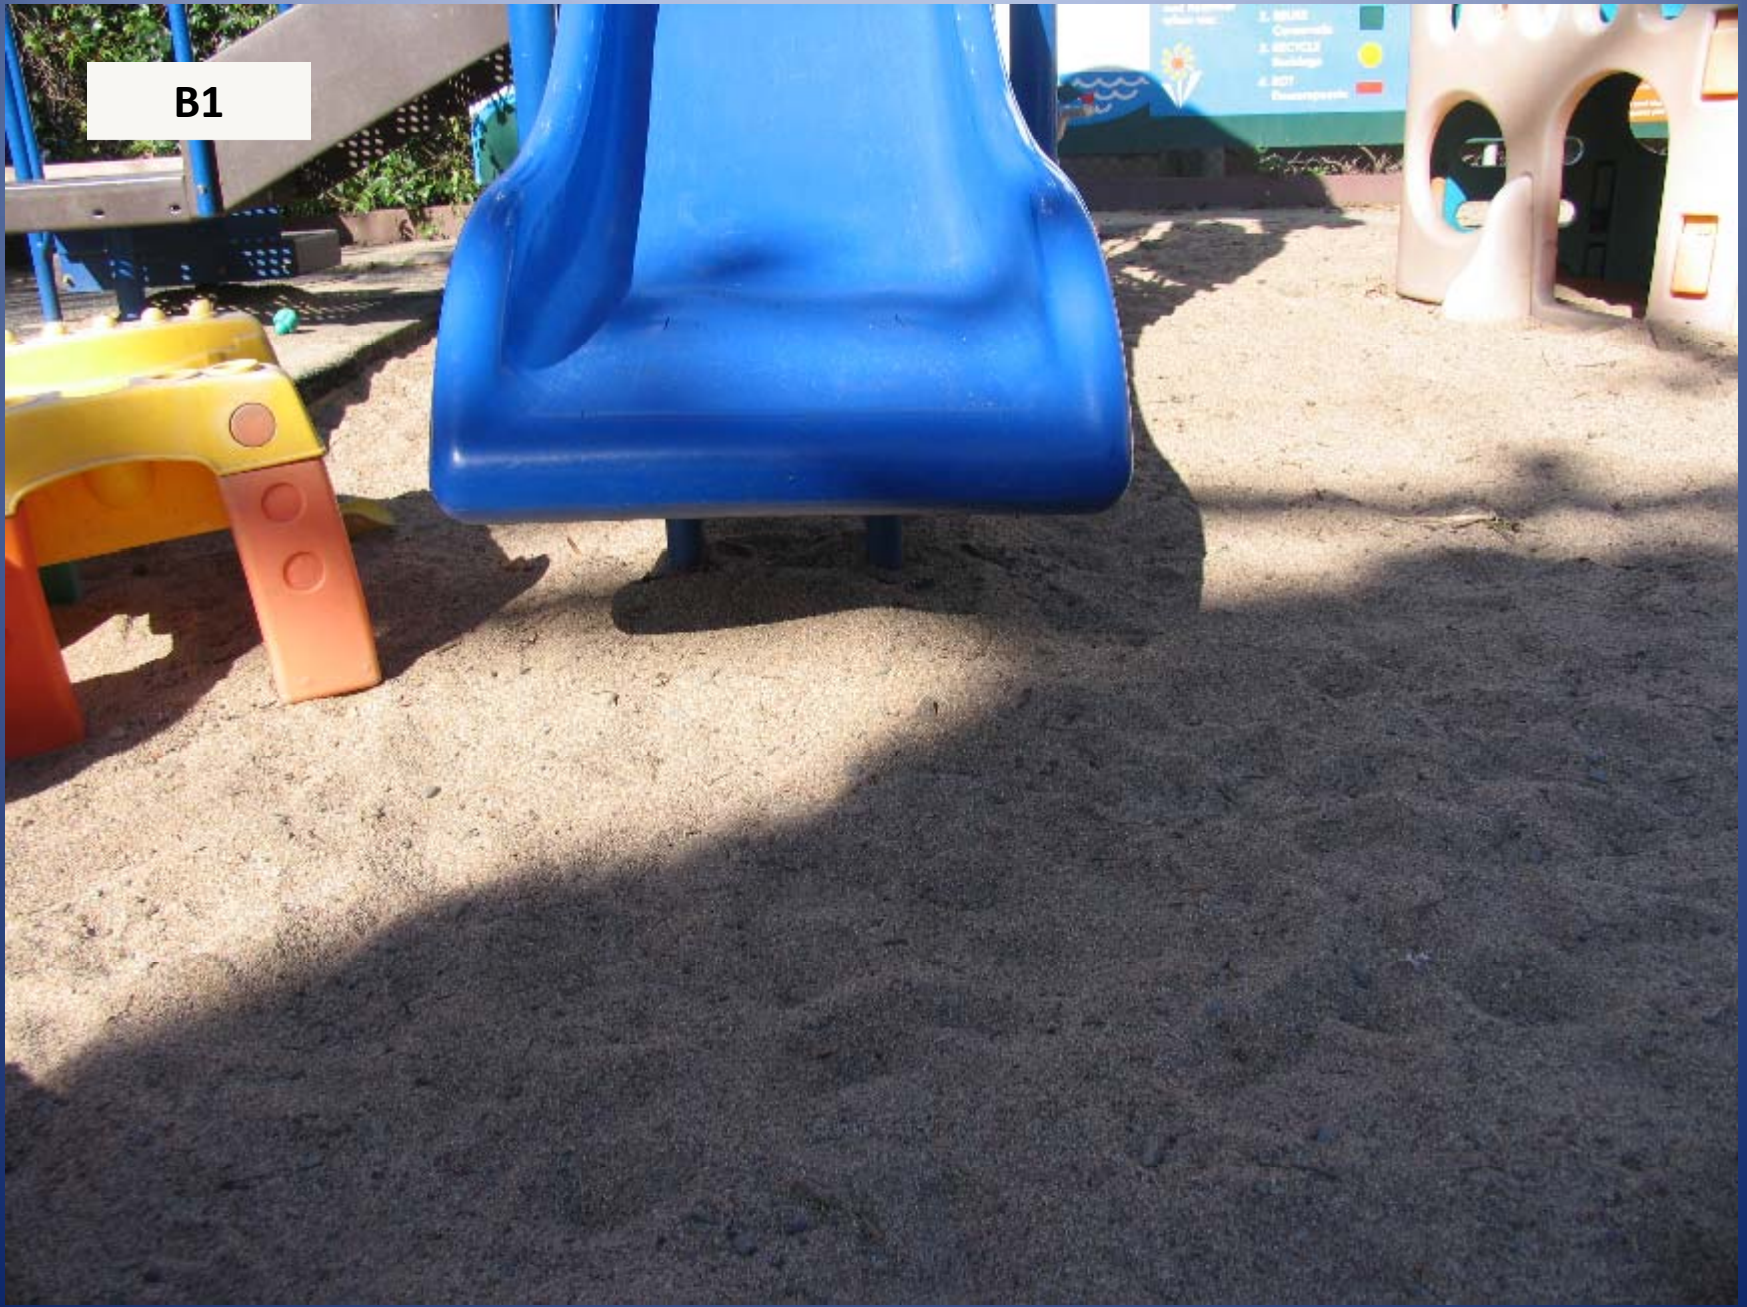
B1

Regarding the ADA requirements, **option 2** shows a design that decreases the rubber surface area compared to option 1, but satisfies ADA compliance. Specifically, picture **B1** shows the area under the slide which is currently sand. In order to be ADA compliant the landing area under the slide needs to be an ADA compliant surface. The entry into the play structure is compliant, see picture **B2**; however, access into and out of the play structure is required to have an ADA surface; therefore, rubber surfacing needs to be extended under the landing area of the slide.

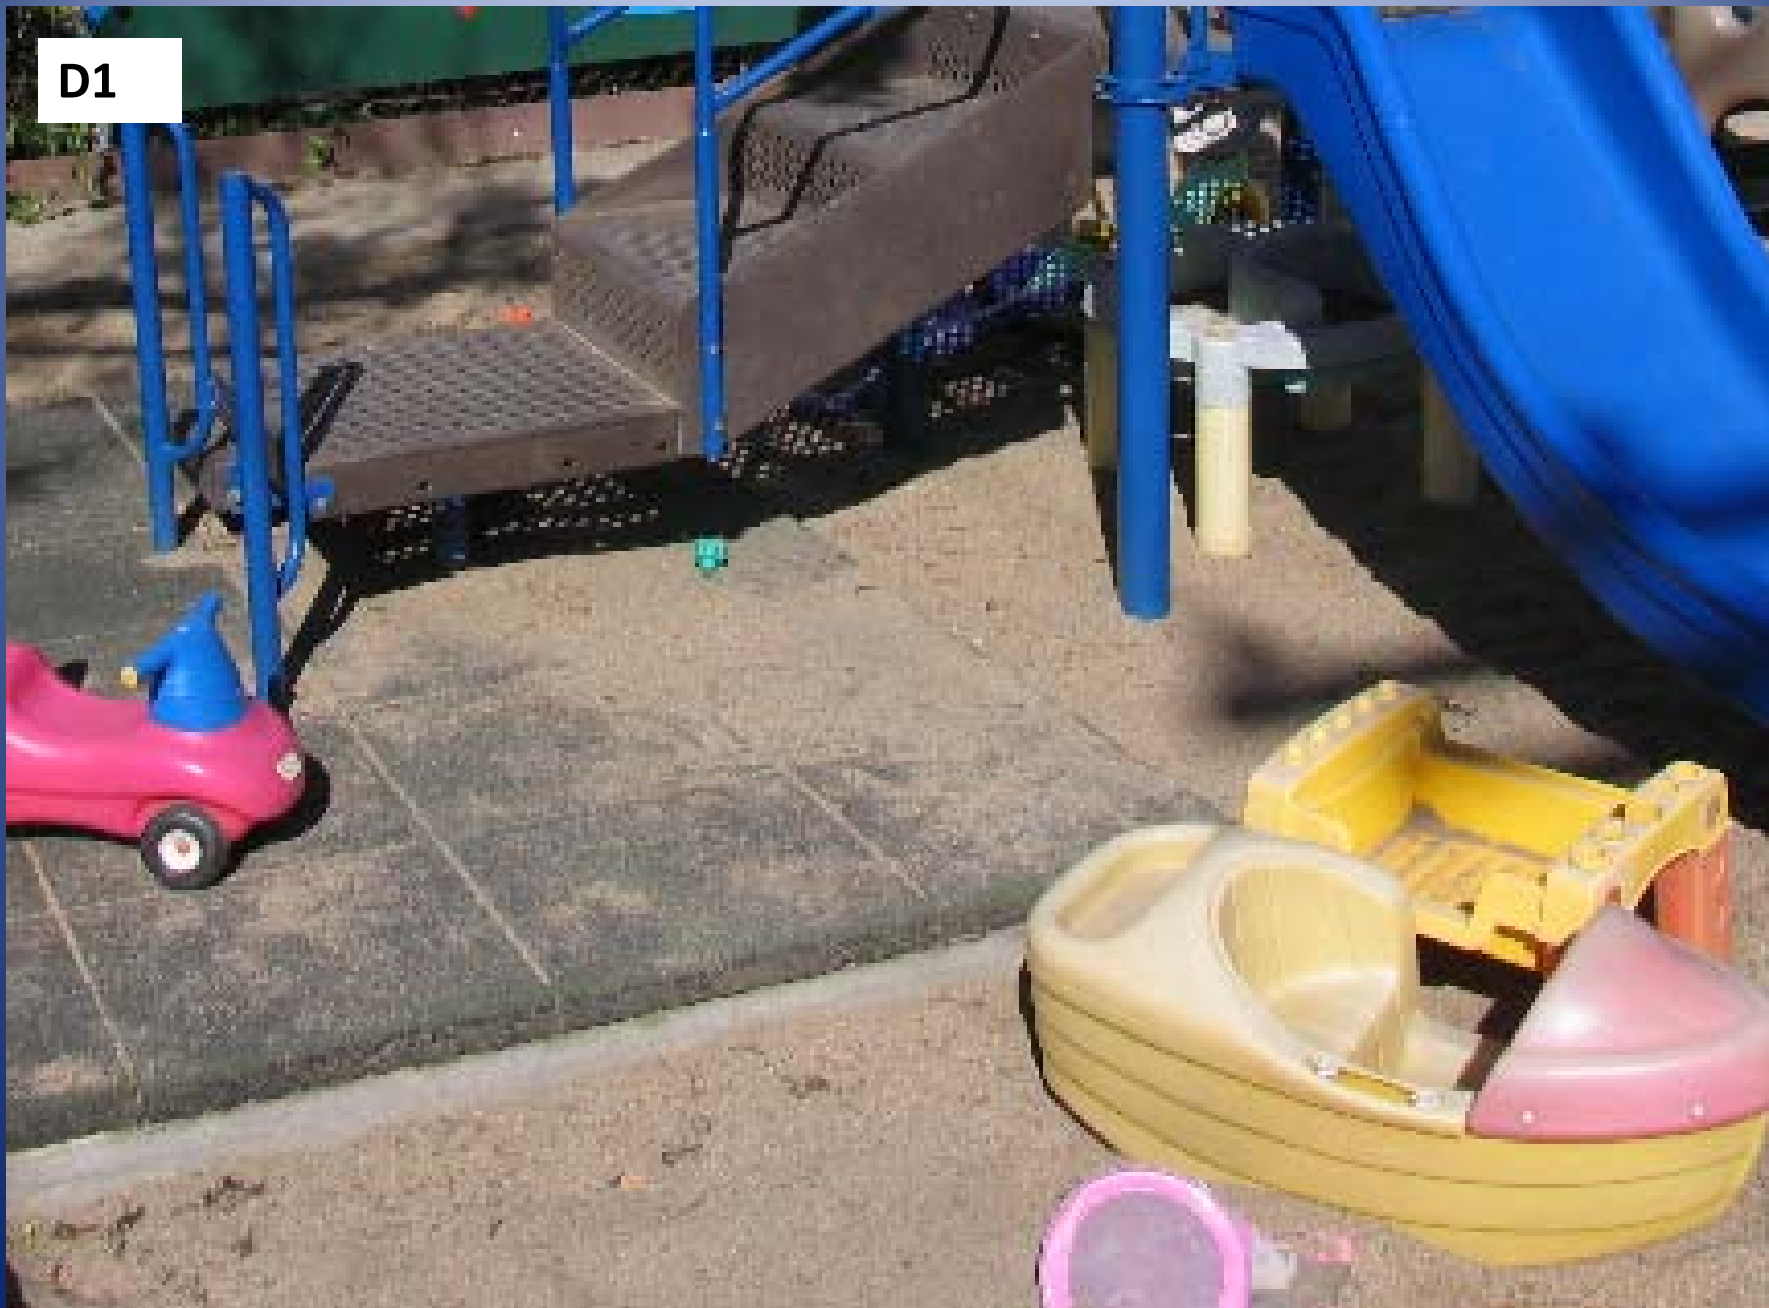
D1

Not an ADA requirement, but a safety issue is the edging of the current rubber surface. The current rubber surface is more than a ½ above the level of the sand and has a straight edge. Anything more than a ½ inch is considered a tripping hazard. Please see the attached pictures labeled **D1 and D2**. A sloping edge into the sand would prevent a tripping hazard. Please see the attached pictures labeled **E1 and E2** to see an example of the sloped edge that needs to be installed. Pictures E1 and E2 are from the recently installed rubber surface at Jewel's Terrace Park. The pictures of Terrace were taken prior to the sand being raked up over the sloped surface; therefore, the entire sloped area is exposed. After the pictures were taken, sand was raked over a portion of the sloped area creating a gentle entry into or out of the sand preventing a potential tripping hazard.
