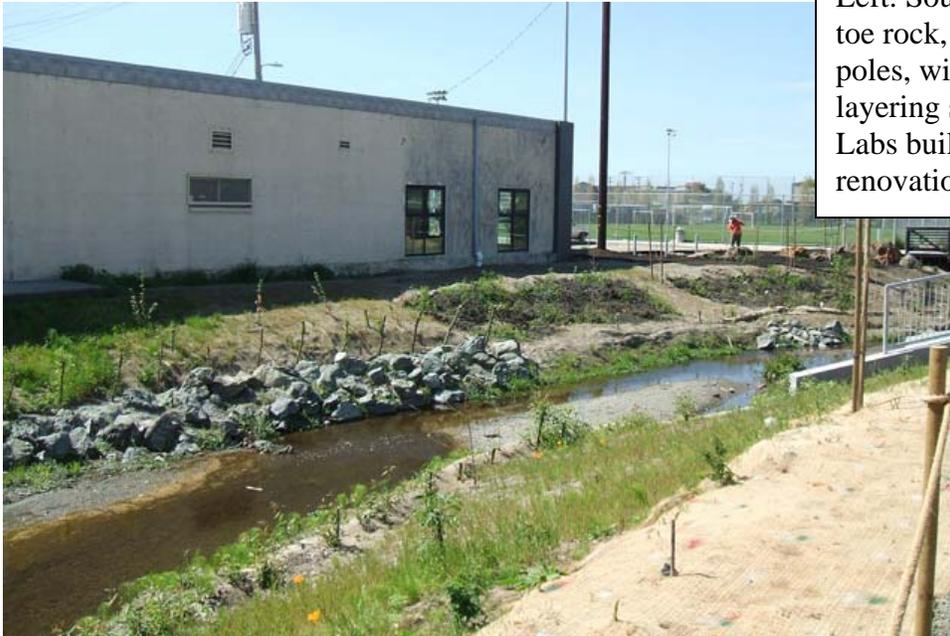
Left: Southwesterly view, toe rock, live willow poles, willow brush layering sprouting, Bryant Labs building under renovation in background

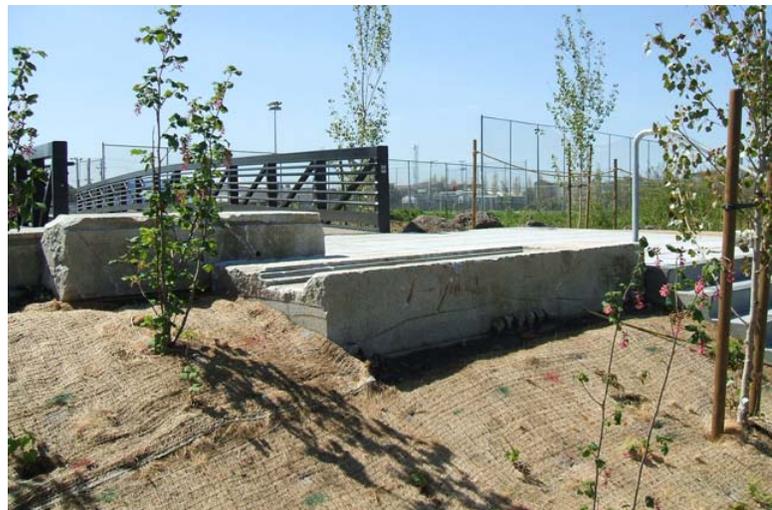
Right: View southwesterly at the North landing of the Phase II 5th Street bridge; “found” granite blocks, steps down to Fielding East ball field.

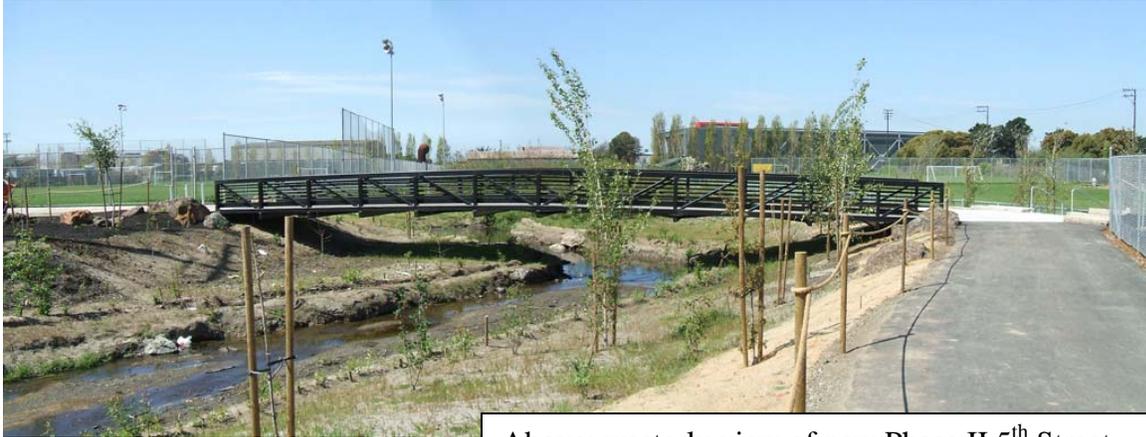
Above: westerly view of new Phase II 5th Street footbridge. Soils are much better than Phase I, and plants are growing much better.

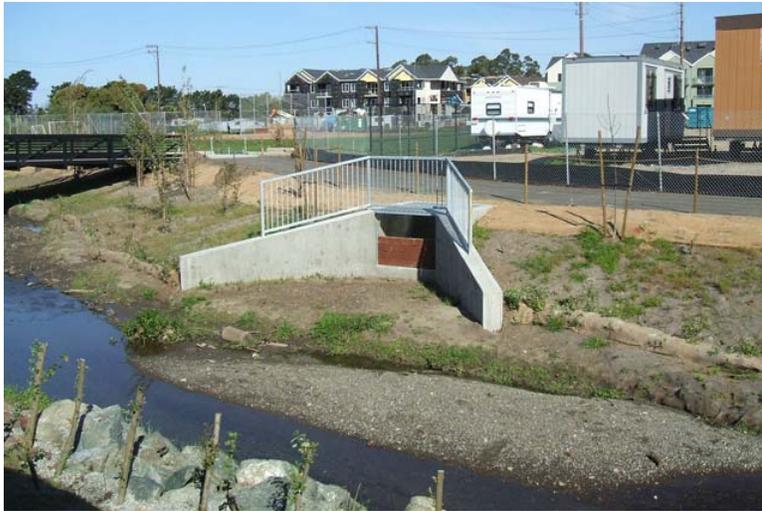
Left: Looking northerly with bypass headwall and timber weir set at elevation 18' (bypass some flood flows to Village Creek)

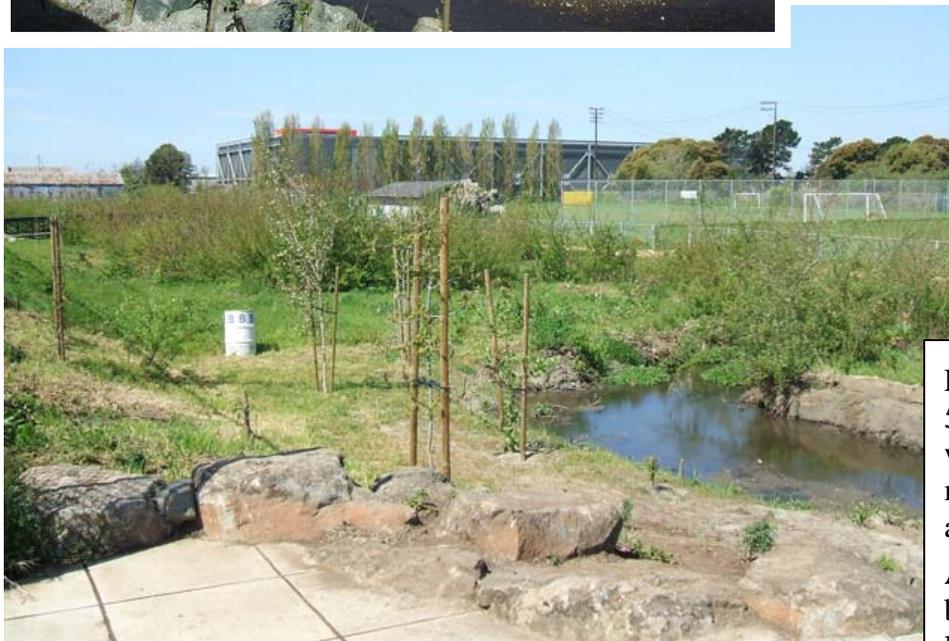
Left: Views from 5th Street landings westerly into maturing Phase I area.

Above: from new bridge south landing at the end of 5th Street.

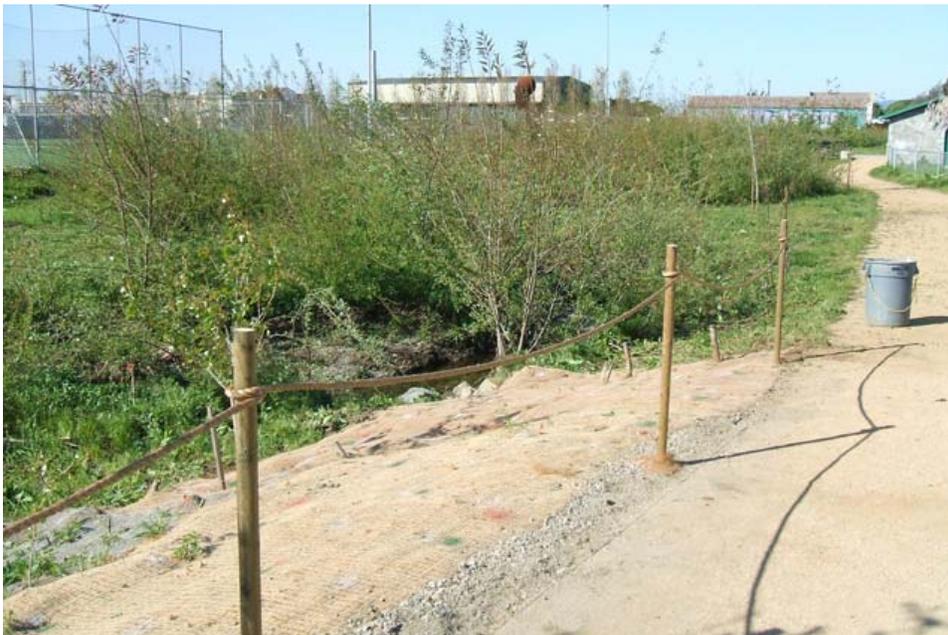
Below, from new north landing, looking up DG pathway at Phase I/II conform.
