**PARKS AND RECREATION COMMISSION MEETING AGENDA**  
**Thursday, November 10, 2016, 7:00 pm**  
**City Hall Council Chambers, 1000 San Pablo Avenue**

**5-1: Tree Removal Application:** The Commission will review the two (2) tree removal applications submitted for 510 Santa Fe Avenue.

# City of Albany Street Tree Inspection / Staff Report

**Tree Location:** 510 Santa Fe Tree # (direction of traffic): 1&2

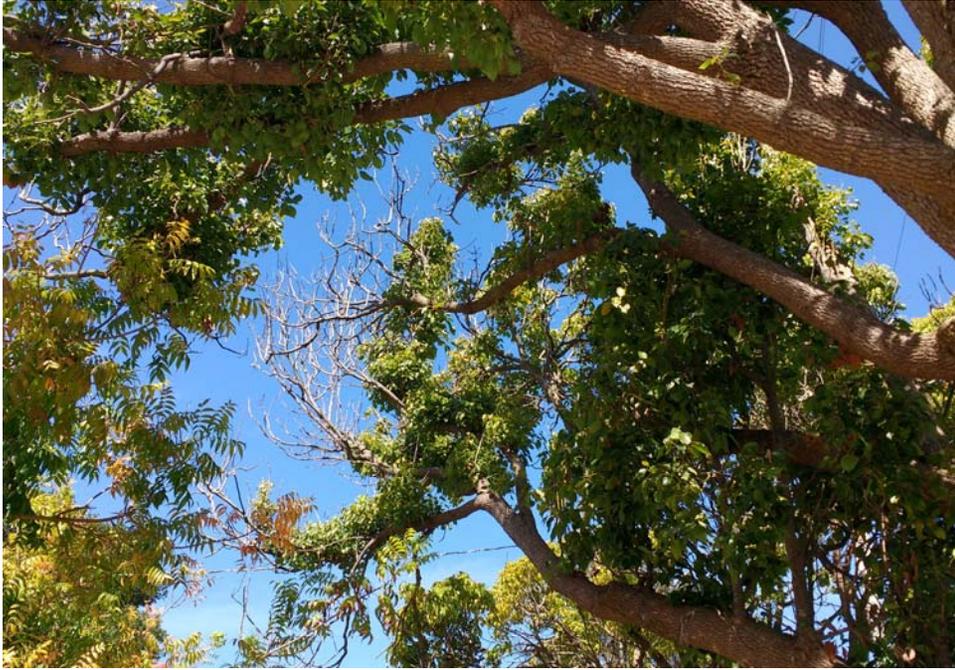
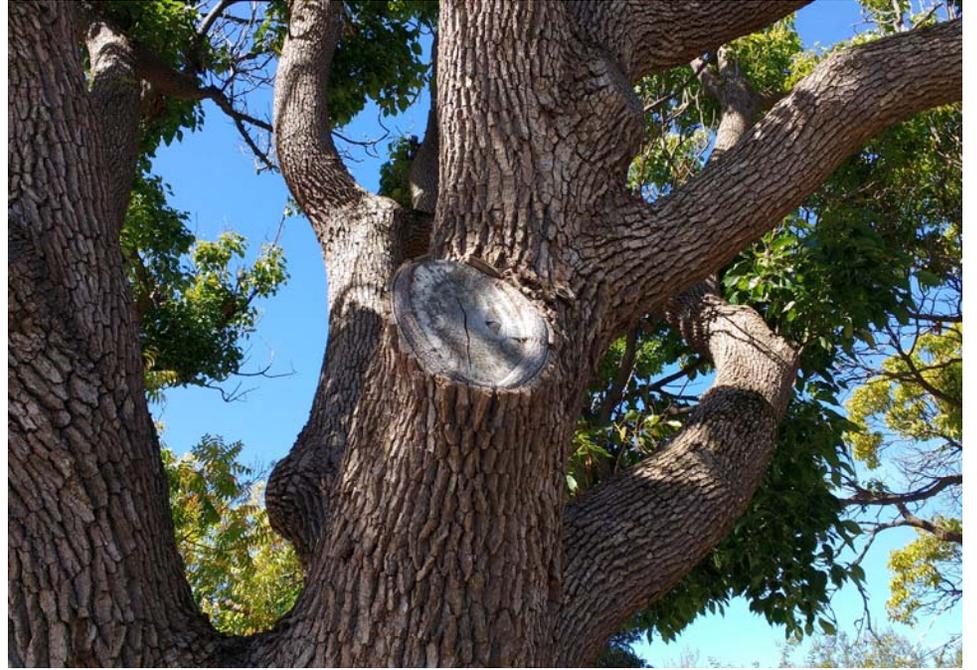
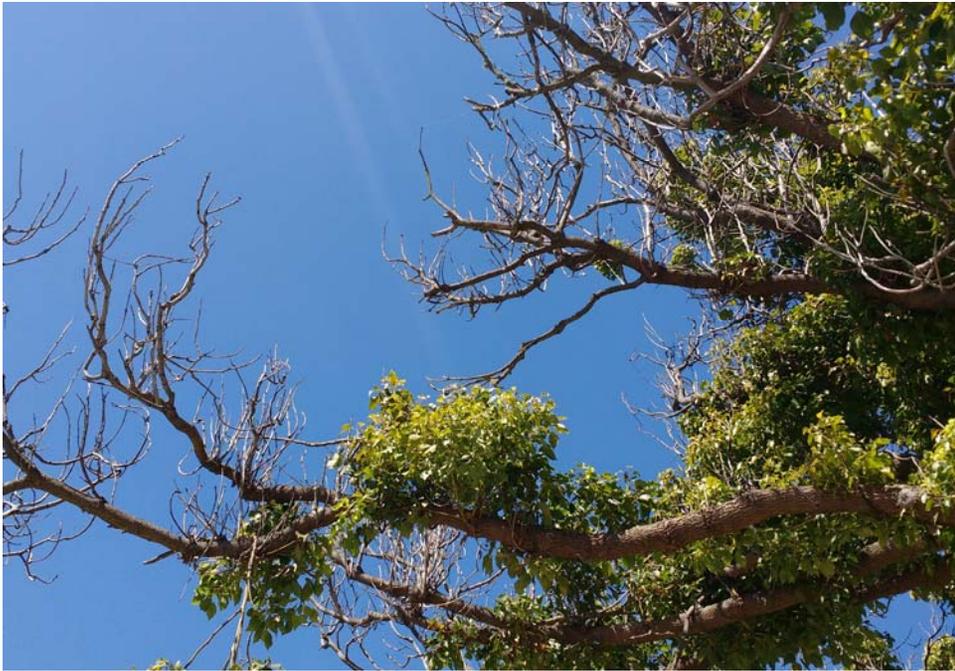
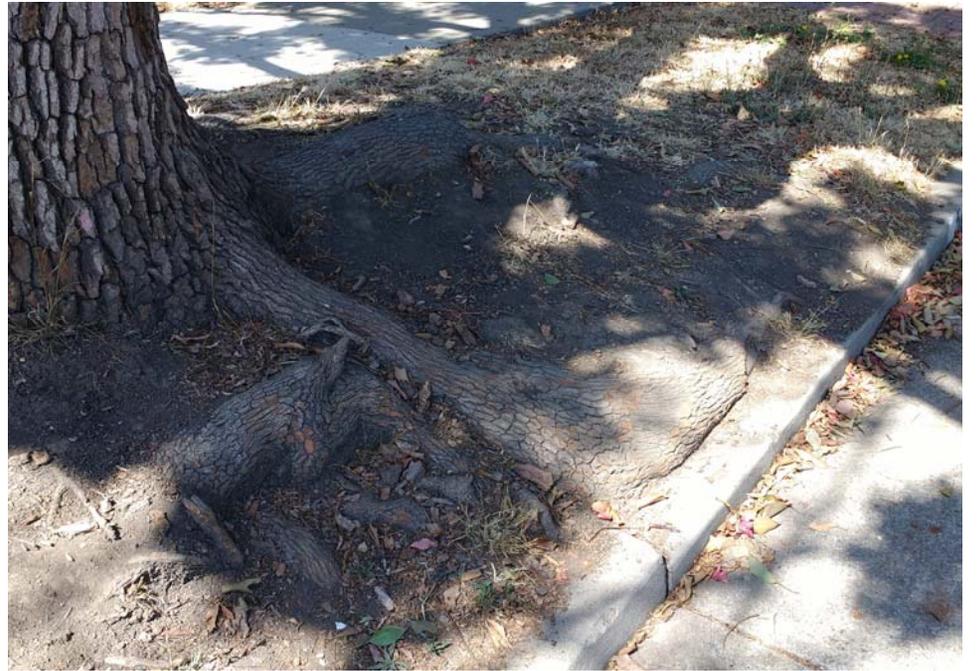
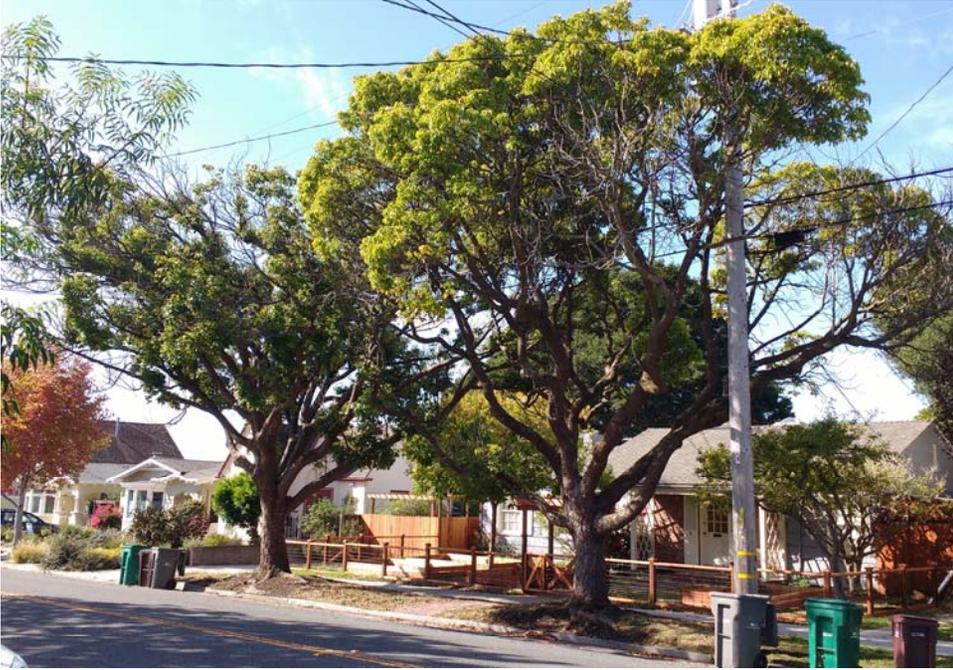
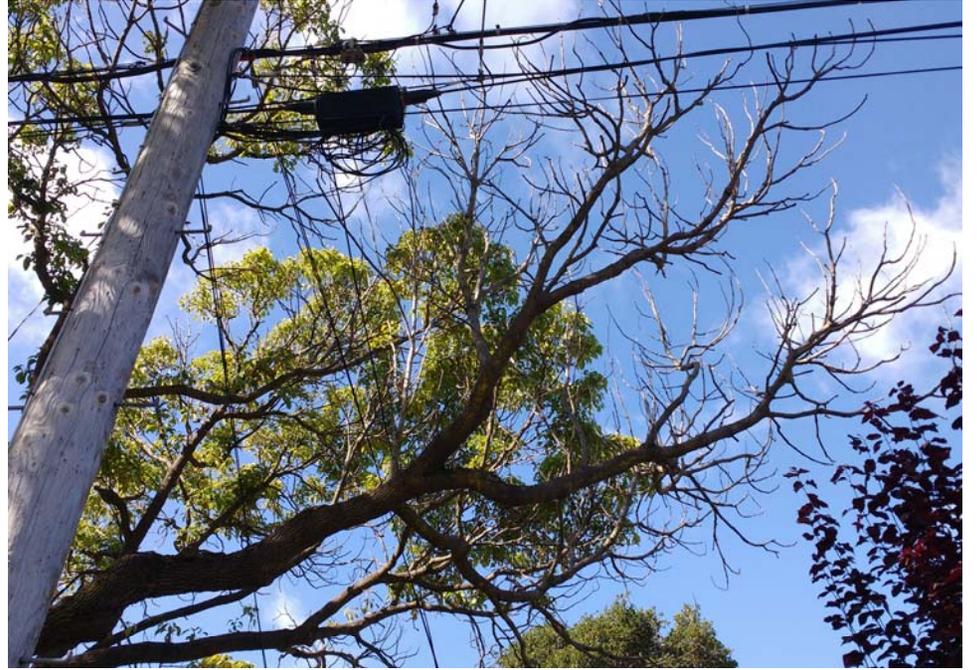
#1: mature tree, some dead branches, one large dead limb, a few smaller dead limbs, epicormic sprouting  
#2: mature tree, many small dead branches, epicormic sprouting, small dead limbs, dieback on several branches

previous sidewalk repair. new sidewalk not broken yet, but lifting and tilting. curb pushed out slightly

Both trees are in decline. Sidewalk has been recently repaired, not damaged yet, but starting to lift and tilt. Recommend remove and replace both trees.

remove and replace

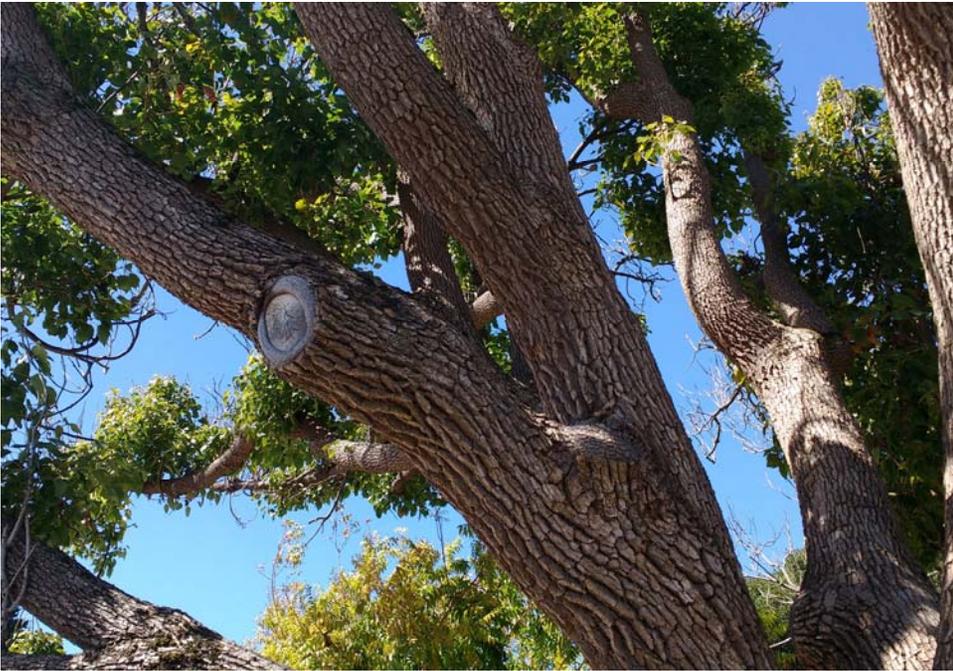
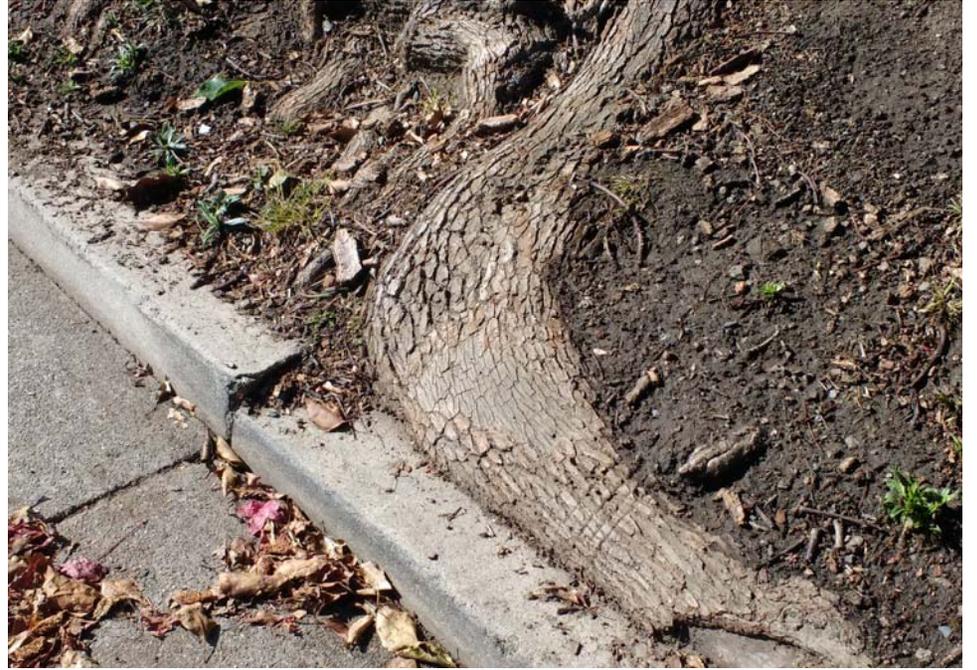
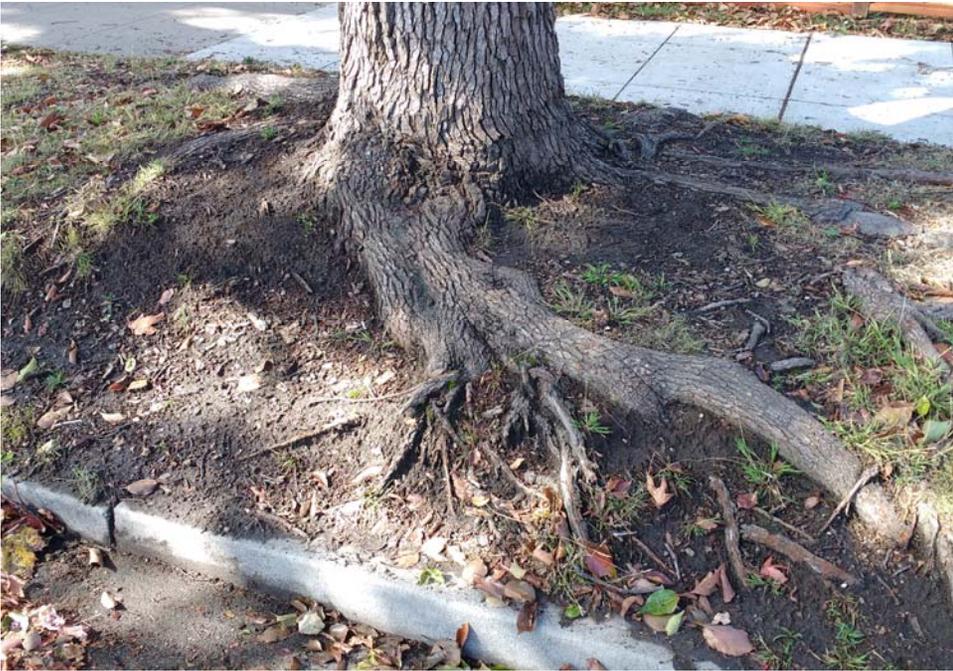
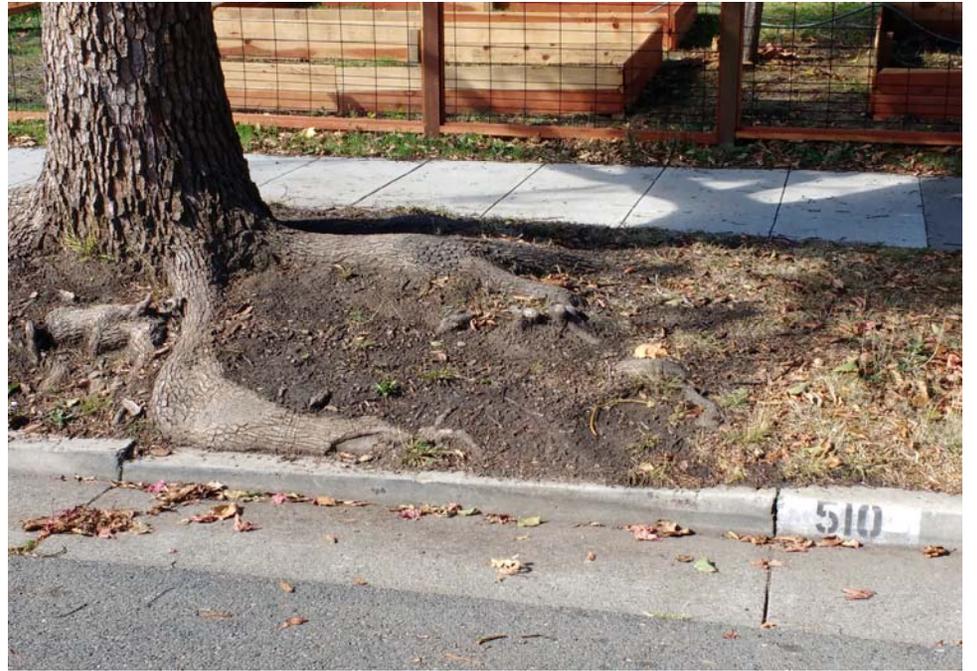
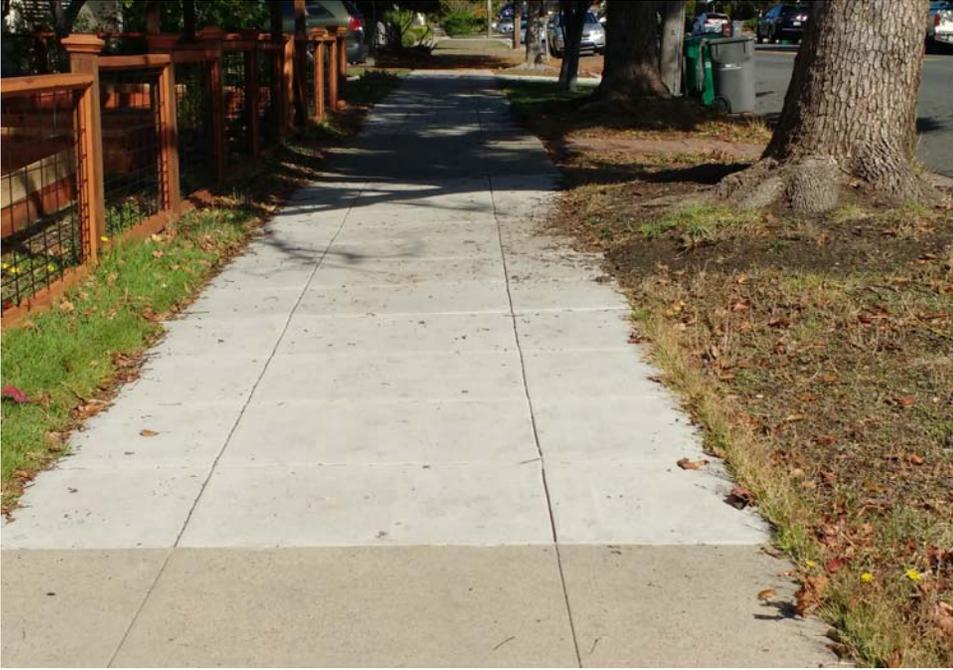
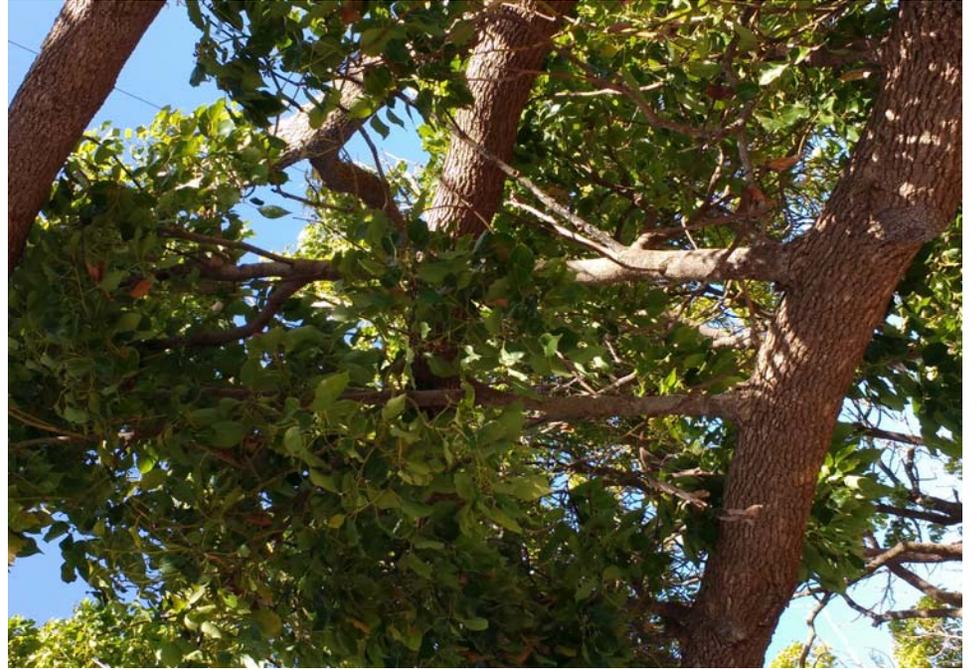
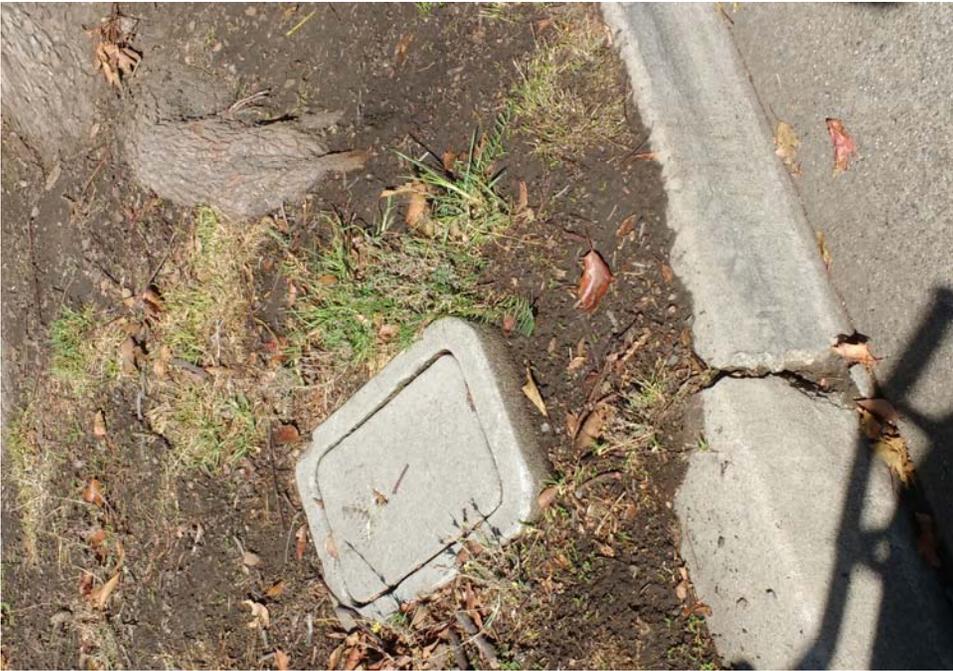
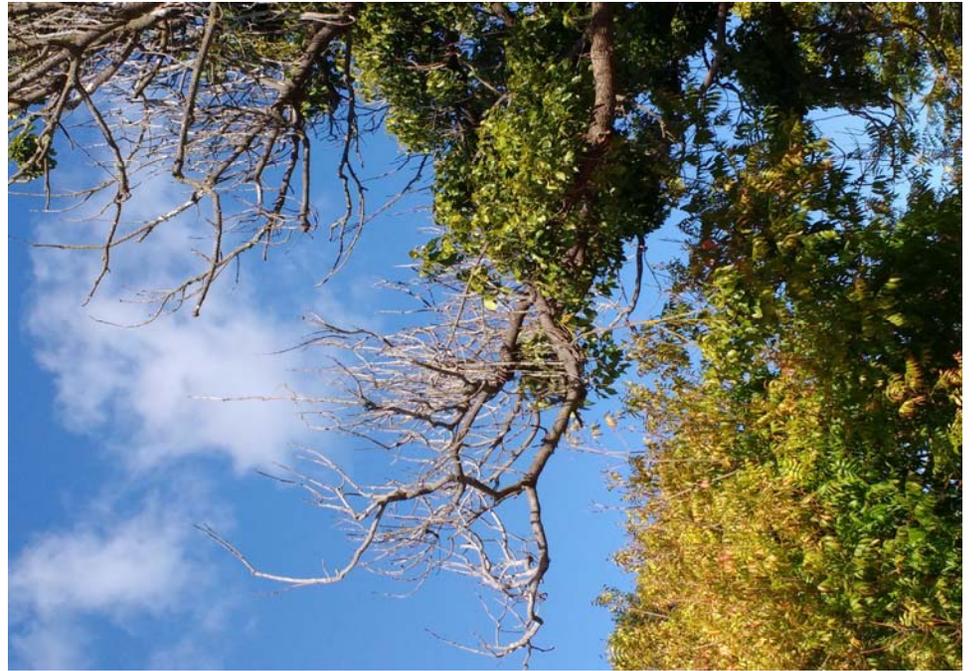
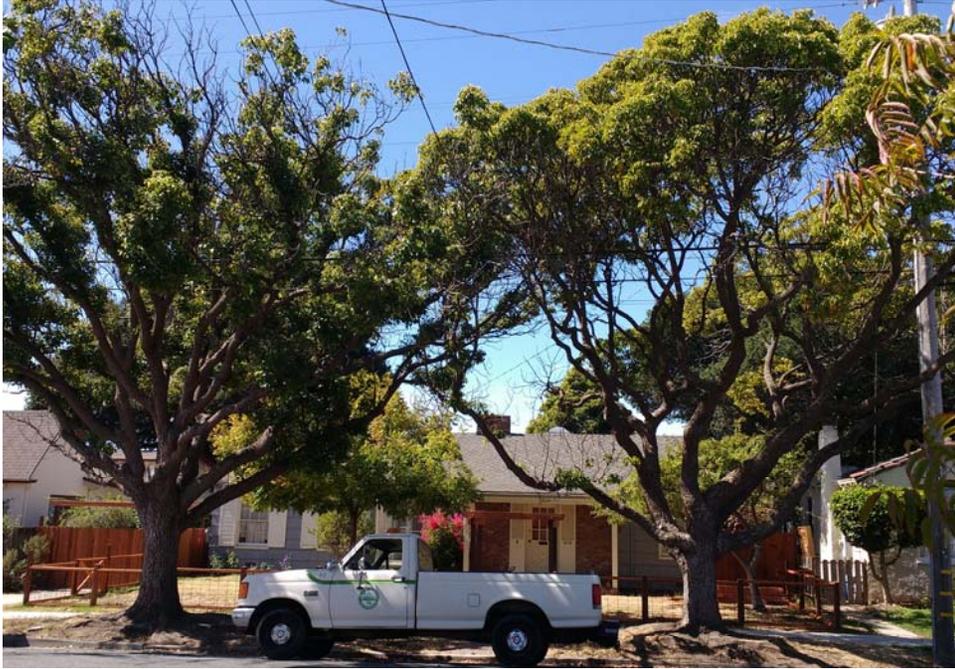
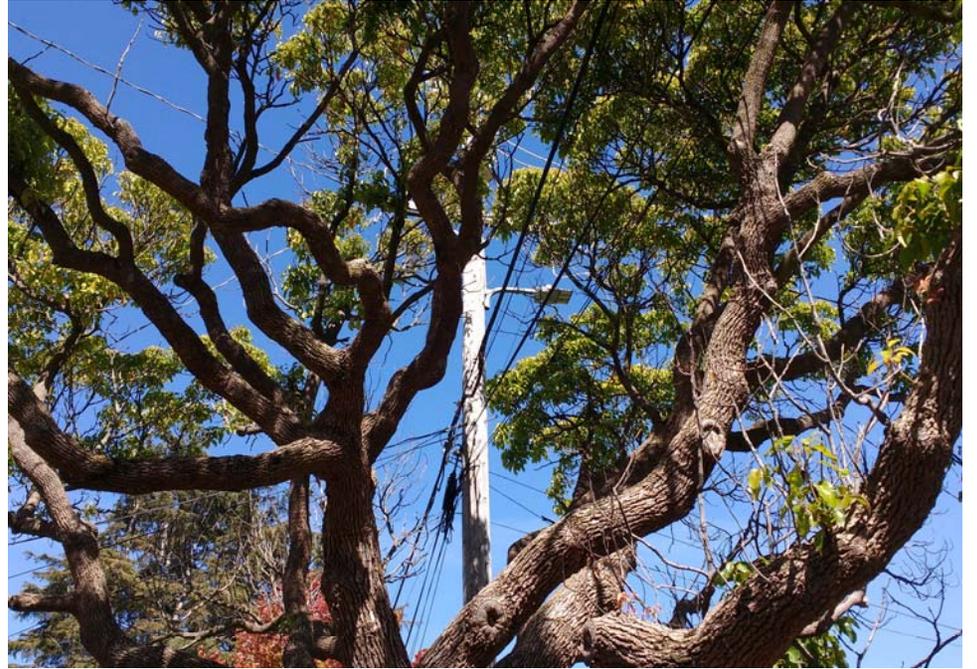
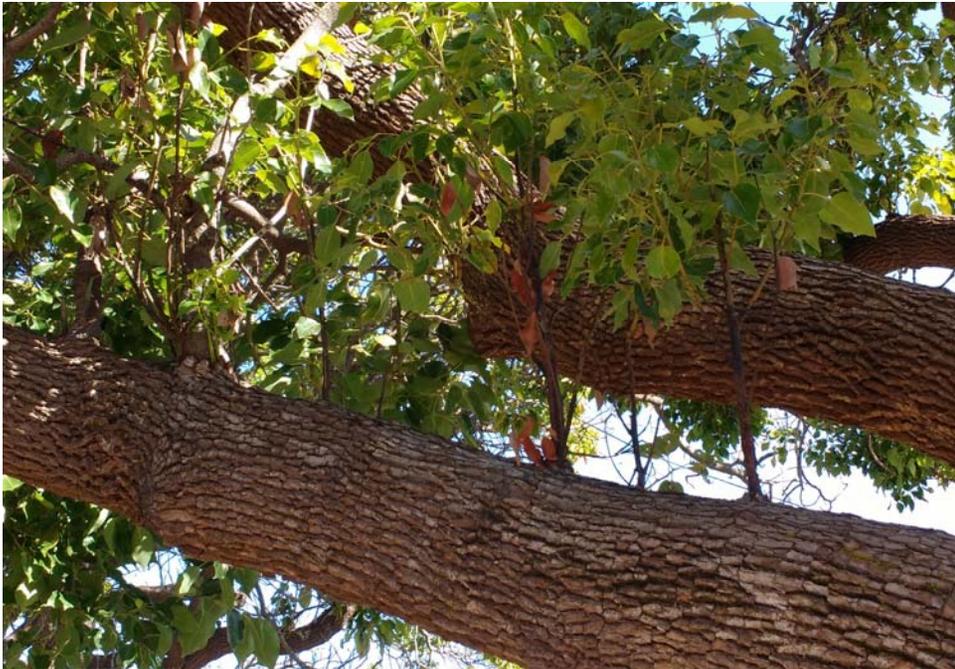
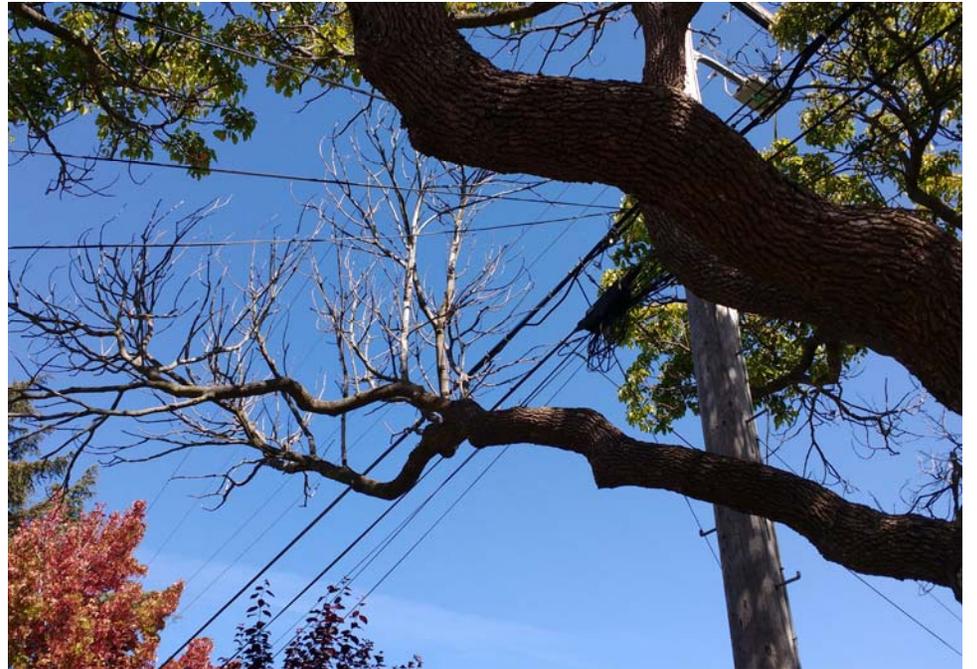
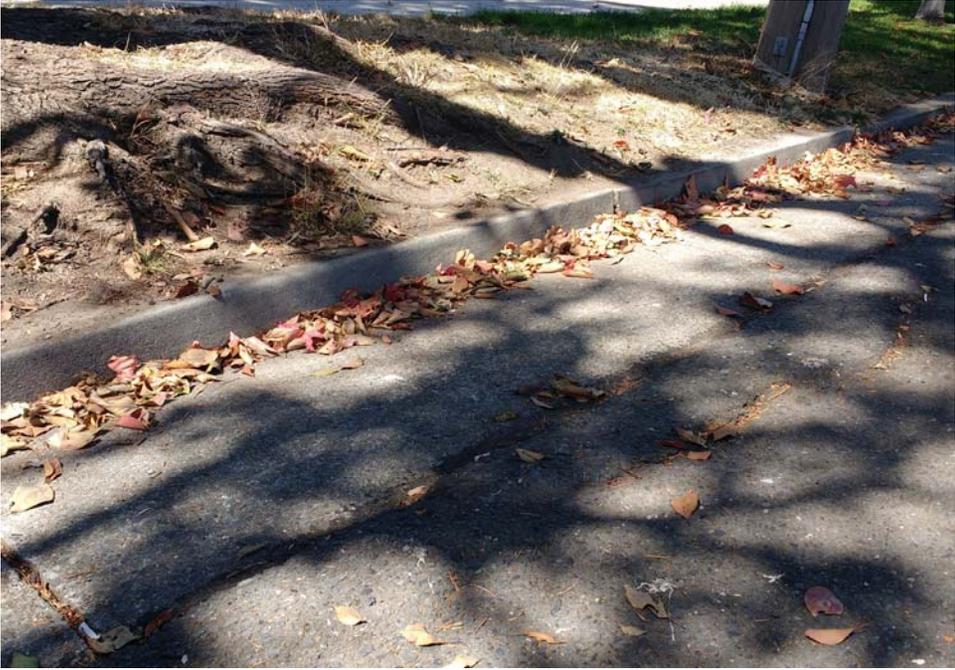
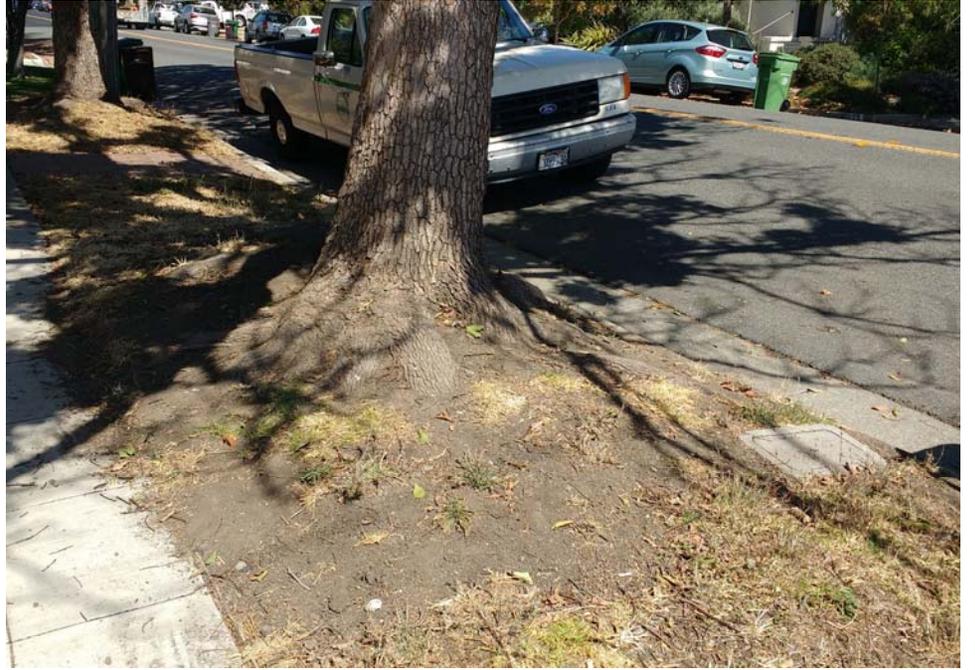
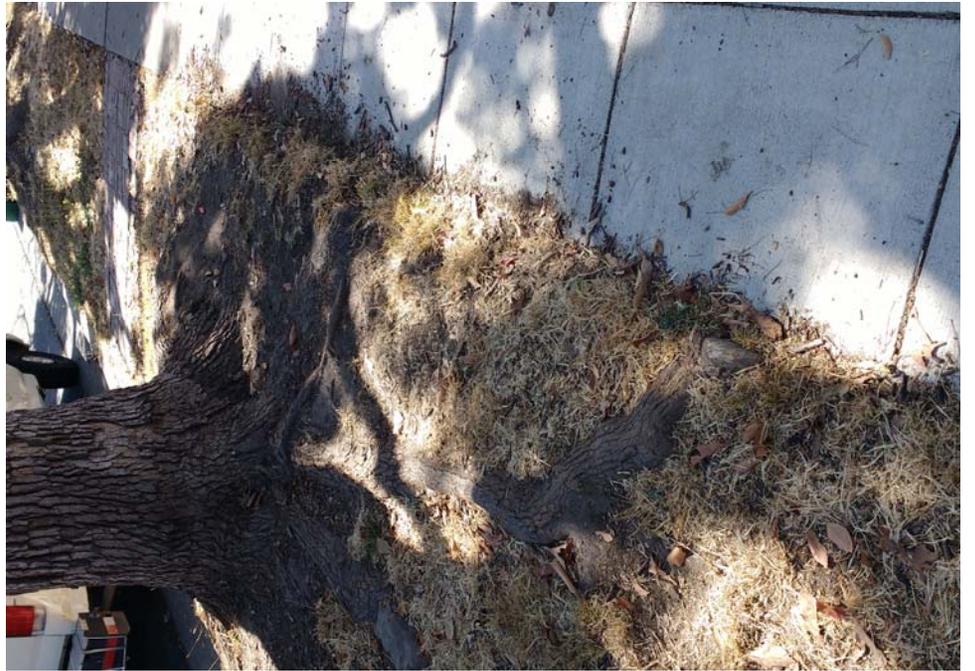
#1: tree has several broken limbs from vehicles due to growth being forced outwards by overshadowing from Cork Oak

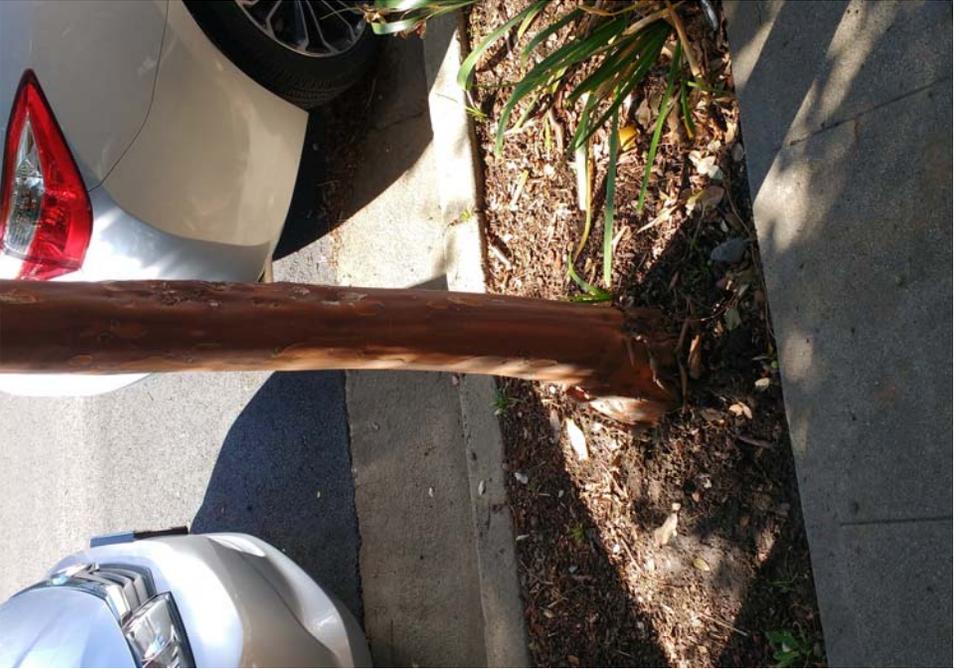
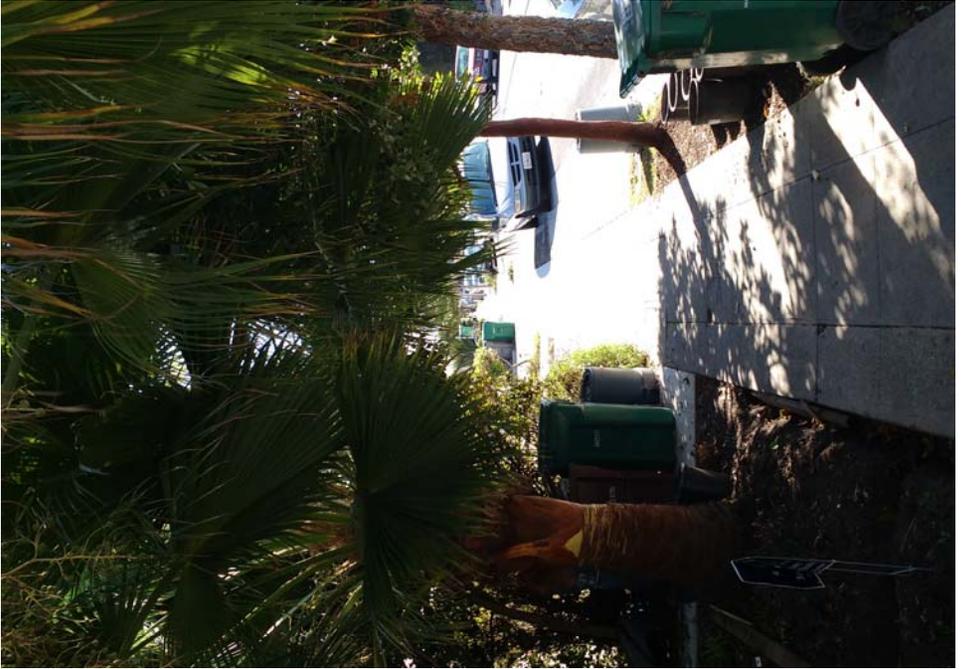
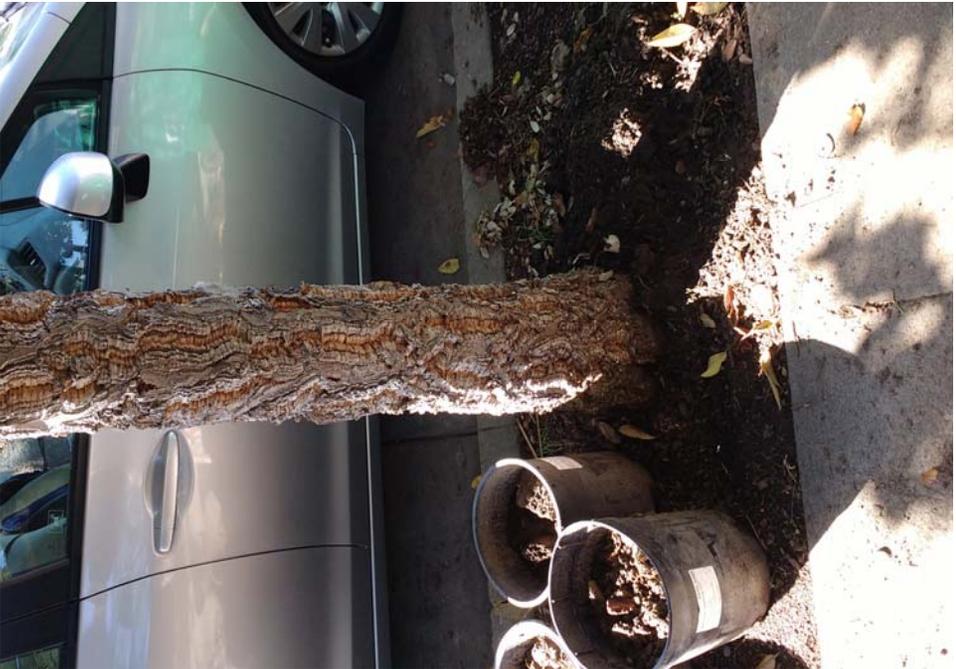
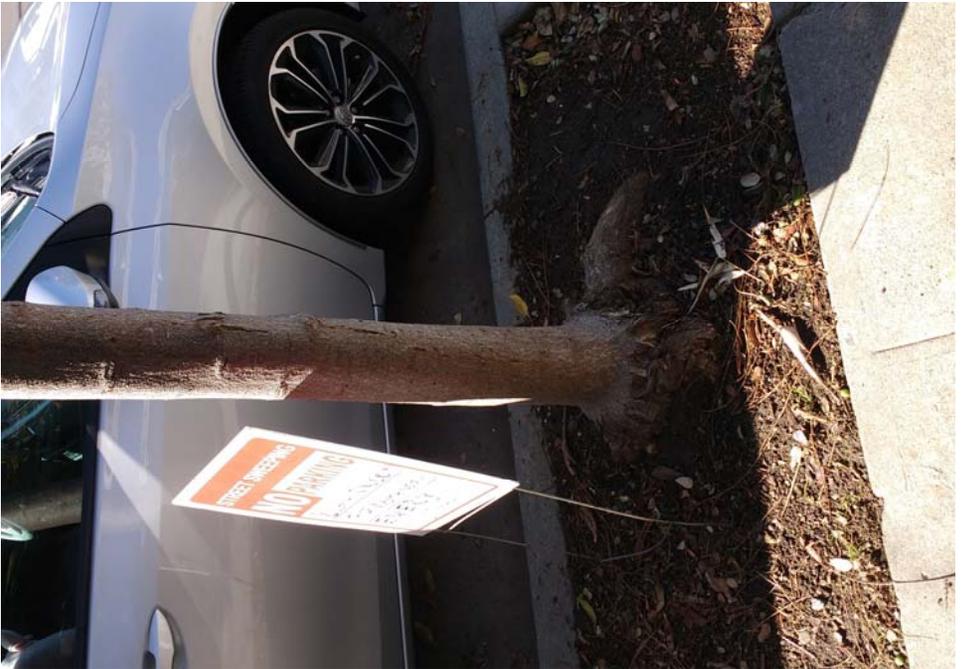
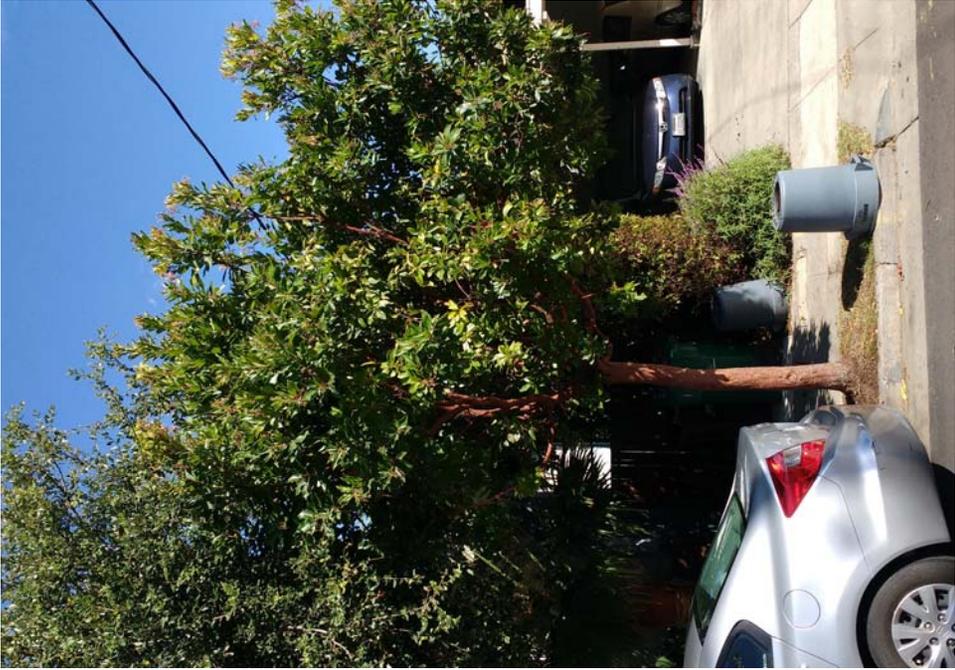
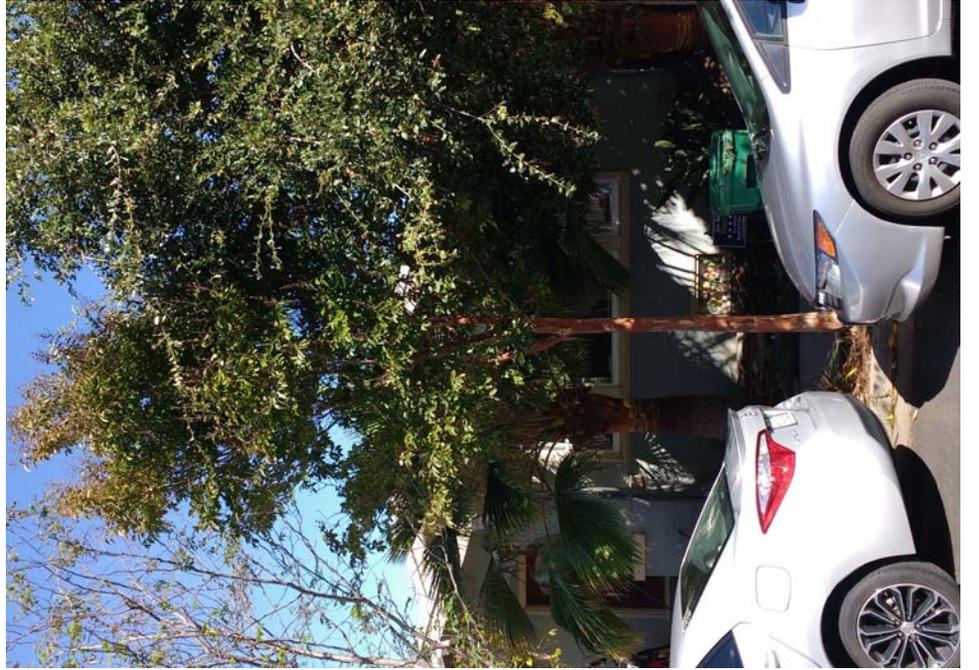
<b>TREE SUMMARY and additional comments</b> (photos and further comments, if any, on separate page):	<b>Total Points</b>	<b><u>5</u></b>
<p>4 trees are planted in front of this house, as well as 2 palms and a lemon tree in the front yard. Trees were planted too closely. Crape Myrtle and Arbutus are being stunted and forced to grow irregularly. Owner would like to remove 2 trees without replacement. This is recommended for health and structure of the remaining 2 trees.</p>

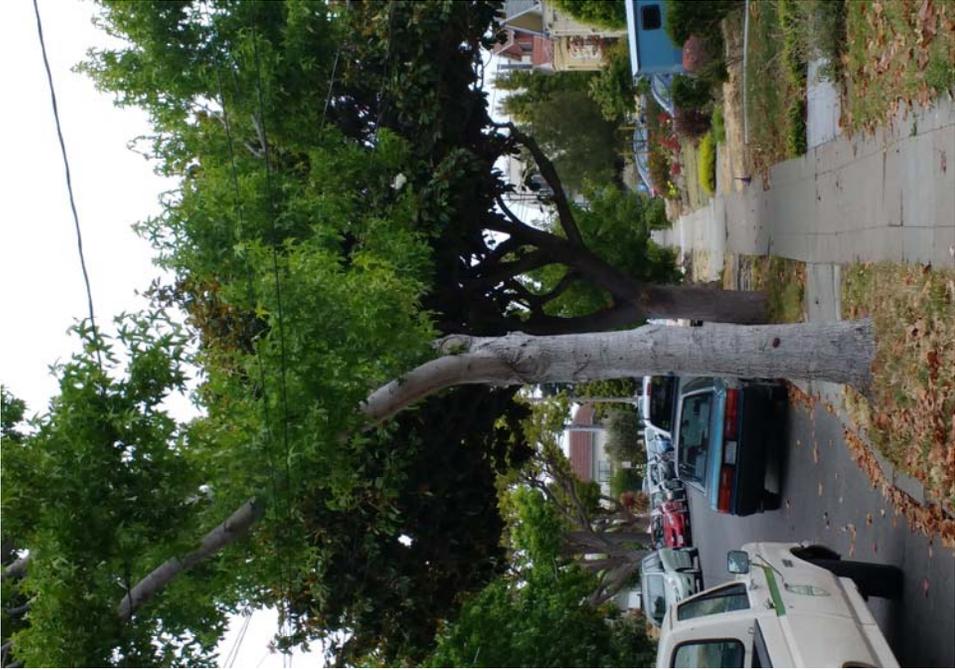
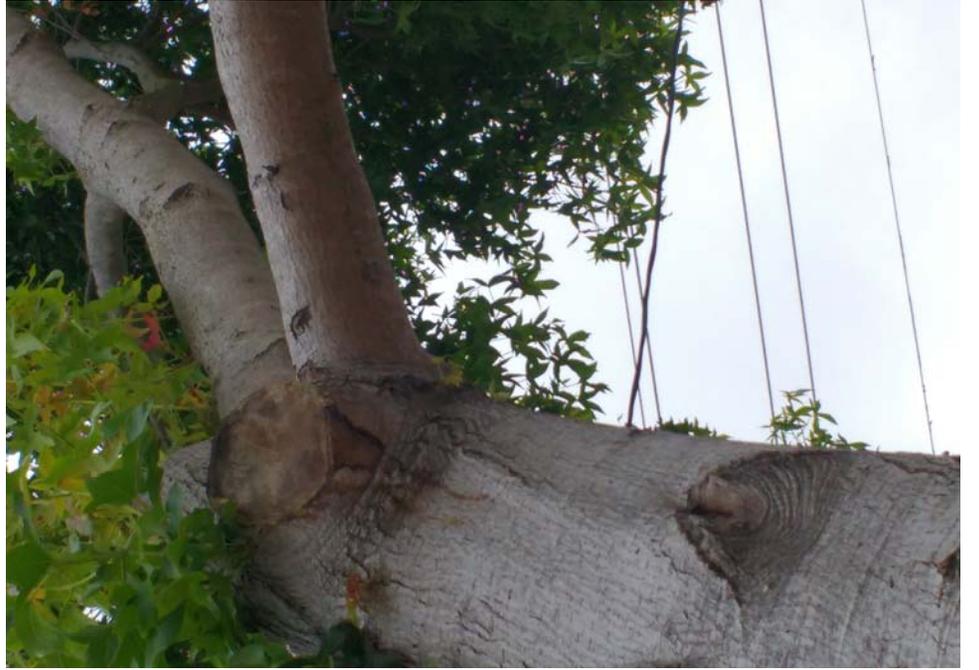
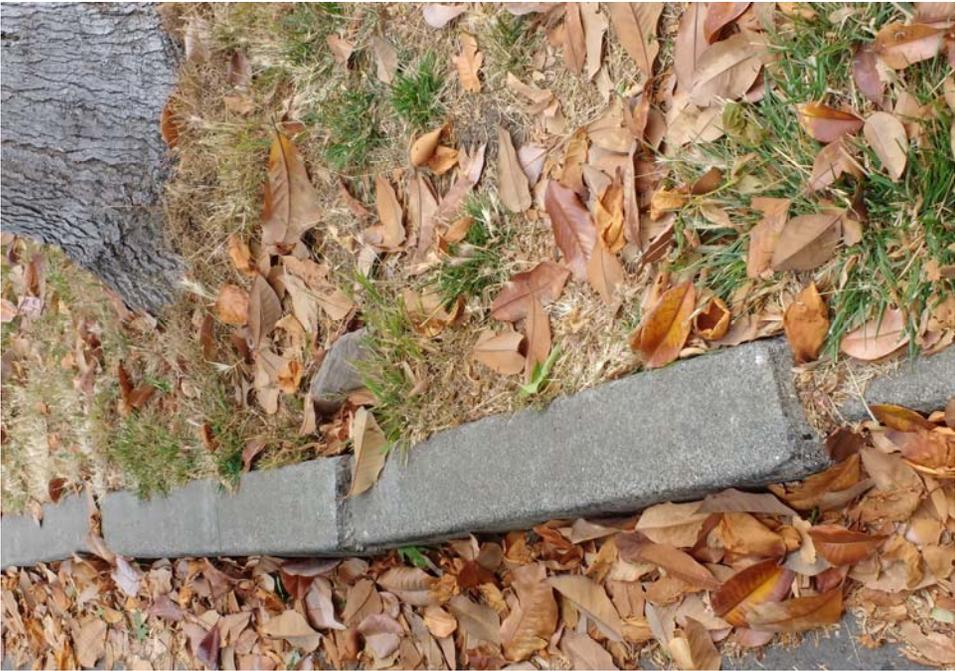
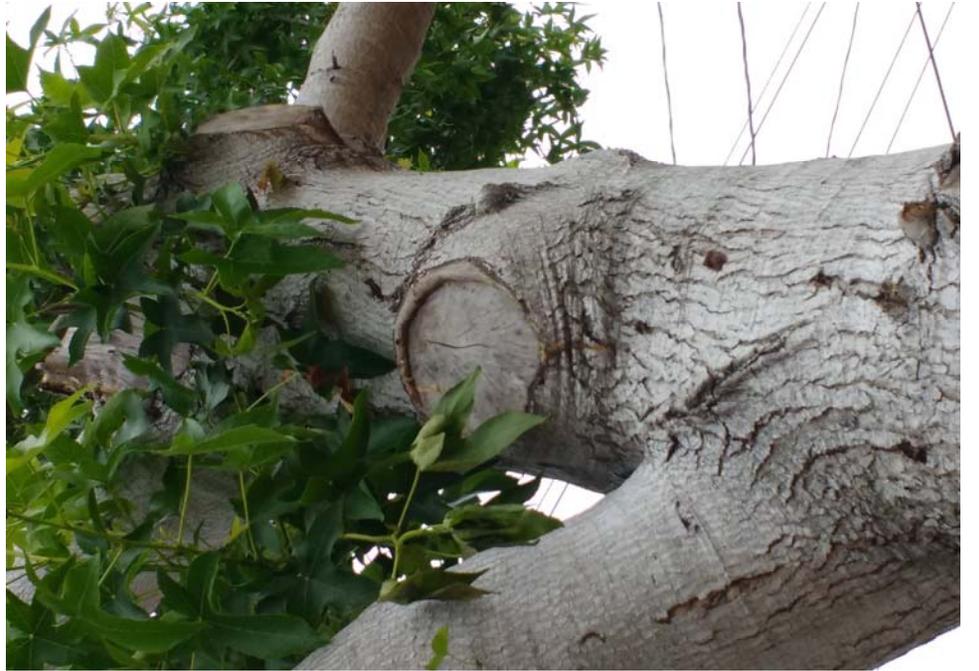
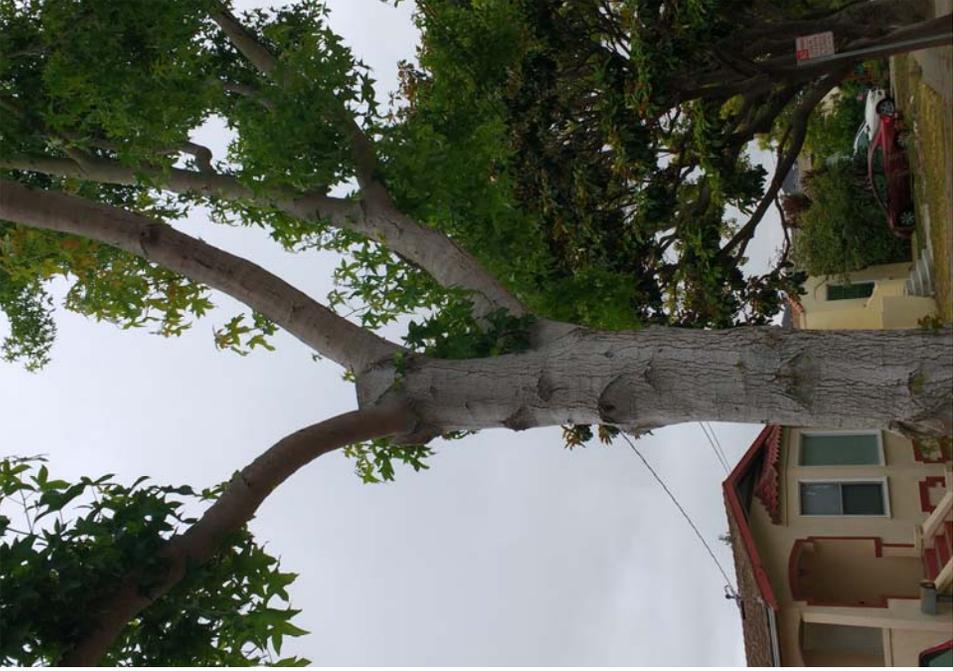
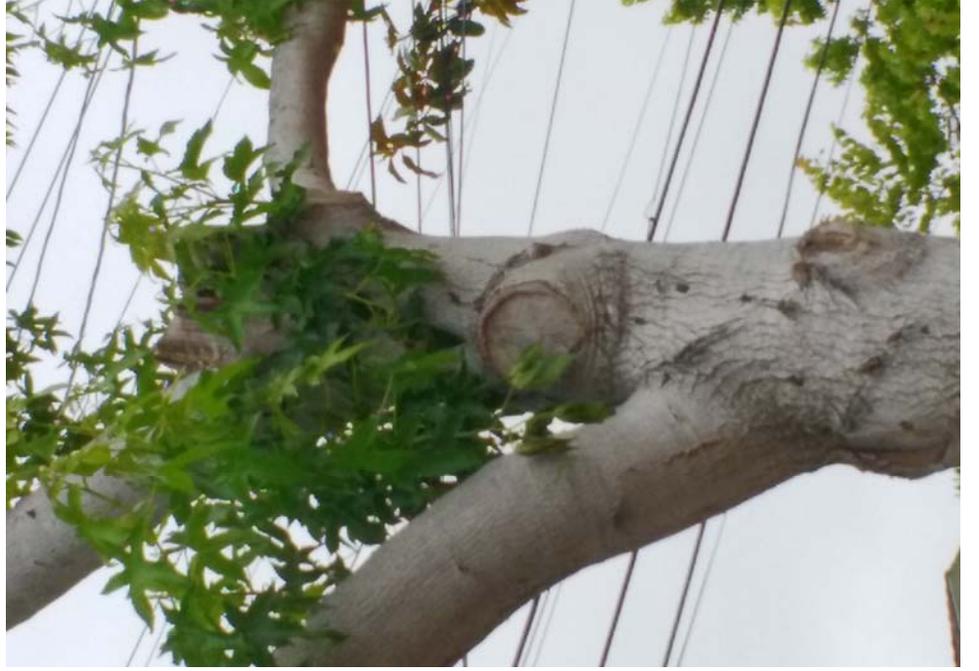
Large wound on main trunk, top of tree broke out leaving tear susceptible to decay. several other large cuts along the main stem.

This tree is prone to failure at site of the large wound on the trunk. Remaining limbs are unevenly balanced over the street. One of 4 remaining limbs is causing excessive stress on an electrical service drop and would need to be removed.

Poorly maintained tree, major wound in mian trunk/top broken out, area of eventual decay and failure. Suggest remove and replace tree.

**remove tree and replace with more suitable species (TBD)**
