**PARKS AND RECREATION COMMISSION MEETING AGENDA**  
**Thursday, November 10, 2016, 7:00 pm**  
**City Hall Council Chambers, 1000 San Pablo Avenue**

**5-1: Tree Removal Application:** The Commission will review the two (2) tree removal applications submitted for 510 Santa Fe Avenue.

# City of Albany Street Tree Inspection / Staff Report

**Tree Location:** 510 Santa Fe Tree # (direction of traffic): 1&2

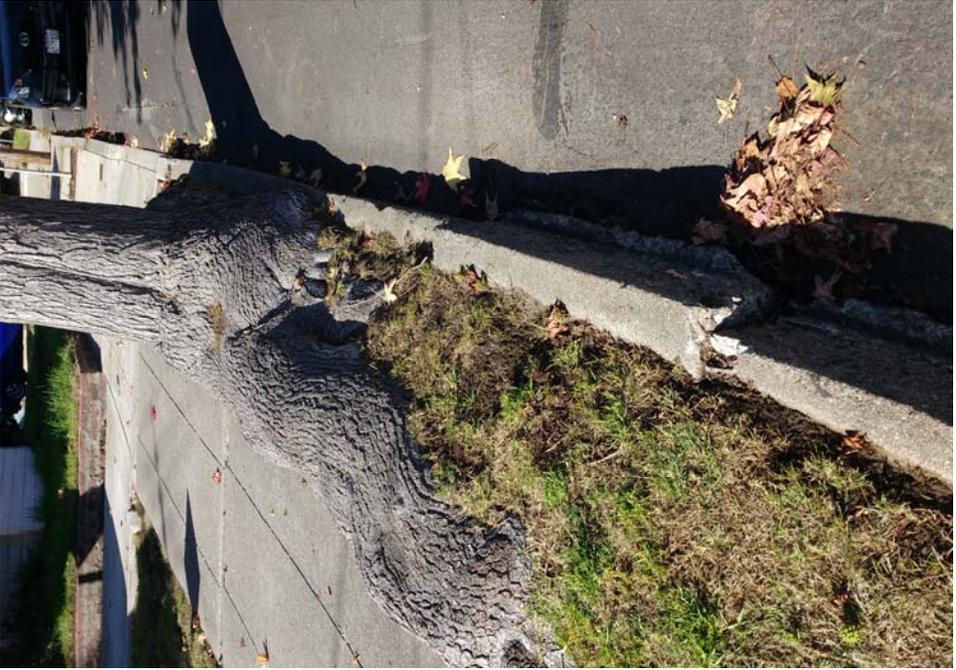
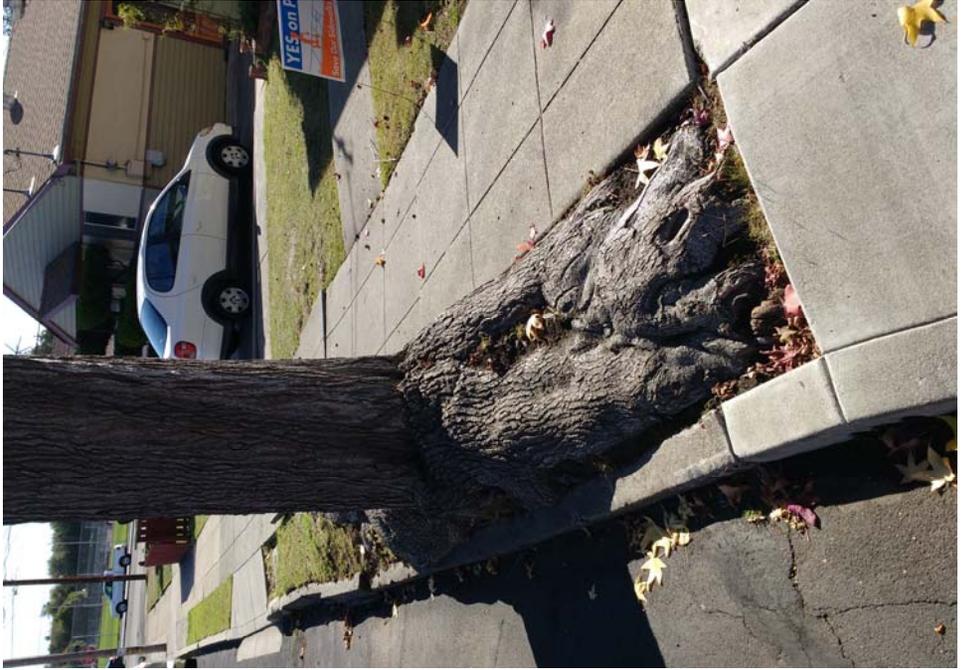
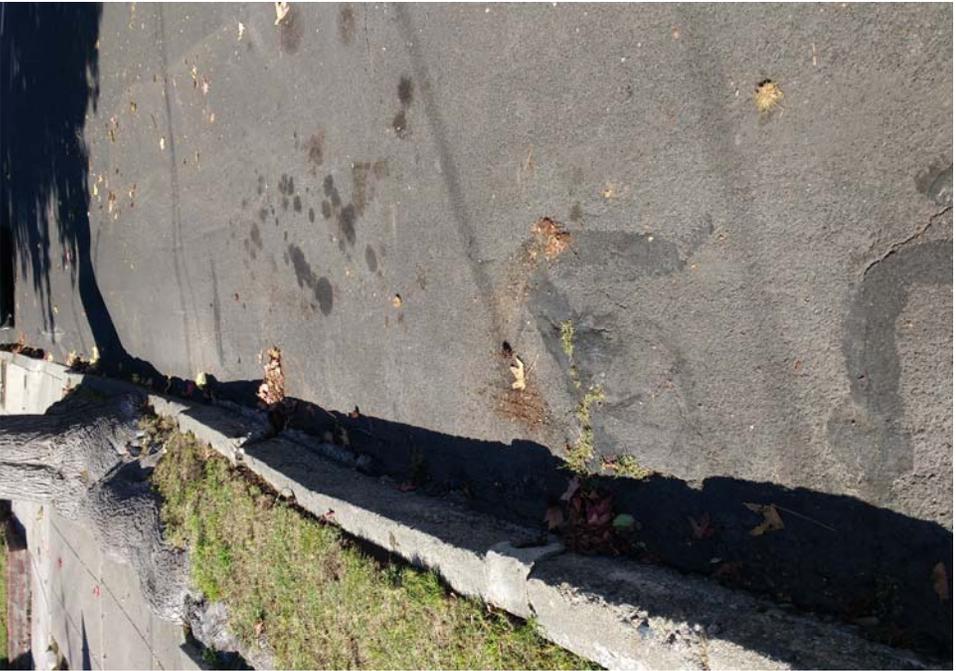
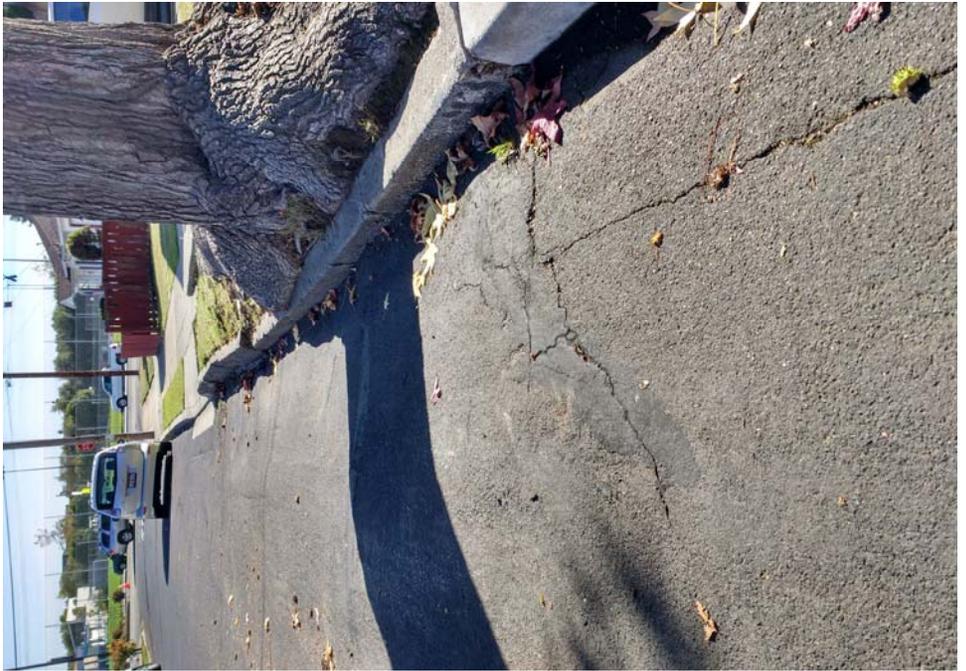
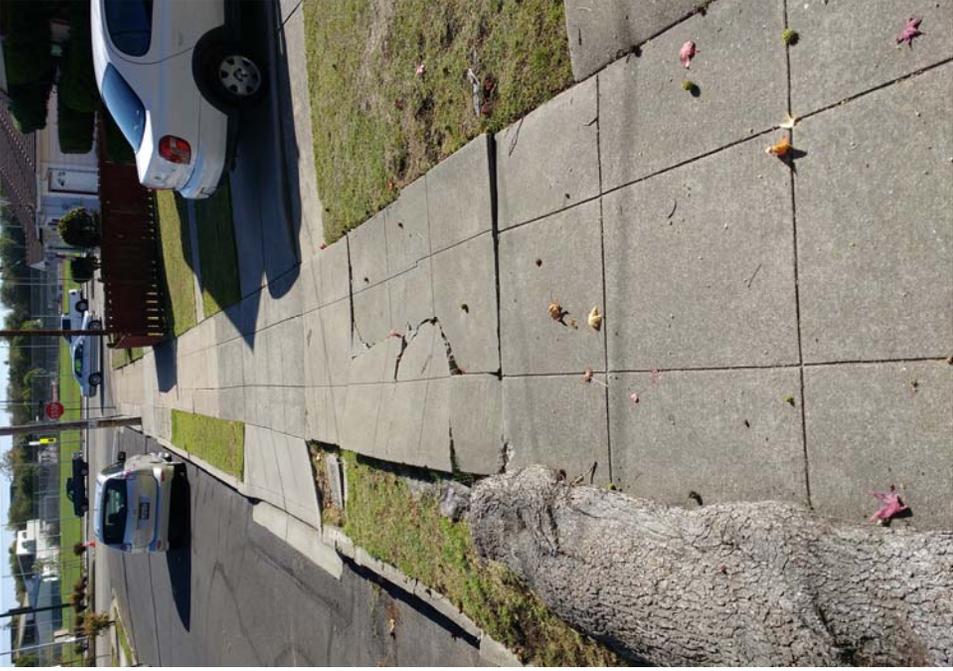
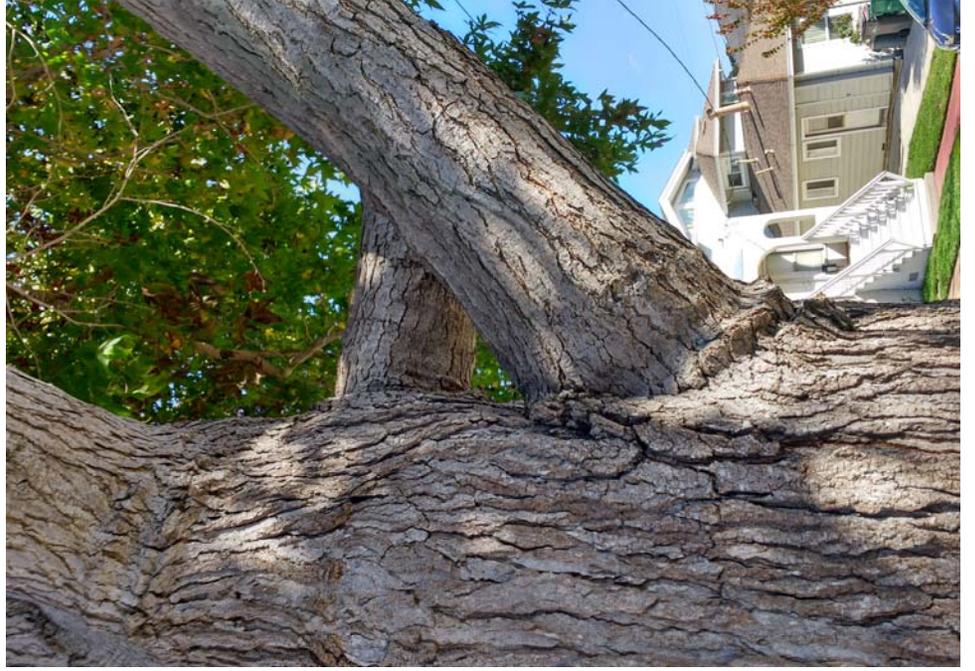
tree has been topped by PG&E and will continue to be topped if left in place. root crown has spread over most of the planting strip. sidewalk, curb and street have some damage due to tree roots.

previous sidewalk repair. new sidewalk broken, lifting and cracking of sidewalk and curb. curb pushed out slightly, asphalt bulged slightly.

remove and replace

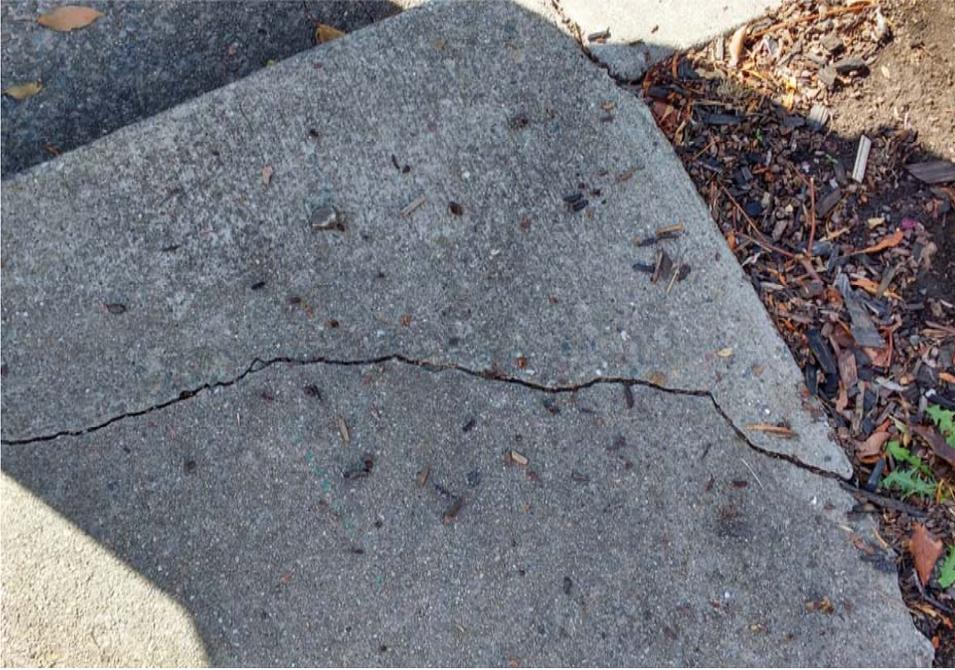
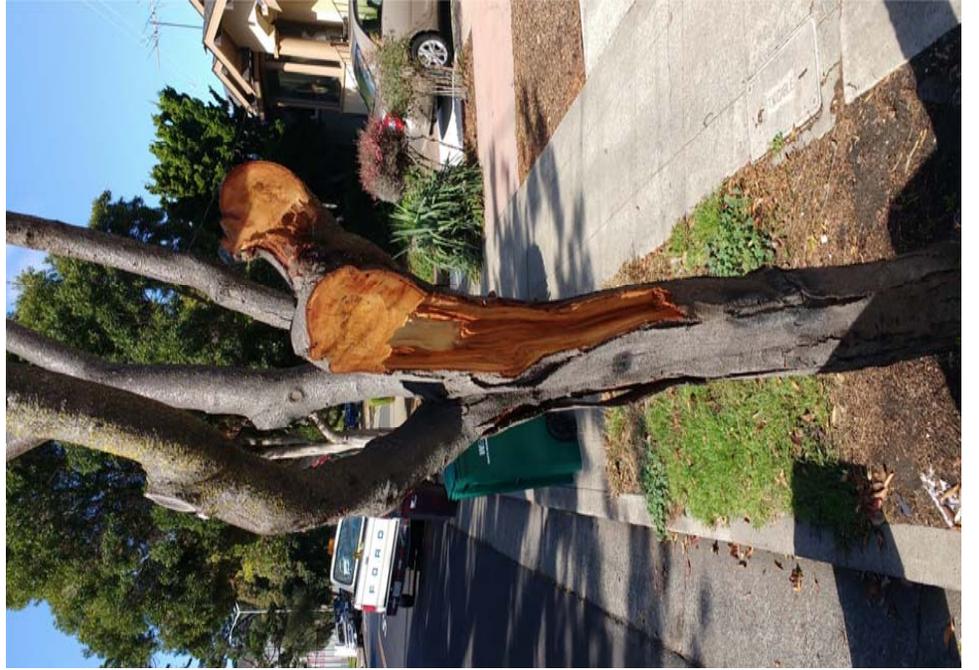
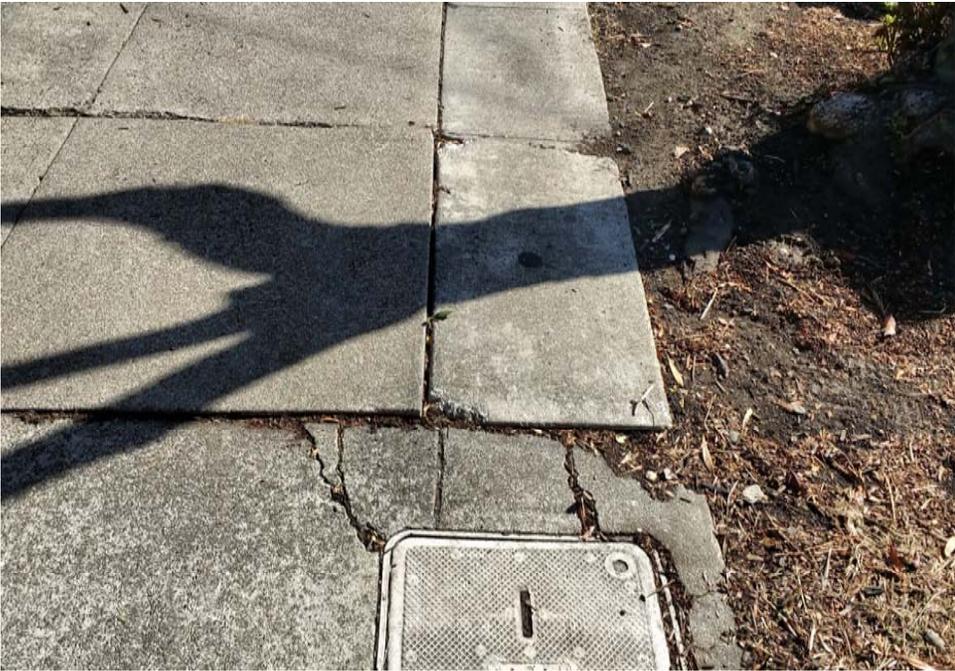
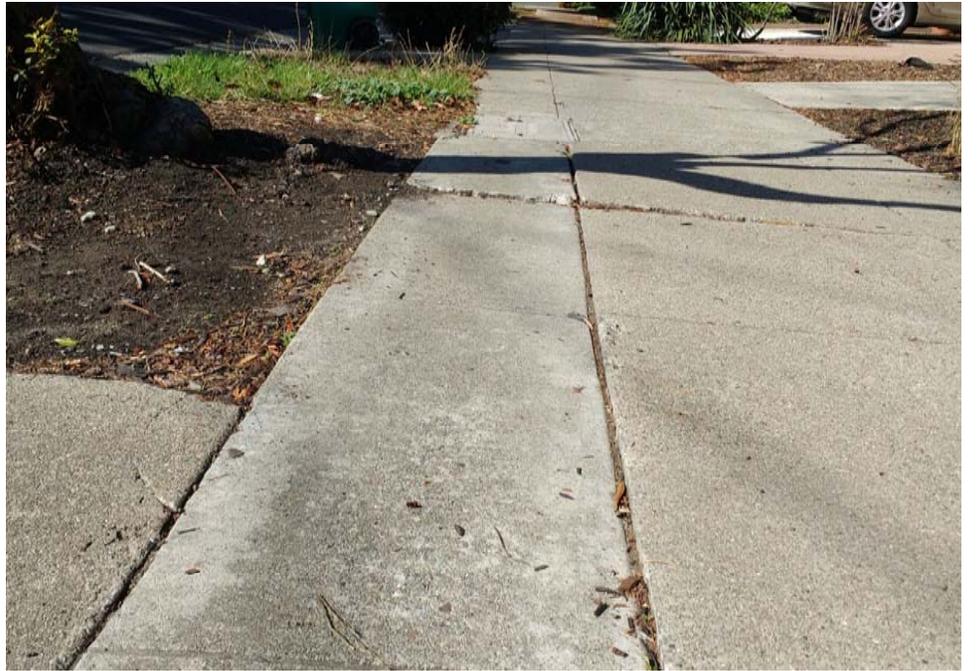
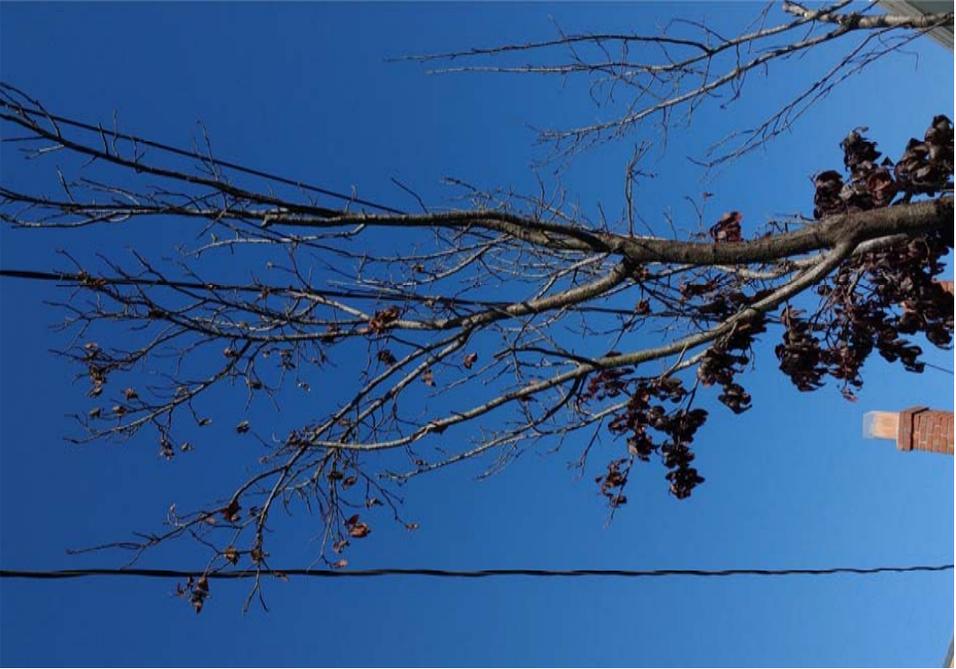
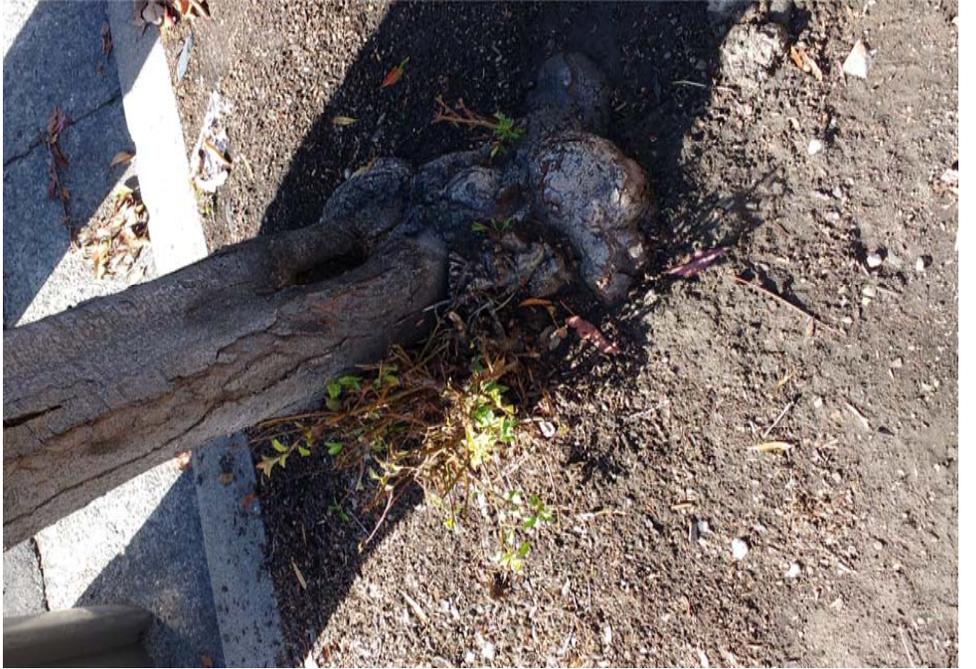
tree has had a large limb failure, limb has been removed, but there is a large tear on the trunk, and another dead limb in the tree

<b>TREE SUMMARY and additional comments</b> (photos and further comments, if any, on separate page):	<b>Total Points</b>	<b><u>24</u></b>
heavy damage due to failed limb. Tree should be removed and replaced.

**remove and replace**
