ALBANY - STREET LIGHTING EVALUATION

EXISTING LIGHTING CONDITIONS

07/28/2023

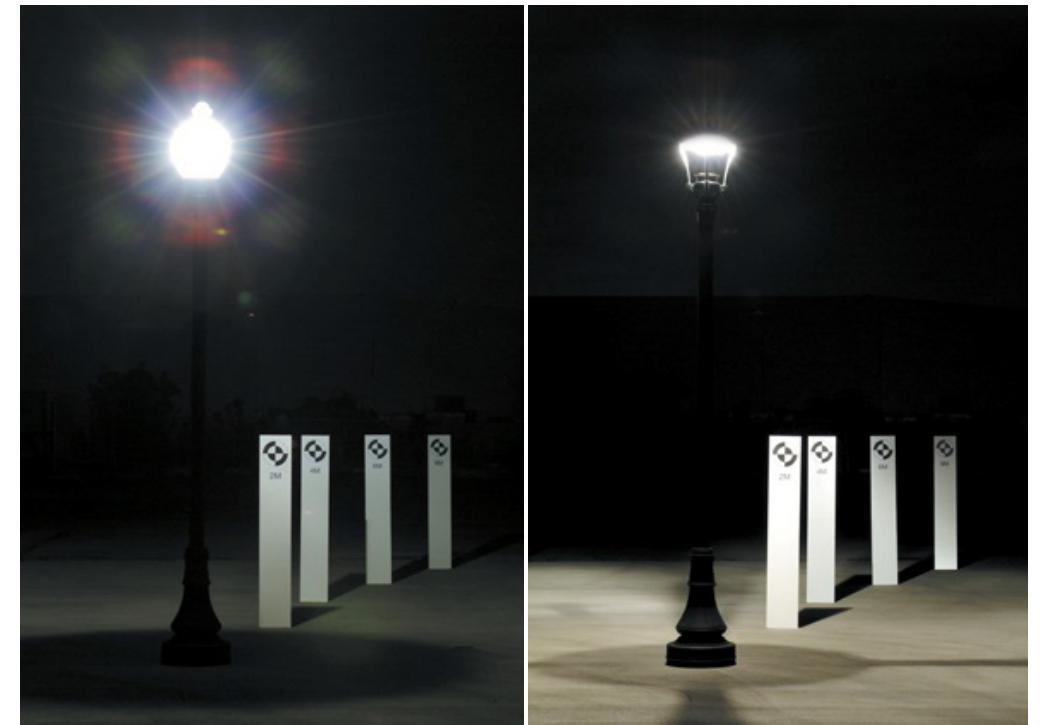
IMPACT OF GLARE

Glare is caused by excessive or undesirable light entering the eye from a bright light source. Glare can result in discomfort, annoyance, and decreased visibility. The experience of direct glare can happen when a light source is in direct view. The presence of direct glare depends on the intensity of the light source and its contrast with the surrounding environment. While experiencing direct glare the eye has a harder time seeing contrast and details. A lighting system designed solely around the desired lighting level tends to aim more light at higher viewing angles, thus producing more potential for glare. Direct glare can be minimized with careful equipment selection as well as luminaire placement.

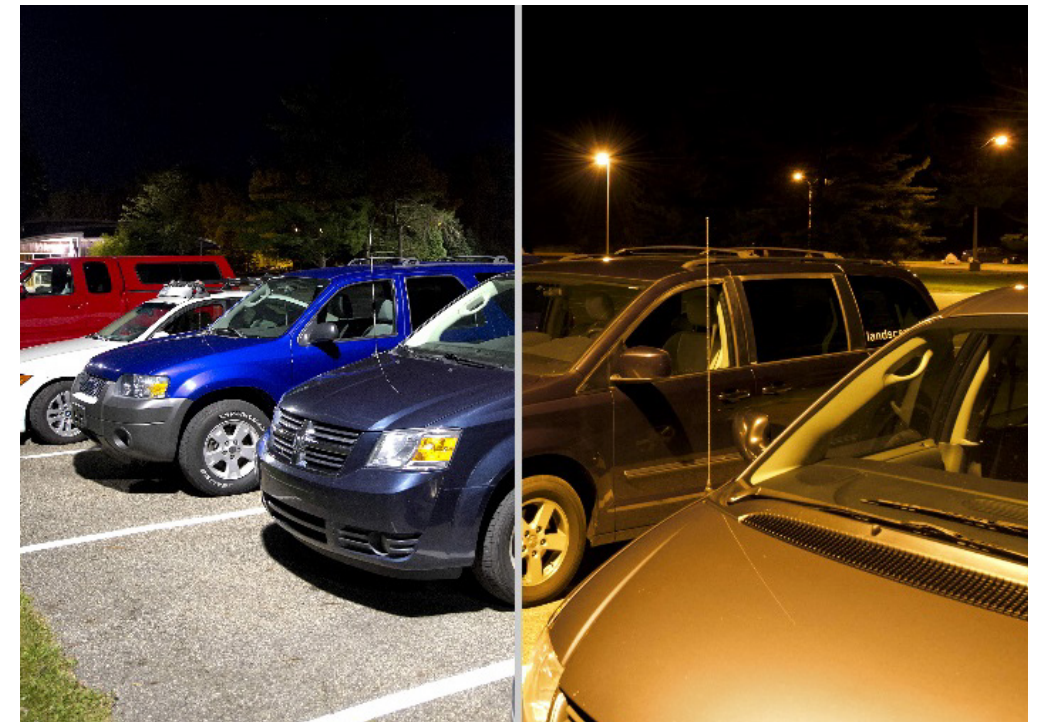
IMPACT OF CRI

This is the standard metric used to evaluate how well a light source renders the true color of an object. CRI is measured on a scale of 0 to 100, with 100 representing how an object would look under a referenced incandescent light source that is very similar to natural daylight. The higher the number, the better the color rendering capacity of the light source. Traditional High-Pressure Sodium (“HPS”) streetlights have a very low CRI of approximately 30, which makes identifying different colors very difficult for the typical human eye. Contemporary LED streetlights have a much higher CRI of around 70 by default. Higher CRI light sources generally contain a fuller spectrum of visible light and thus appear brighter to the human eye even when the lumen output is ostensibly the same.

In the past, higher CCT’s have had better CRI scores, but improvements in LED technology have made higher CRI with lower CCT’s increasingly possible. This has applications in environmentally sensitive areas. Overall these improvements in lighting technology increase color detection, visual acuity, and the overall effectiveness of outdoor lighting in our communities.

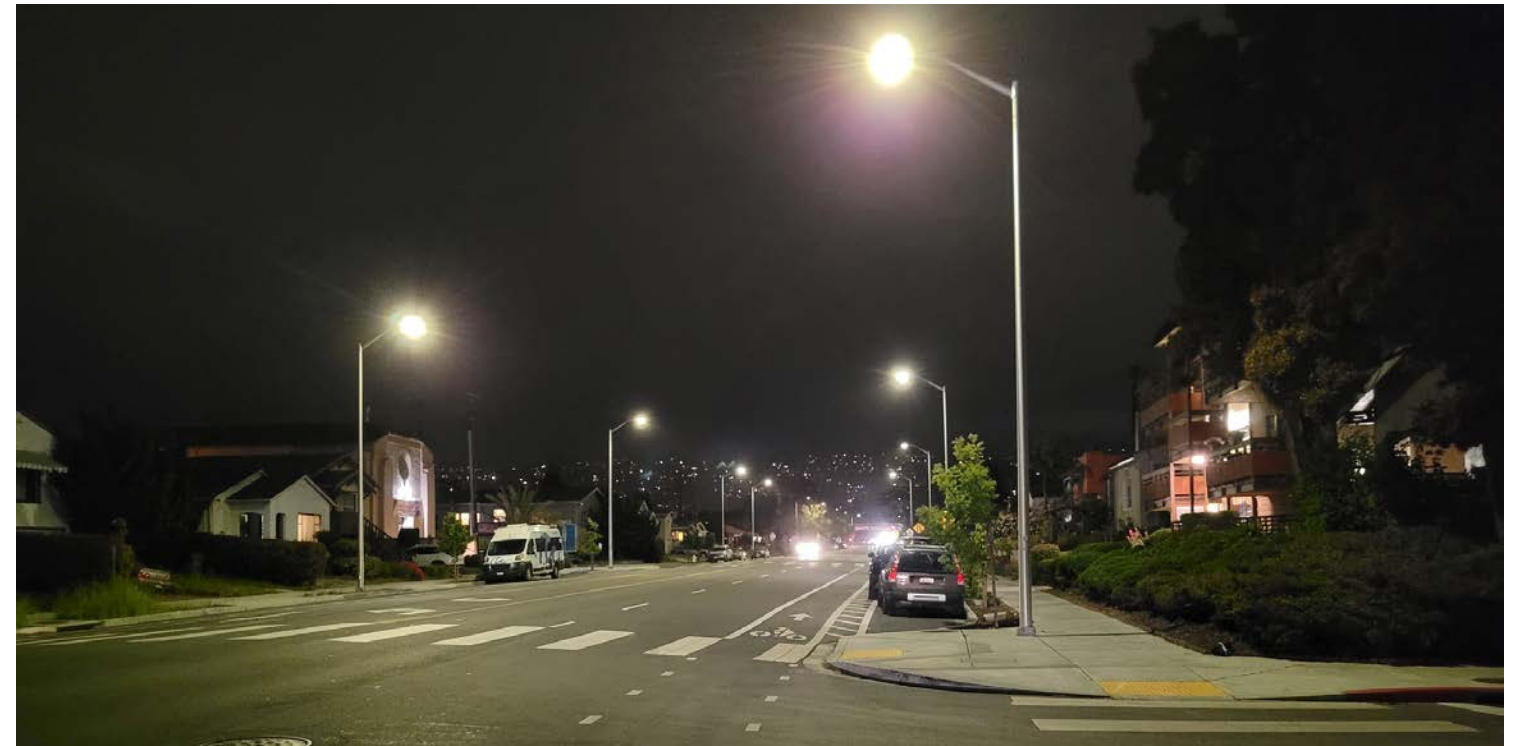
SITE PHOTO: ACCEPTABLE

- # **Acceptable:** Sites given this classification either met or were generally in an acceptable range of meeting IES criteria. They provided enough quality lighting for safety and visual comfort.
- # **Marginal:** Sites given this classification had lighting that was satisfactory by some measurements but provided a poor experience in other categories. There is room for improvement.
- # **Poor:** Sites given this classification had light levels that were too far below criteria. Visibility was inadequate and there were safety concerns.
- # **Excessive:** Sites given this classification had light levels that were too high above criteria. This leads to glare and difficulties adapting to the lighting in other areas, compromising visibility.

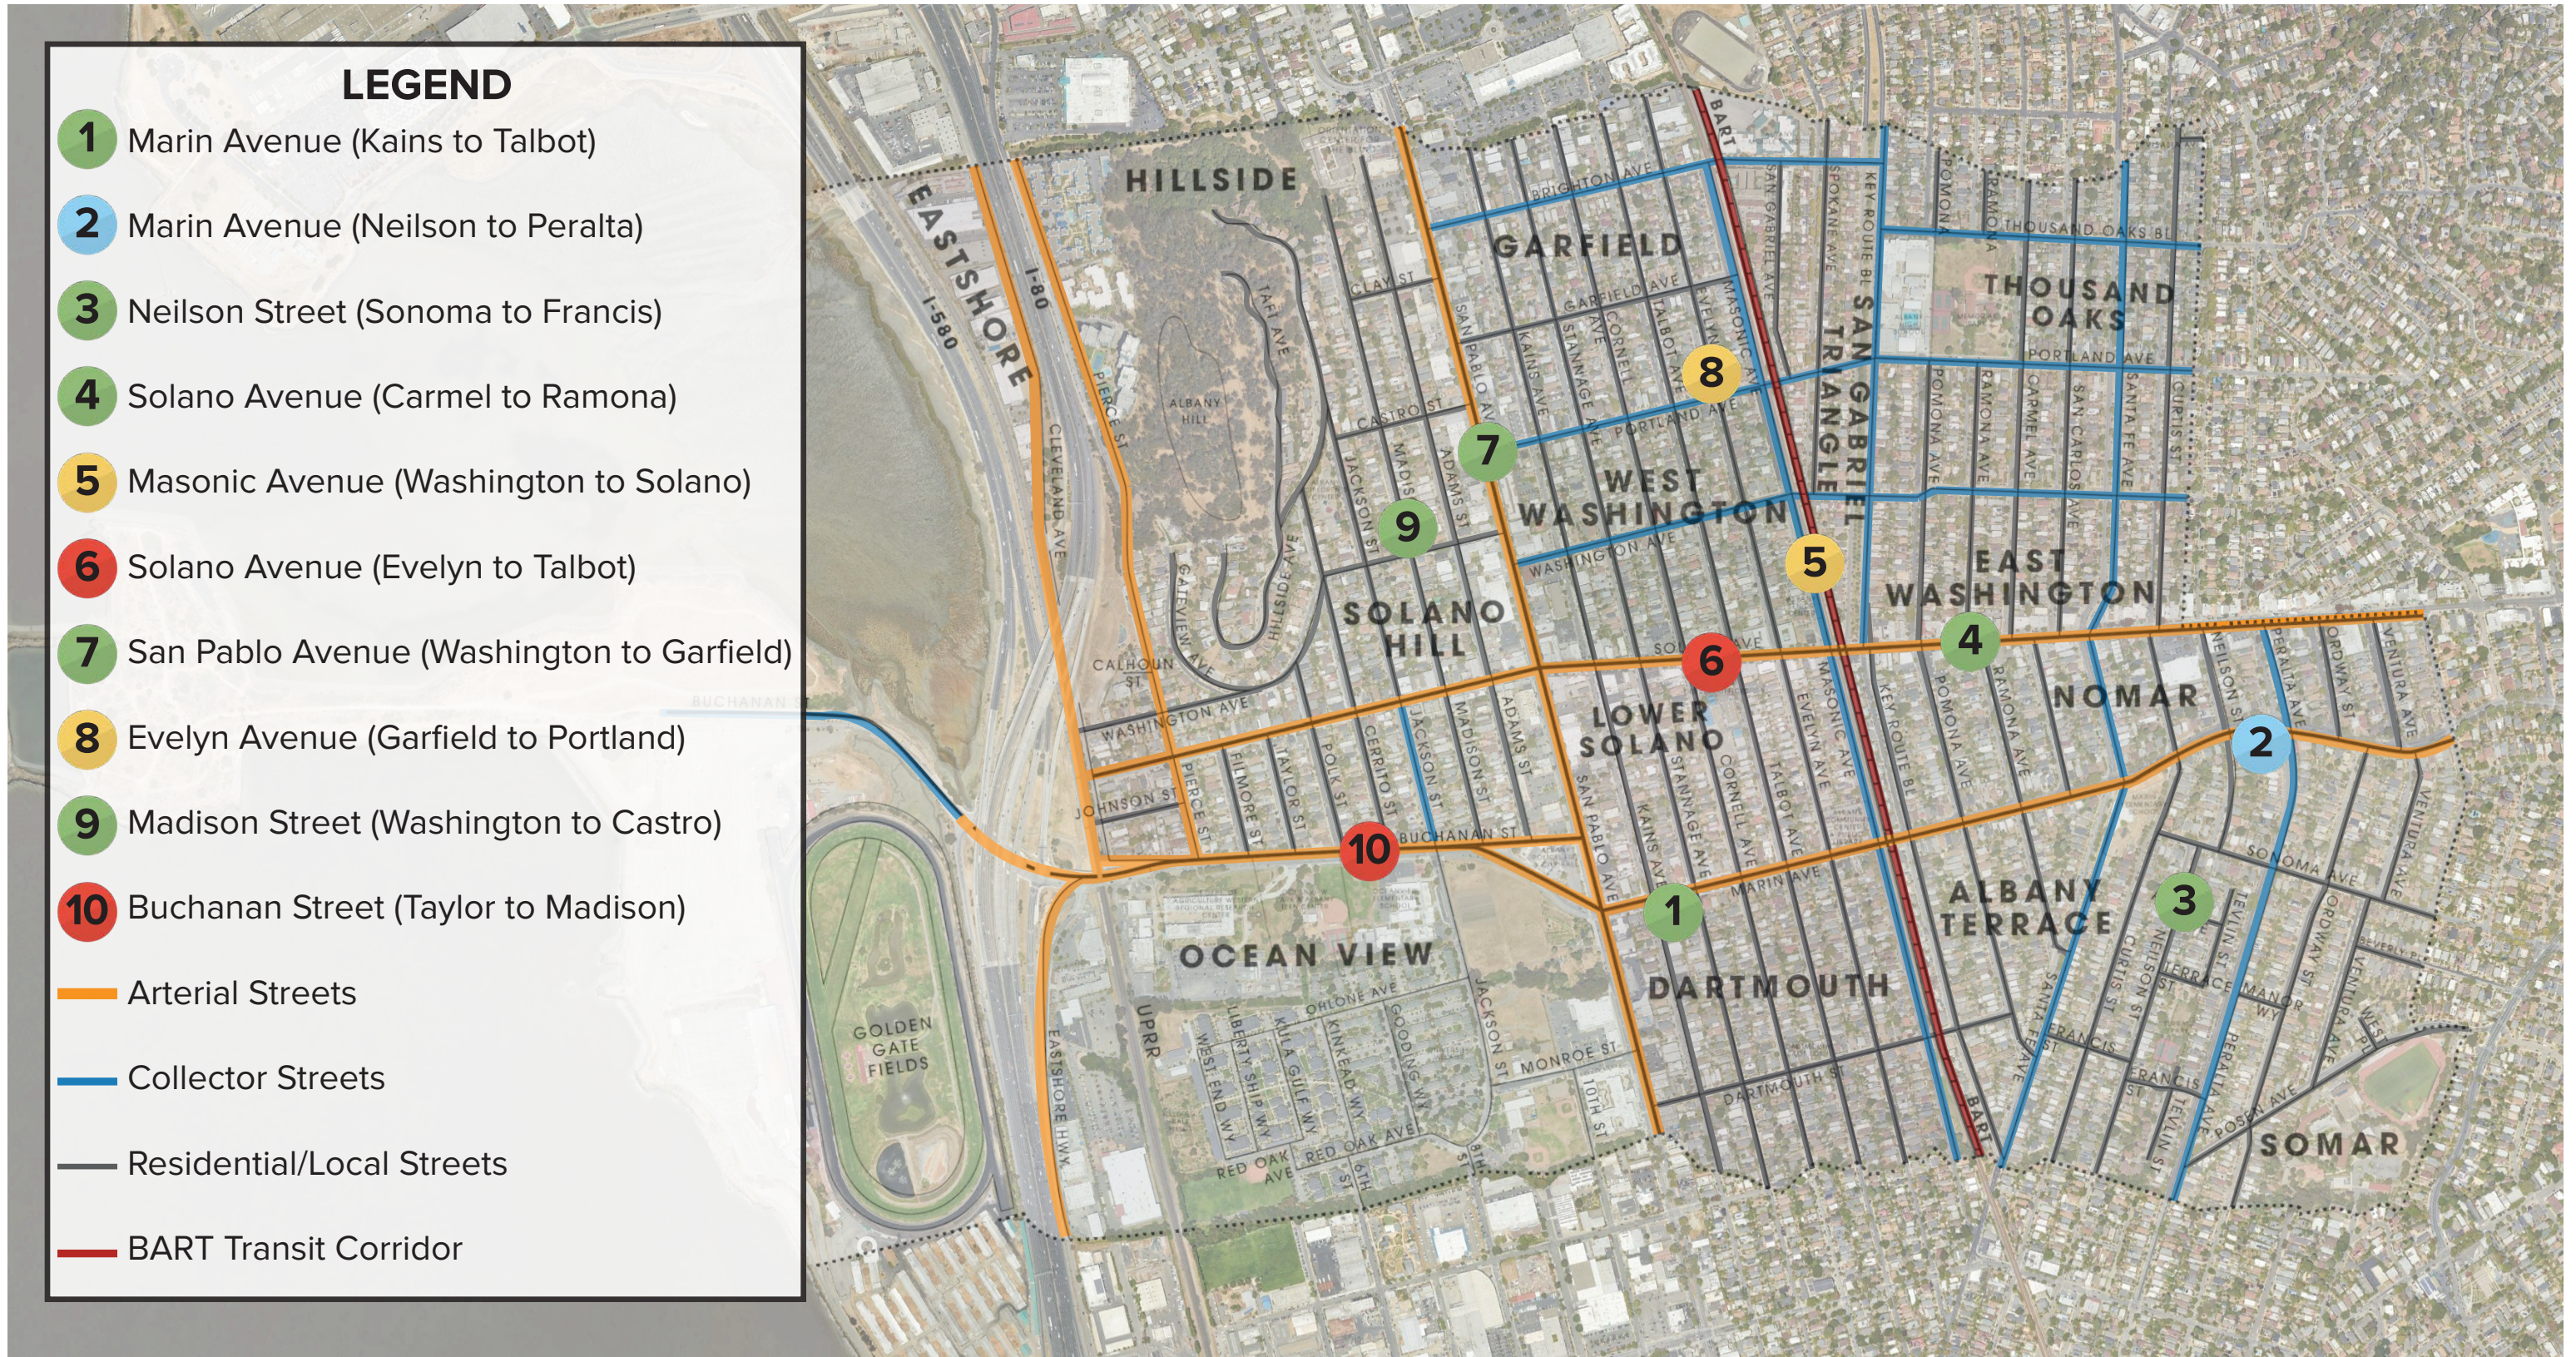
SITE EVALUATION LOCATIONS

- 1) Marin Avenue (Kains to Talbot)
- 2) Marin Avenue (Neilson to Peralta)
- 3) Neilson Street (Sonoma to Francis)
- 4) Solano Avenue (Carmel to Ramona)
- 5) Masonic Avenue (Washington to Solano)
- 6) Solano Avenue (Evelyn to Talbot)
- 7) San Pablo Avenue (Washington to Garfield)
- 8) Evelyn Avenue (Garfield to Portland)
- 9) Madison Street (Washington to Castro)
- 10) Buchanan Street (Taylor to Madison)

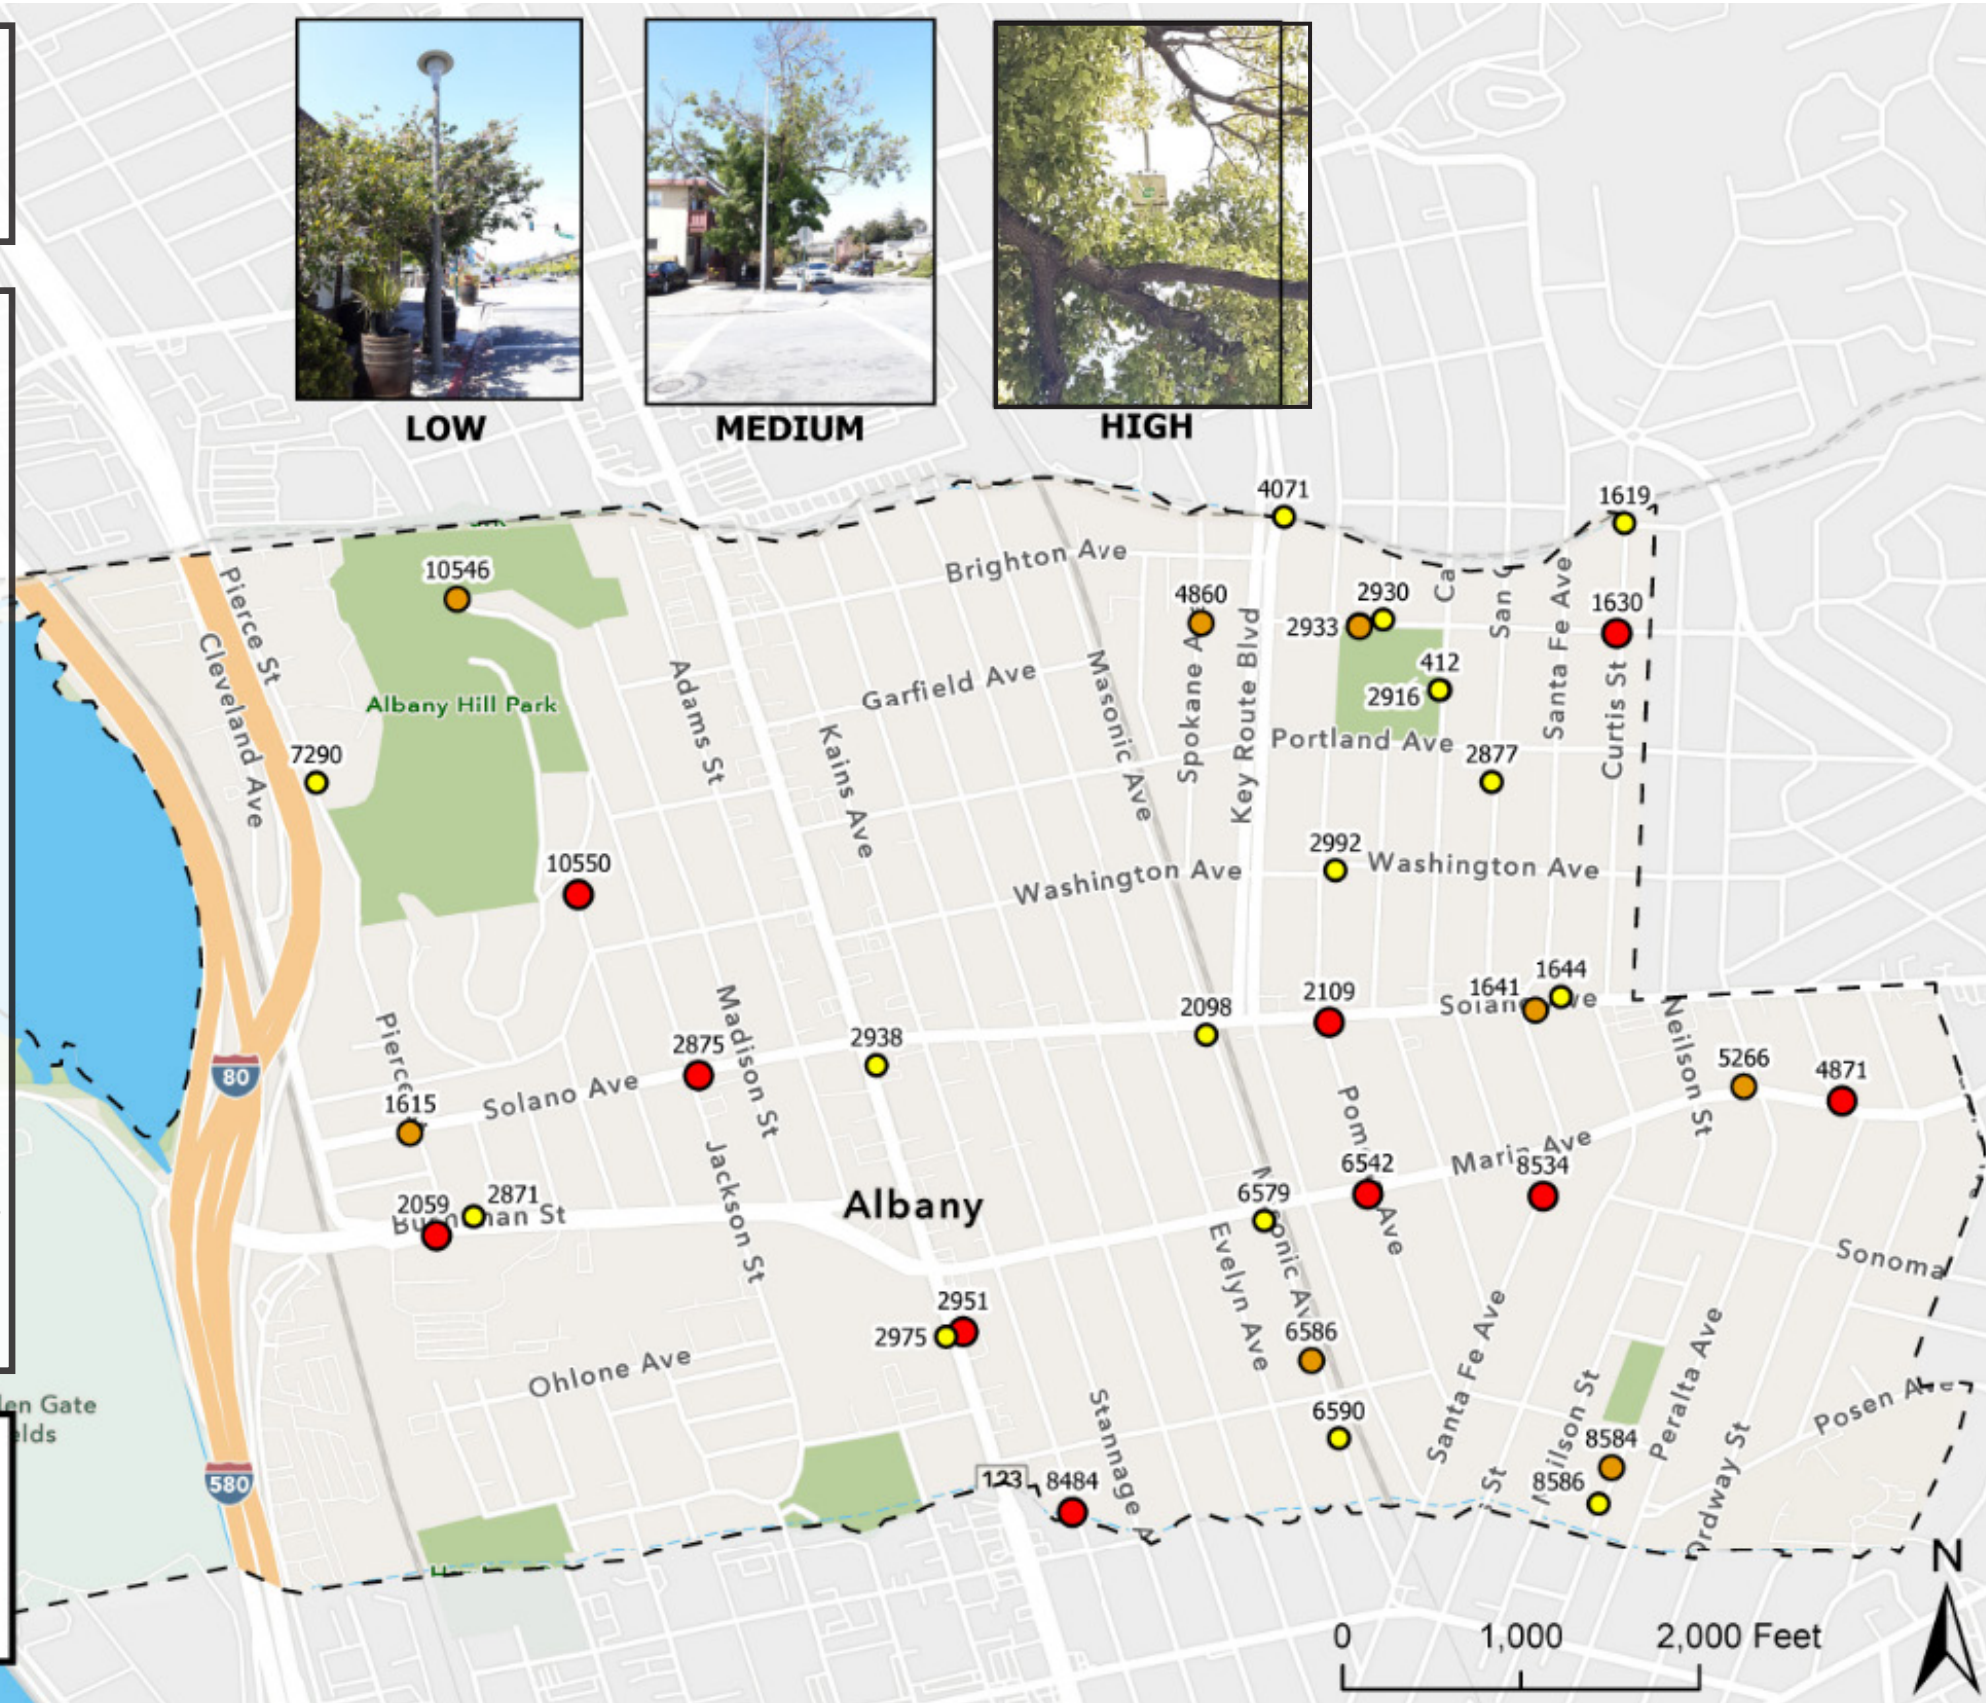
NON-DAYTIME 5-YEAR COLLISION HISTORY MAP (2018 - 2022)

This map utilized UC Berkeley's Transportation Injury Mapping System (TIMS) database to identify crashes that took place in Albany during the last five years. The color matrix shown below identifies what time of night the accident took place and how severe the injuries were simultaneously per location. Accidents that only caused property damage were excluded. Daytime accidents causing injury were excluded from the color matrix but included on the map. Data from 2021-2022 is still provisional. The mapping process identified three patterns in the crashes that are relevant to this streetlighting evaluation:

- 1) A hotspot of active transportation collisions are occurring after dark along Solano Avenue east of San Pablo Avenue. This area needs immediate attention.
- 2) The intersection of Solano Avenue and Peralta Avenue had multiple twilight collisions involving active transportation. This intersection needs immediate attention.
- 3) The crashes along San Pablo Avenue were primarily during the day. Reducing crashes in this area may require interventions other than streetlighting.

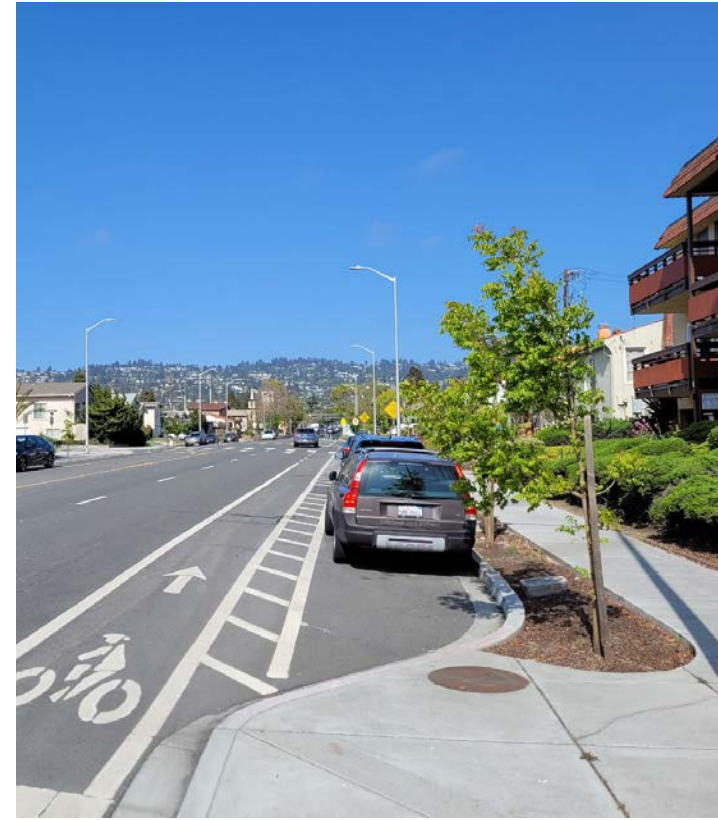
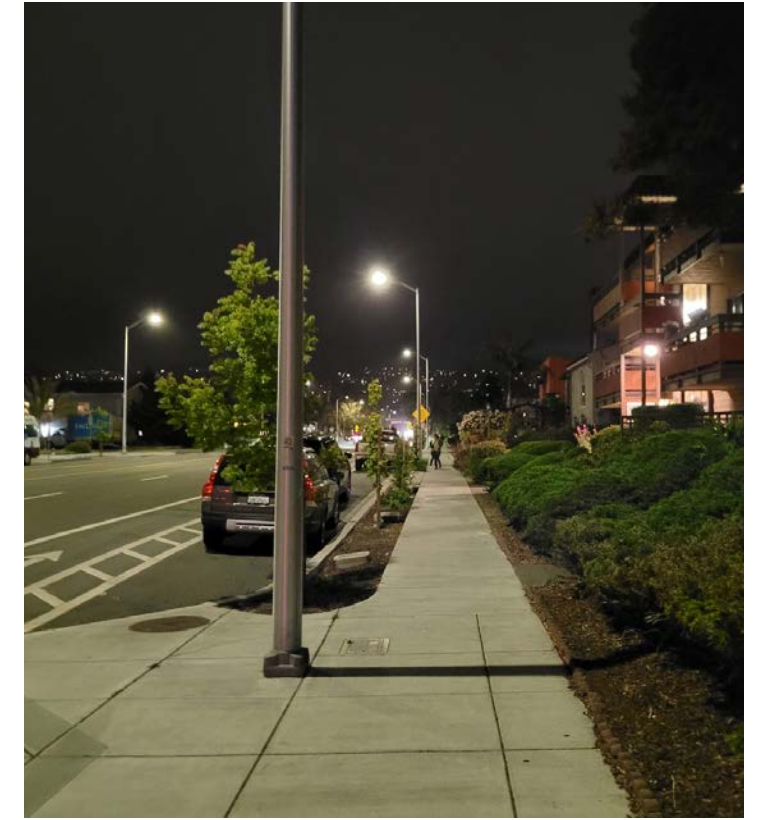
1 SITE 1 - MARIN AVENUE

- **Time:** Site was visited at approximately 4:40 PM & 9:40 PM
- **Location:** Site is along an arterial street with Class II bicycle lanes and low pedestrian activity at night
- **Street:** Lighting on the street is appropriate, visually comfortable with low glare, and provides excellent uniformity. The light level currently provides excellent visibility for travel lanes, bike lanes and on-street parking.
- **Sidewalk:** Lighting on the sidewalk is higher than criteria but is still within a reasonable range. The lighting currently provides excellent visibility and reassurance for pedestrians.
- **Light Trespass:** Light spilling beyond the sidewalk and into private property is somewhat excessive and could be disturbing residents trying to sleep. However, with higher density multi-family residential, some residents may object to reducing the light in shared outdoor space.

Site 1 - Marin Avenue (Kains to Talbot)						
Street Classification	Arterial					
Land Use	Residential / School					
Pedestrian Activity	Low					
Illuminance Summary (fc)						
	Avg	Max	Min	Avg/Min	Max/Min	Multiple of Criteria
Sidewalk Criteria	0.2			10		HIGH
Sidewalk Summary Eh	0.4	0.6	0.2	2.8	3.4	2.21
Sidewalk Summary Ev	0.3	0.5	0.1	2.1	3.5	1.39
Light Trespass Summary						
	Avg	Max	Min	Avg/Min	Max/Min	Multiple of Criteria
Light Trespass Criteria		0.3				HIGH
Light Trespass Eh		0.6				2.0
Light Trespass Ev		0.5				1.6
Street Luminance Summary - cd/m ²						
	Avg	Max	Min	Avg/Min	Max/Min	Multiple of Criteria
Criteria	0.6			3.5		ADEQUATE
Street Summary	0.5	0.7	0.3	1.4	2.2	0.8

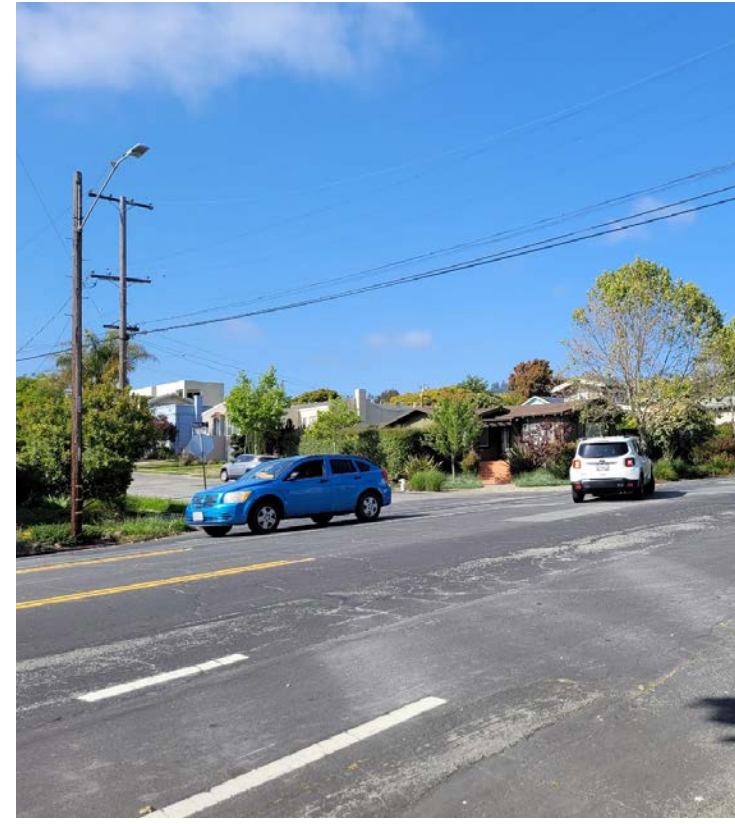
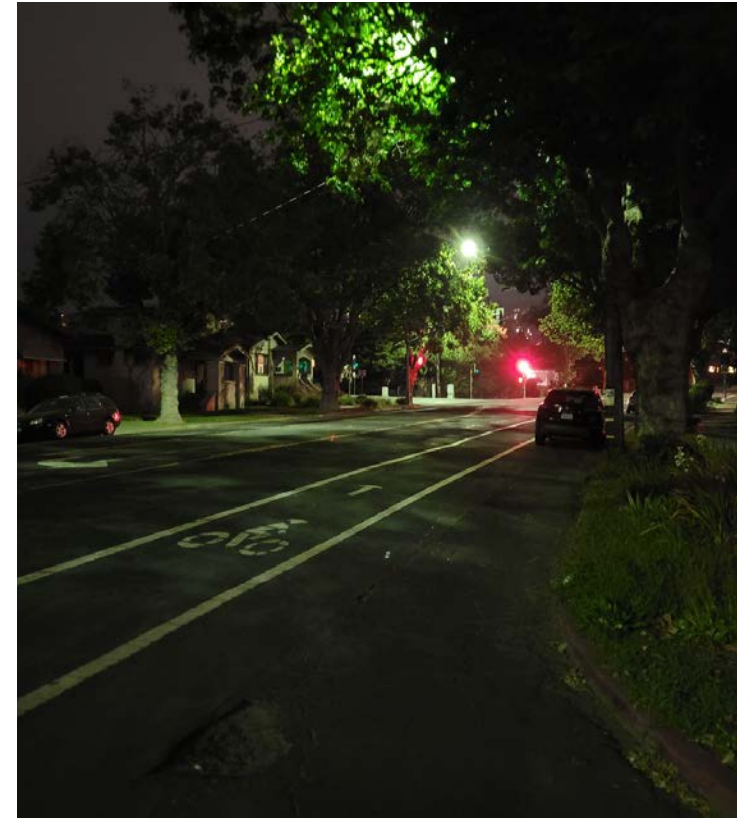
- **Time:** Site was visited at approximately 4:50 PM & 10:10 PM
- **Location:** Site is along an arterial street in a residential area with Class II bicycle lanes and low pedestrian activity at night
- **Street:** Lighting around this site is generally located at intersections with some additional mid-block lights. When only one streetlight was present at some large intersections the crosswalk lighting feels too low and uneven.
- **Sidewalk:** The sidewalks are mostly shadowed by the large street trees. While the sidewalks are dark, it may be preferred by this neighborhood. Some areas near the brighter intersections were dark enough they may be a tripping hazard.
- **Light Trespass:** The mature street trees prevented most streetlights from trespassing backwards onto private residential properties. Front yards and residential windows were not being negatively impacted by streetlighting.

Site 2 - Marin Avenue (Nielson to Peralta)						
Street Classification	Arterial					
Land Use	Residential					
Pedestrian Activity	Low					
Illuminance Summary (fc)						
	Avg	Max	Min	Avg/Min	Max/Min	Multiple of Criteria
Sidewalk Criteria	0.2			10		LOW
Sidewalk Summary Eh	0.1	0.2	0.0	9.3	22.3	0.37
Sidewalk Summary Ev	0.0	0.3	0.0	4.3	22.8	0.24
	□					
Light Trespass Criteria		0.3				APPROPRIATE
Light Trespass Eh		0.1				0.5
Light Trespass Ev		0.2				0.8
Street Luminance Summary - cd/m2						
	Avg	Max	Min	Avg/Min	Max/Min	
Criteria	0.6			3.5		LOW
Measurement Summary	0.2	0.3	0.1	3.0	5.2	0.4

- **Intersection & Crosswalk Lighting:** The poorly illuminated intersections and crosswalks on Upper Marin Ave should be prioritized for investment in improved street lighting. This is a safety concern for any pedestrians or cyclists in this area at night.
- **Relocate lights within Tree Canopies:** Some streetlights are currently located within the tree canopies which are shadowing most of the light from these luminaires. When possible these streetlights should be relocated rather than damage the mature trees.

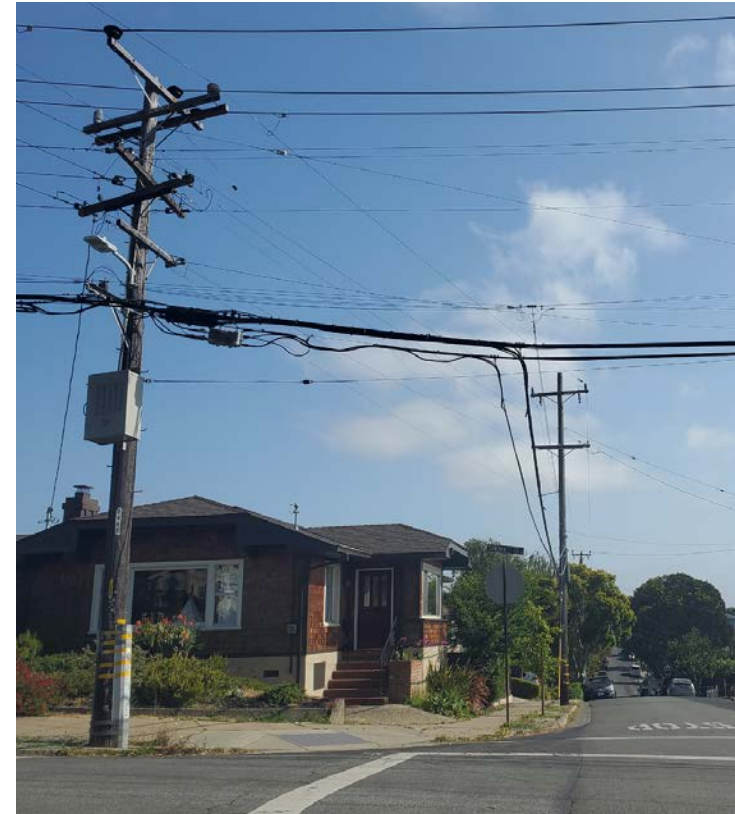
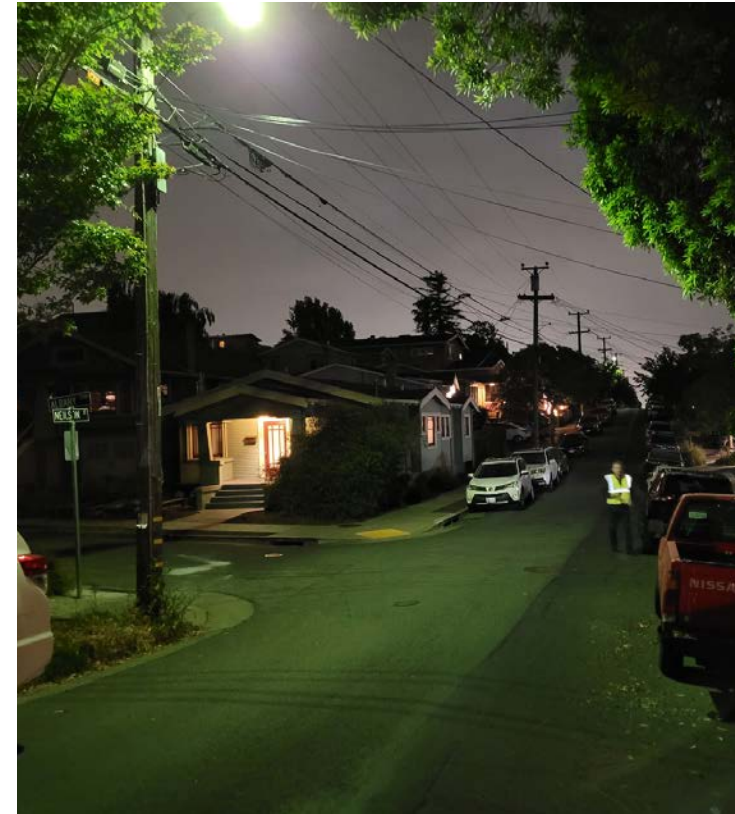
- **Time:** Site was visited at approximately 5:00 PM & 10:30 PM
- **Location:** Site is along a local, residential street with low pedestrian activity at night
- **Street:** This area only has streetlights at intersections. The streets are narrow and thus have small intersections with very low traffic. The lighting seems appropriate for the neighborhood, even though the light levels are below criteria.
- **Sidewalk:** The sidewalks near this intersection light measured lower than criteria, yet feels appropriate for the activity level of this neighborhood. There is limited contribution from porch lights.
- **Light Trespass:** The light distribution and low output of these luminaires results in low levels of light trespass. Light is also prevented from spilling into many residential windows by the neighborhood's typical landscaping.

Site 3 - Neilson Street (Sonoma to Francis)						
Street Classification	Local / Local					
Land Use	Residential					
Pedestrian Activity	Low					
Illuminance Summary (fc)						
	Avg	Max	Min	Avg/Min	Max/Min	Multiple of Criteria
Sidewalk Criteria	0.2			10		LOW
Sidewalk Summary Eh	0.1	0.3	0.0	4.0	10.9	0.53
Sidewalk Summary Ev	0.1	0.4	0.0	7.1	29.8	0.46
□						
Light Trespass Criteria		0.1				APPROPRIATE
Light Trespass Eh		0.2				0.8
Light Trespass Ev		0.2				0.8
□						
Street Luminance Summary - cd/m ²						
	Avg	Max	Min	Avg/Min	Max/Min	
Criteria	0.3			6.0		LOW
Measurement Summary	0.1	0.2	0.0	2.5	5.3	0.2

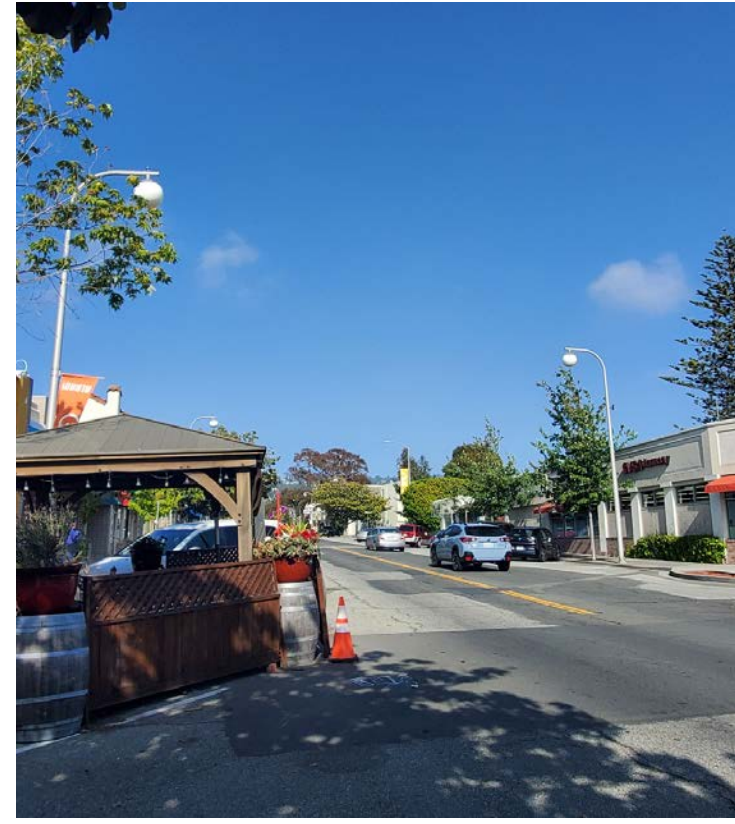
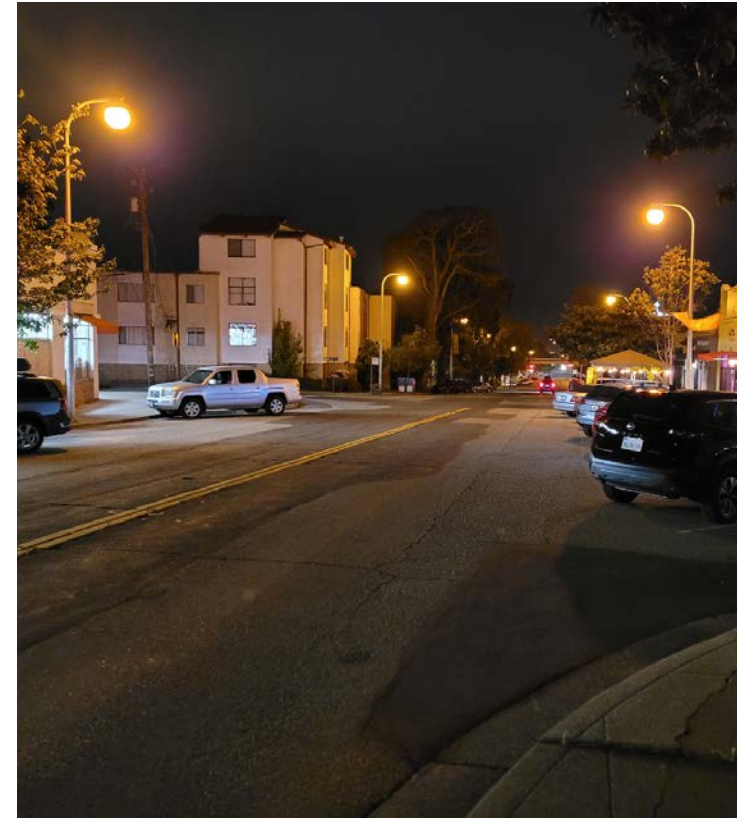
- **Time:** Site was visited at approximately 5:20 PM & 10:40 PM
- **Location:** Site is along an arterial street with mixed land uses and medium pedestrian activity
- **Street:** This area is lit continuously by unshielded luminaires with inconsistent CCT's. However, the street's surface itself felt evenly and adequately lit and while unshielded the luminaires were not creating a lot of glare.
- **Sidewalk:** The sidewalks near this area were dimly lit on average but felt comfortable. The intermittent bright light coming from storefronts along this site created some visual discomfort and adaptation issues that cannot be addressed through streetlighting.
- **Light Trespass:** The unshielded globe lights in this area create significant light trespass, which is especially concerning near the residential buildings along Solano Ave.

Site 4 - Solano Avenue (Carmel to Ramona)						
Street Classification	Arterial / Local					
Land Use	Residential / Community Center / Commercial					
Pedestrian Activity	Medium					
Illuminance Summary (fc)						
	Avg	Max	Min	Avg/Min	Max/Min	Multiple of Criteria
Sidewalk Criteria	0.5			5		LOW
Sidewalk Summary Eh	0.3	3.9	0.3	1.0	14.0	0.57
Sidewalk Summary Ev	0.3	2.9	0.1	4.4	42.1	0.62
□						
Light Trespass Criteria		0.3				HIGH
Light Trespass Eh		0.4				-
Light Trespass Ev		0.4				-
□						
Street Luminance Summary - cd/m2						
	Avg	Max	Min	Avg/Min	Max/Min	
Criteria	0.9			3.0		LOW
Measurement Summary	0.5	0.9	0.3	2.0	3.3	0.6

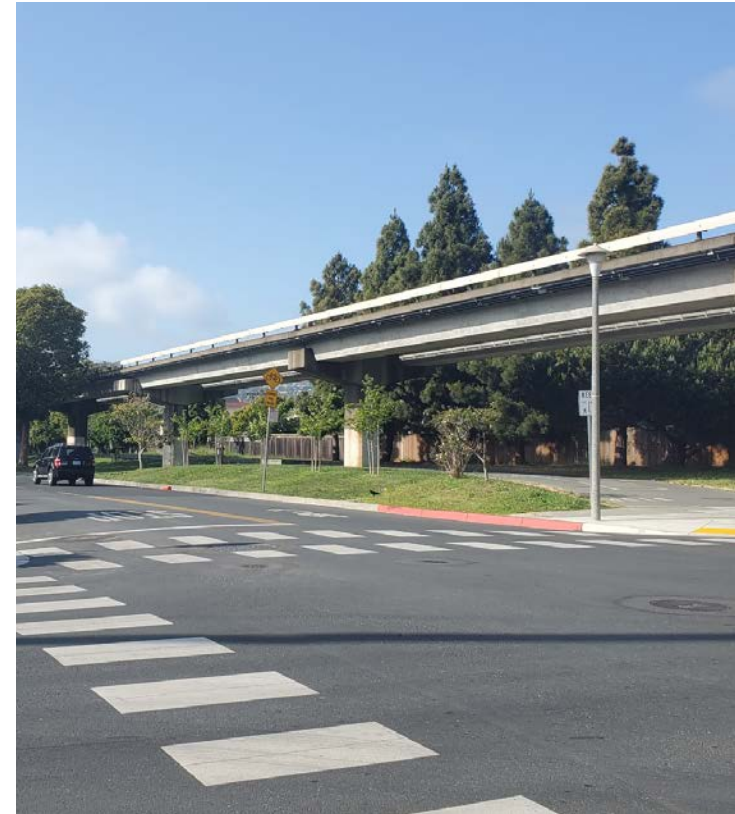
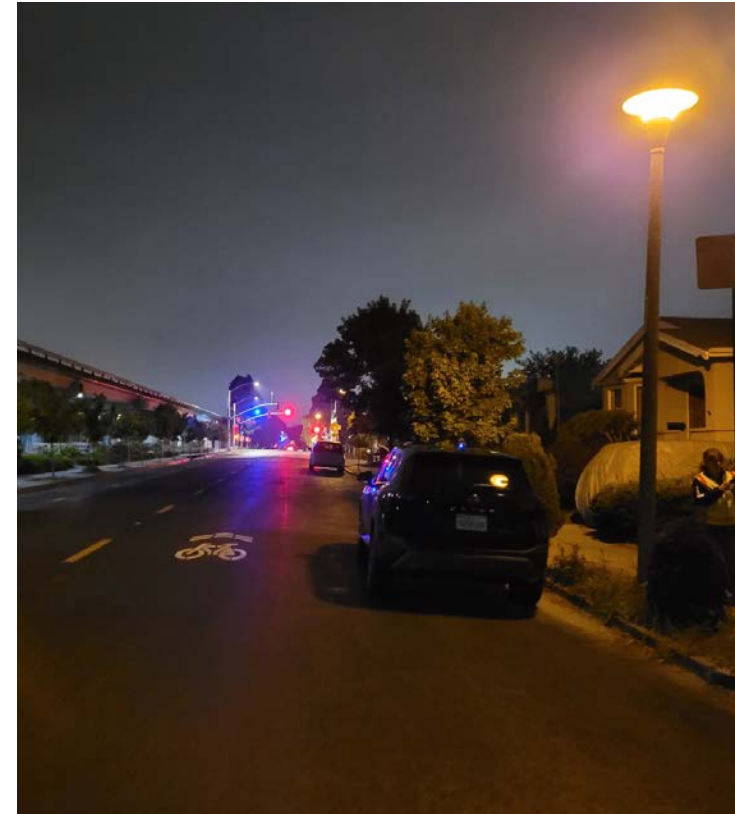
- **Sidewalk:** The sidewalks along this area were inconsistently lit. Due to the luminaire currently in use, more light was reaching residential facades than the sidewalk itself in some locations. Unexpected gaps in the spacing of the luminaires led to some uncomfortably dark spaces.

- **Light Trespass:** In some areas there is more measurable light on the facades of homes than on the street or sidewalks. This is severe light trespass from unsuitable luminaires. This is likely disturbing residents and is contributing to light pollution in the region.

Site 5 – Masonic Avenue (Washington to Solano)						
Street Classification	Collector / Collector					
Land Use	Residential / Commercial / Park					
Pedestrian Activity	Medium					
Illuminance Summary (fc)						
	Avg	Max	Min	Avg/Min	Max/Min	Multiple of Criteria
Sidewalk Criteria	0.5			5		LOW
Sidewalk Summary Eh	0.2	0.4	0.0	11.6	22.8	0.37
Sidewalk Summary Ev	0.1	0.4	0.0	6.2	31.6	0.17
Light Trespass Summary						
Light Trespass Criteria		0.2				HIGH
Light Trespass Eh		0.3				1.1
Light Trespass Ev		0.4				1.5
Street Luminance Summary - cd/m2						
	Avg	Max	Min	Avg/Min	Max/Min	
Criteria	0.6			3.5		LOW
Measurement Summary	0.1	0.2	0.1	1.9	3.1	0.2

- **One-for-One Replacements:** The existing spacing of the post-top luminaires along this part of Masonic is generally sufficient. There are some gaps in the spacing due to conflicts with driveways where alternative spacing should be considered. The luminaires should be replaced in a one-for-one strategy with a low-glare luminaire with better backlight shielding to address the high light trespass.
- **Comprehensive Lighting Redesign:** The Ohlone Greenway is an ideal location for a distinctive lighting redesign along this well-traveled bike and pedestrian path. Lighting could be better layered and coordinated around the greenway to create a more welcoming space.

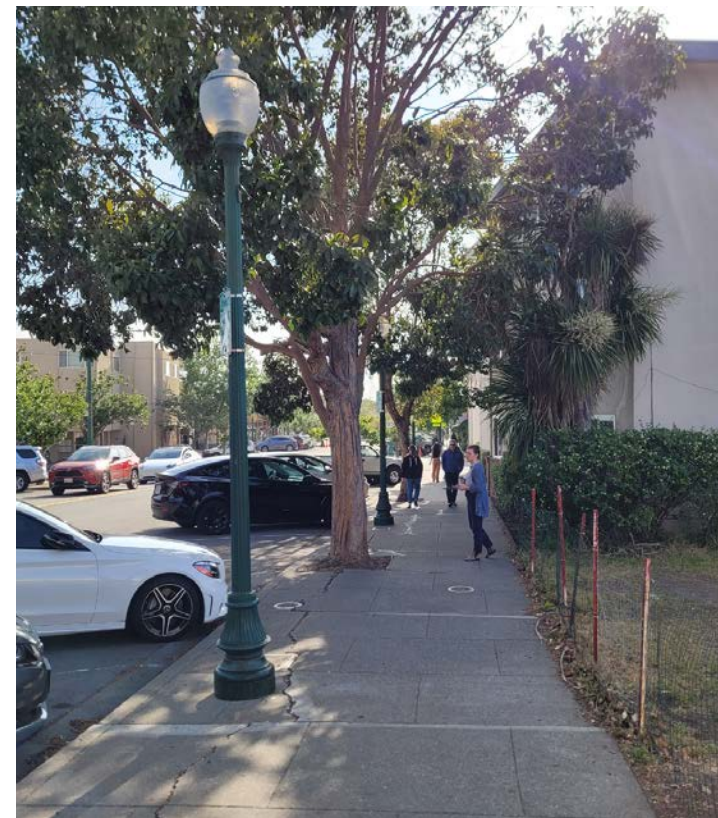
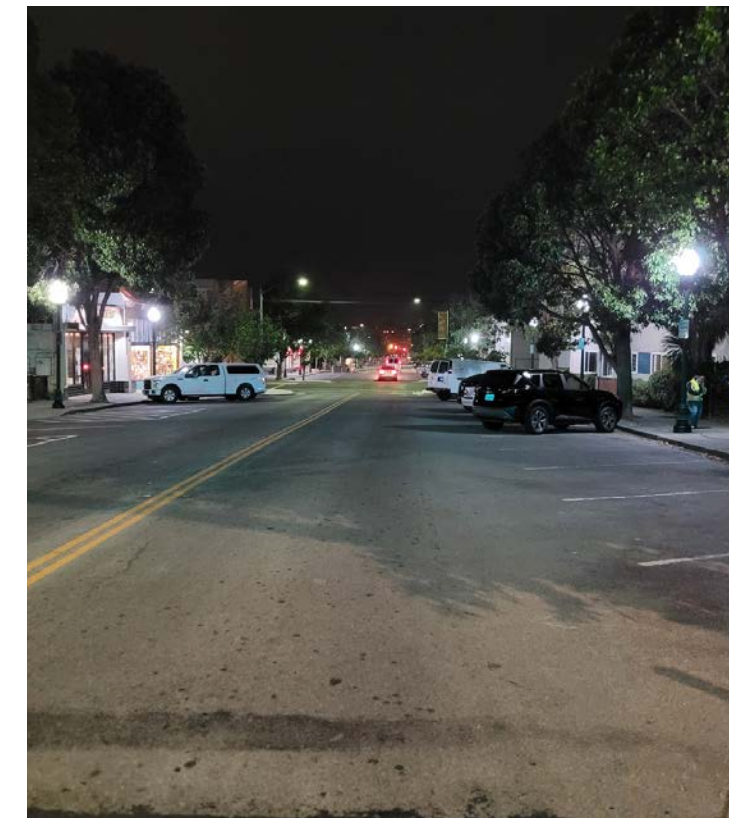
- **Time:** Site was visited at approximately 5:45 PM & 11:10 PM
- **Location:** Site is along an arterial street in a commercial area with low pedestrian activity at night
- **Street:** This area is receiving streetlighting from pedestrian-scale acorn lights. While the roadway feels comfortably and uniformly lit, this type of luminaire can be glaring for drivers.
- **Sidewalk:** The sidewalks are uniformly lit and are comfortable to walk around at night. However, this area feels brighter than other similar areas in the City.
- **Light Trespass:** The light trespass in this area is severe. The acorn luminaires offer no shielding and is using a bright light source with a high color temperature. This is not energy efficient and is very detrimental to the night sky and nearby residences. This is likely disturbing residents and is contributing to light pollution in the region.

Site 6 – Solano Avenue (Evelyn to Talbot)						
Street Classification	Arterial					
Land Use	Commercial					
Pedestrian Activity	Low					
Illuminance Summary (fc)						
	Avg	Max	Min	Avg/Min	Max/Min	Multiple of Criteria
Sidewalk Criteria	0.2			10		HIGH
Sidewalk Summary Eh	0.8	1.5	0.1	5.3	10.8	3.79
Sidewalk Summary Ev	0.5	1.5	0.1	3.6	10.8	2.53
Light Trespass Summary						
Light Trespass Criteria		0.3				HIGH
Light Trespass Eh		0.0				0.0
Light Trespass Ev		1.1				3.6
Street Luminance Summary - cd/m2						
	Avg	Max	Min	Avg/Min	Max/Min	
Criteria	0.6			3.5		ADEQUATE
Measurement Summary	0.5	0.8	0.3	1.8	3.0	0.8

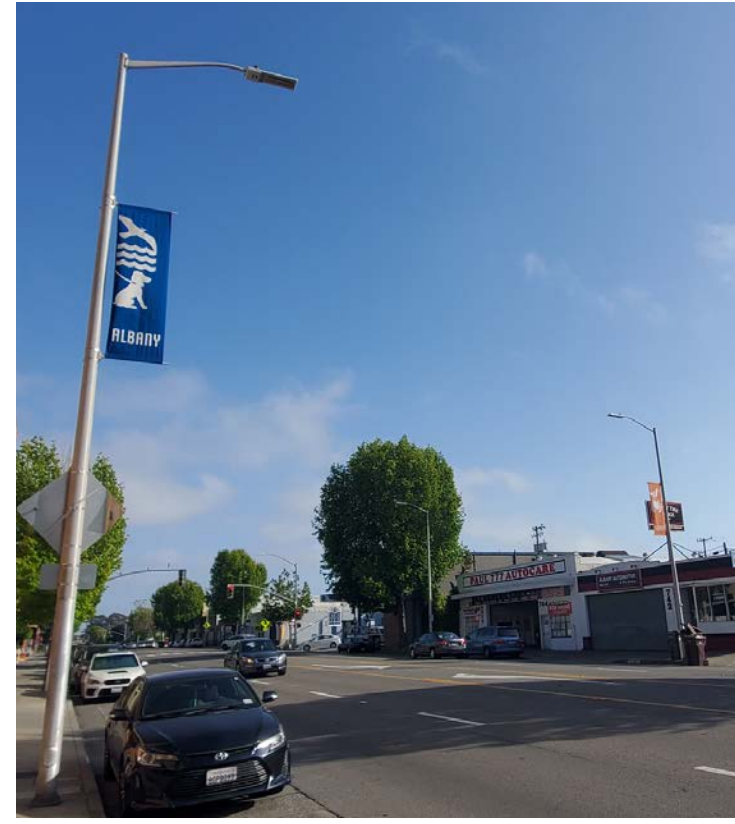
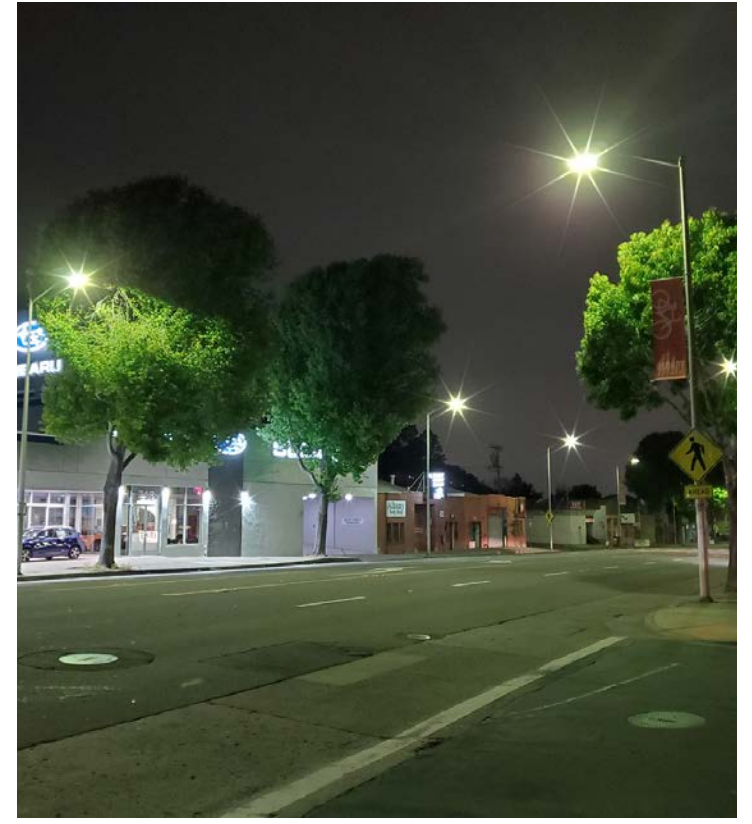
- **Street:** The streetlighting in this area is from typical LED cobraheads. When part of a signalized intersection these luminaires are owned by Caltrans. The lighting in the street wasn't uncomfortable, but felt high for the low activity level when the site was observed.

- **Sidewalk:** The sidewalks are uniformly lit and are comfortable to walk around at night. However, this area feels brighter than other areas in the City. Combined with lighting from businesses, some areas feel overbright and harsh.

- **Light Trespass:** While this site is mainly commercial, there is still a significant amount of streetlighting on building facades. This is detrimental to the night sky and the environment. It could also diminish the impact of these businesses' decorative lighting and architecture.

Site 7 – San Pablo Avenue (Washington to Garfield)						
Street Classification	Arterial					
Land Use	Commercial					
Pedestrian Activity	Low					
Illuminance Summary (fc)						
	Avg	Max	Min	Avg/Min	Max/Min	Multiple of Criteria
Sidewalk Criteria	0.2			10		HIGH
Sidewalk Summary Eh	0.6	1.2	0.2	3.1	6.0	3.14
Sidewalk Summary Ev	0.3	1.0	0.1	5.2	16.2	1.57
Light Trespass Summary						
Light Trespass Criteria		0.3				HIGH
Light Trespass Eh		0.0				0.0
Light Trespass Ev		0.3				1.0
Street Luminance Summary - cd/m2						
	Avg	Max	Min	Avg/Min	Max/Min	
Criteria	0.6			3.5		HIGH
Measurement Summary	0.9	1.8	0.5	1.6	3.3	1.4

- **Additional Shielding:** Street and pedestrian lighting in this core retail/commercial/mixed-use area should be replaced with luminaires that have better shielding to reduce light trespass and light pollution. Better shielding would also reduce glare that may be uncomfortable for drivers and keep streetlighting from conflicting with businesses' facade lighting.
- **Part-Night Dimming:** These lights could be dimmed during the late-night hours while still maintaining appropriate visibility and safety for any drivers that may pass through this arterial at those times. Part-night dimming saves energy and does not negatively impact drivers as their headlights are sufficient for the reduced amount of conflicts encountered late at night.
