ALBANY - STREET LIGHTING EVALUATION

EXISTING LIGHTING CONDITIONS

07/28/2023

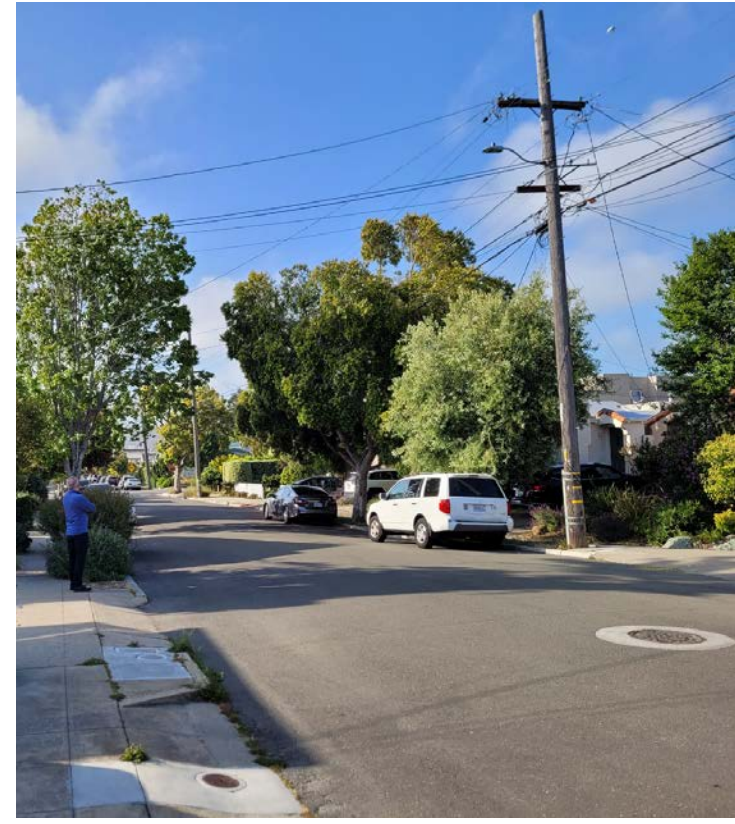
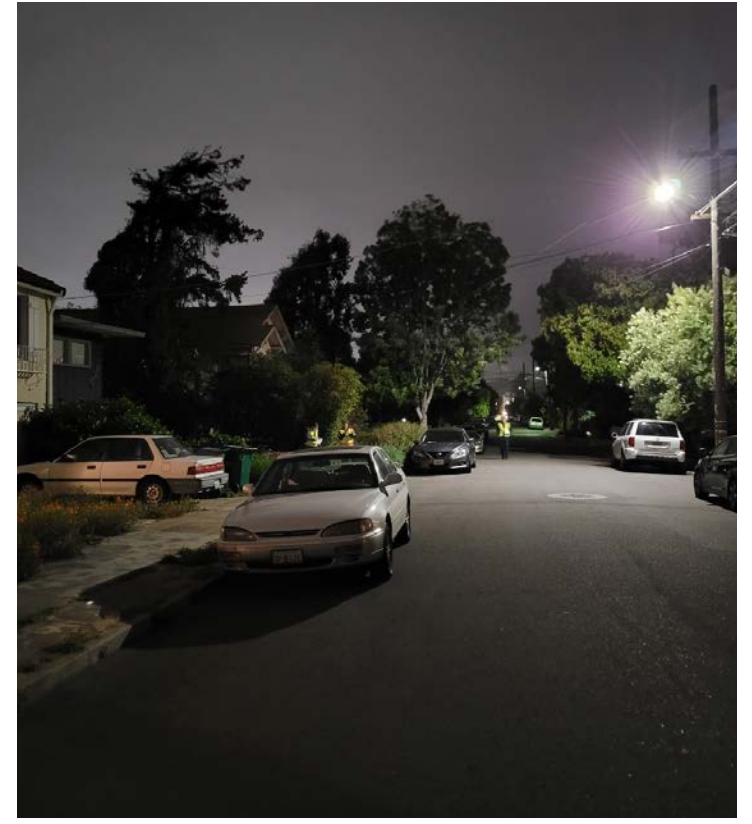
- **Time:** Site was visited at approximately 5:55 PM & 11:30 PM
- **Location:** Site is along a local, residential street with low pedestrian activity at night
- **Street:** This site was illuminated by mid-block lighting. While the area was not lit continuously, visibility was sufficient for navigating the street.
- **Sidewalk:** The sidewalks in this area were adequate, but the areas closer to the mid-block luminaire felt significantly brighter than areas several houses down.
- **Light Trespass:** The light trespass on this site is severe. The narrow streets exacerbate the issue. Facades and windows of homes are being brightly lit due to poor shielding and an inappropriate light distribution pattern. This is likely disturbing residents and is contributing to light pollution.

Site 8 – Evelyn Avenue (Garfield to Portland)						
Street Classification	Local / Local					
Land Use	Residential					
Pedestrian Activity	Low					
Illuminance Summary (fc)						
	Avg	Max	Min	Avg/Min	Max/Min	Multiple of Criteria
Sidewalk Criteria	0.2			10		ADEQUATE
Sidewalk Summary Eh	0.2	0.5	0.0	13.6	33.0	0.95
Sidewalk Summary Ev	0.1	0.5	0.0	12.9	54.6	0.64
Light Trespass Criteria		0.1				HIGH
Light Trespass Eh		0.0				0.0
Light Trespass Ev		0.4				1.2
Street Luminance Summary - cd/m2						
	Avg	Max	Min	Avg/Min	Max/Min	
Criteria	0.3			6.0		LOW
Measurement Summary	0.2	0.4	0.0	6.1	14.0	0.6

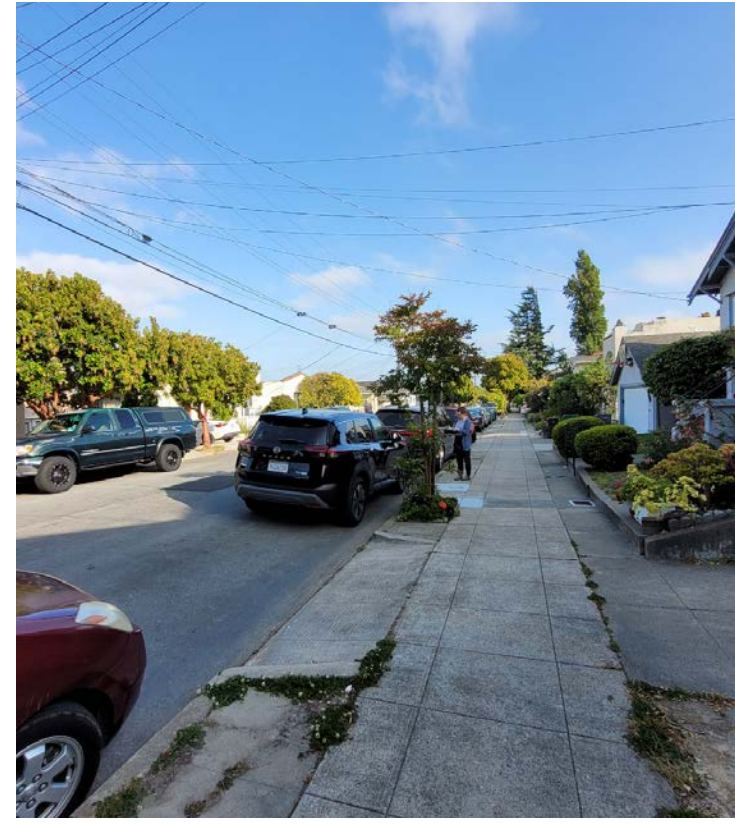
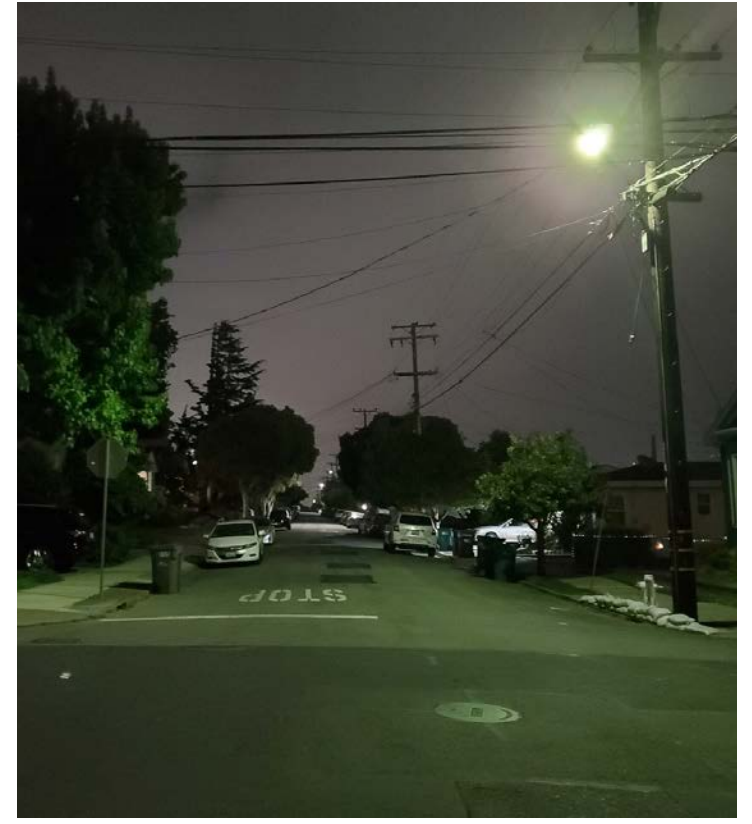
- **Time:** Site was visited at approximately 6:00 PM & 12:00 PM
- **Location:** Site is along a local, residential street with low pedestrian activity at night
- **Street:** This site was mainly illuminated by mid-block lighting. Longer block lengths in this area made the mid-block lighting feel more appropriate for navigating the street.
- **Sidewalk:** The sidewalks along this site were visually comfortable with few areas of intense shadow or excessive brightness.
- **Light Trespass:** Mature trees and wider streets reduced the intensity of the light trespass taking place when compared to similar sites. However, the amount of streetlighting spilling into yards and windows was noticeable. This sites proximity to the Albany Hill park space makes light trespass a heightened concern due to the potential for negative environmental impact.

Site 9 – Madison Street (Washington to Castro)						
Street Classification	Local / Local					
Land Use	Residential					
Pedestrian Activity	Low					
Illuminance Summary (fc)						
	Avg	Max	Min	Avg/Min	Max/Min	Multiple of Criteria
Sidewalk Criteria	0.2			10		ADEQUATE
Sidewalk Summary Eh	0.2	0.4	0.0	4.7	10.0	0.92
Sidewalk Summary Ev	0.1	0.4	0.0	6.1	23.2	0.58
Light Trespass Summary						
Light Trespass Criteria		0.1				HIGH
Light Trespass Eh		0.0				0.0
Light Trespass Ev		0.3				1.0
Street Luminance Summary - cd/m2						
	Avg	Max	Min	Avg/Min	Max/Min	Multiple of Criteria
Criteria	0.3			6.0		ADEQUATE
Measurement Summary	0.2	0.6	0.0	7.4	19.7	0.7

- **Evaluate Usage of Mid-block Lighting:** Adding mid-block lighting should be driven by neighborhood preferences but should not be considered compulsory. IES criteria would usually not warrant continuous lighting on residential streets with low activity at night, especially with the short block lengths in many areas of Albany. Extra care should be given to providing shielding options to reduce light trespass when this type of lighting has been requested by a street or neighborhood. It is recommended mid-block lighting not be installed when it is only being requested by a singular household. This recommendation applies to Sites 3 and 8, could also apply to Site 9, and would also apply to any similar areas throughout the City.

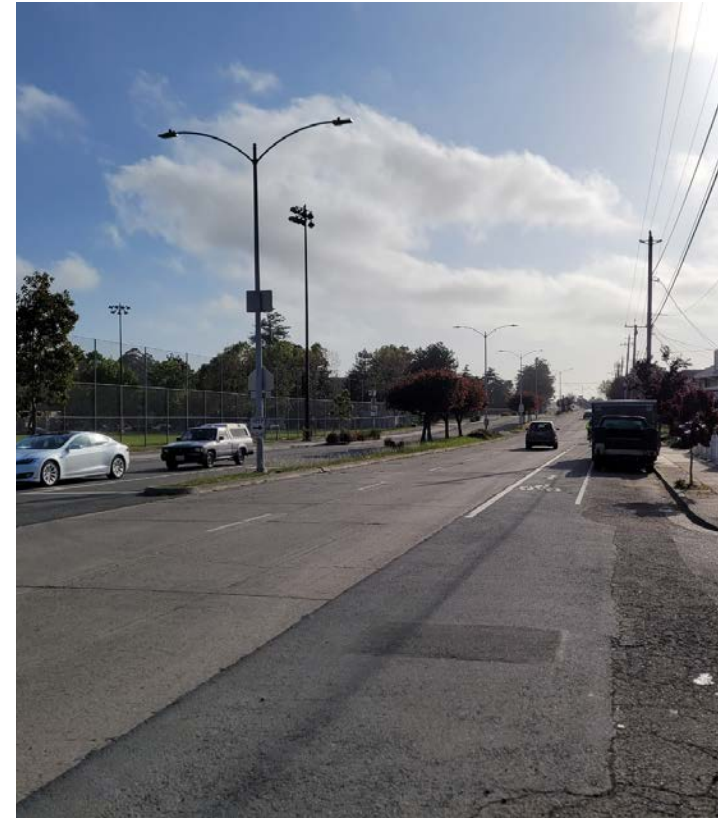
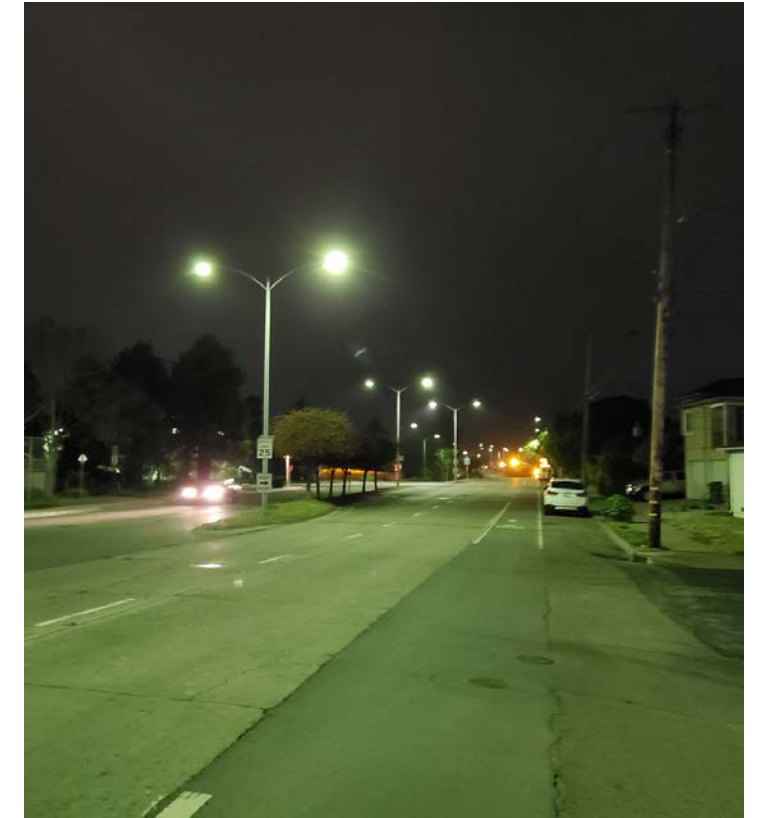
- **Time:** Site was visited at approximately 6:10 PM & 12:10 AM
- **Location:** Site is along an arterial street with a Class I bicycle path, Class II bicycle lane, and low pedestrian activity at night. All measurements were taken on the north side of the site.
- **Street:** Streetlighting is being provided to this site through median-mounted, LED cobraheads mounted at a height suitable for lighting a major roadway. There was some variation in CCT's and luminaire type.
- **Sidewalk:** The sidewalks are uniformly lit and are comfortable to walk around at night. However, this area feels brighter for pedestrians than other areas in the City.
- **Light Trespass:** The light trespass on this site is severe. Facades and windows of homes are being brightly lit due to poor shielding and light distribution. This is likely disturbing residents and is contributing to light pollution in the region.

Site 10 – Buchanan Street (Taylor to Madison)						
Street Classification	Arterial					
Land Use	Residential / Park / School					
Pedestrian Activity	Medium					
Illuminance Summary (fc)						
	Avg	Max	Min	Avg/Min	Max/Min	Multiple of Criteria
Sidewalk Criteria	0.5			5		LOW
Sidewalk Summary Eh	0.2	0.5	0.1	4.2	8.5	0.48
Sidewalk Summary Ev	0.2	0.7	0.1	2.9	8.3	0.45
Light Trespass Summary						
Light Trespass Criteria		0.3				HIGH
Light Trespass Eh		0.0				0.0
Light Trespass Ev		0.5				1.8
Street Luminance Summary - cd/m2						
	Avg	Max	Min	Avg/Min	Max/Min	
Criteria	0.9			3.0		LOW
Measurement Summary	0.5	0.8	0.2	2.4	3.7	0.6

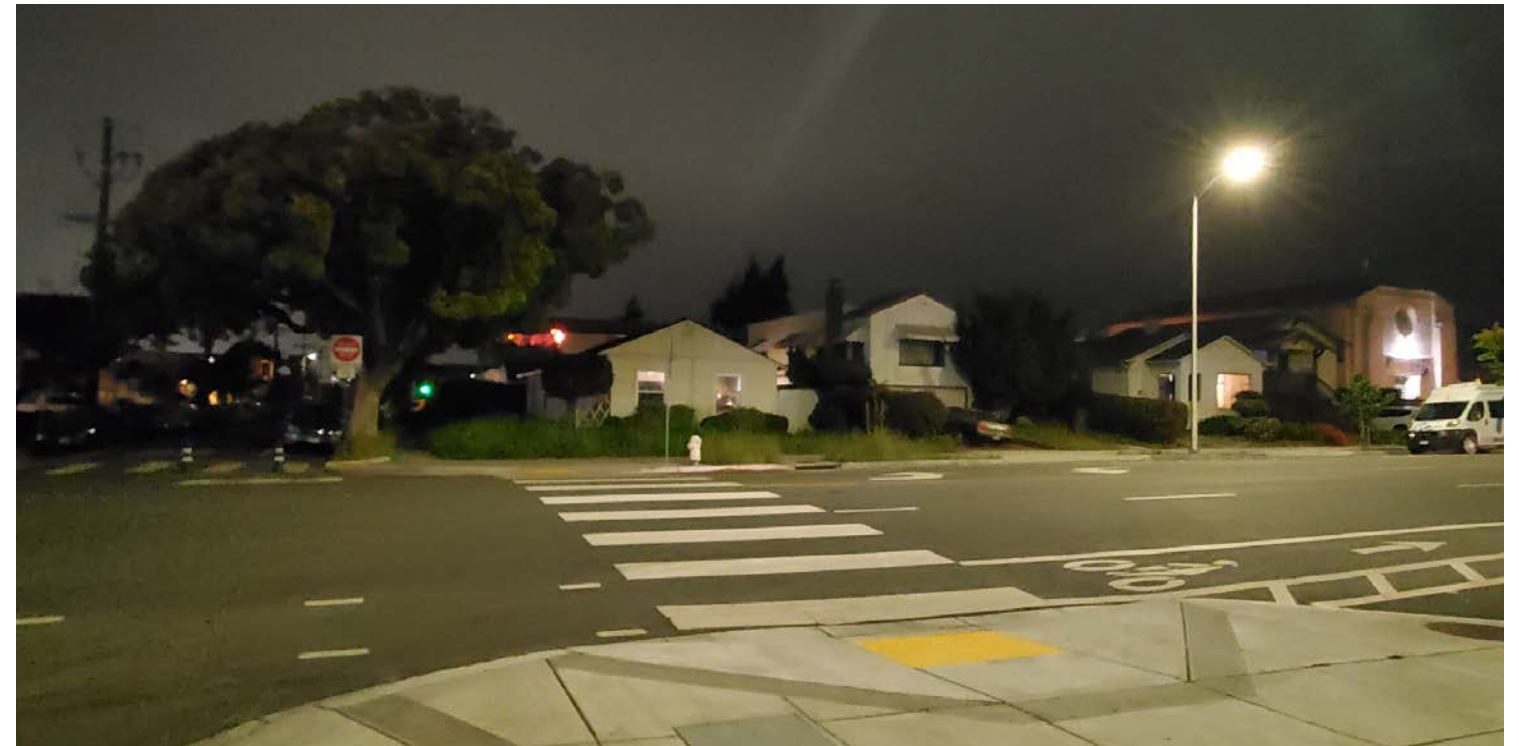
WELL-LIT CROSSWALK

Most of Albany’s pedestrian and cyclist traffic moves through the City via sidewalks or on-street bikeways. While there are several off-street trails that see high usage rates, especially the Ohlone Greenway, these trails are in few locations throughout the City. Most of the lighting for pedestrians and cyclists is therefore provided by streetlighting. Since there are many sidewalks and short block lengths in Albany there are many crosswalks. These crosswalks are often the key conflict zone between pedestrians and vehicles and require extra care be taken with their lighting.

Improving the consistency and quality of crosswalk lighting throughout Albany would be a significant improvement for pedestrian safety for the community.

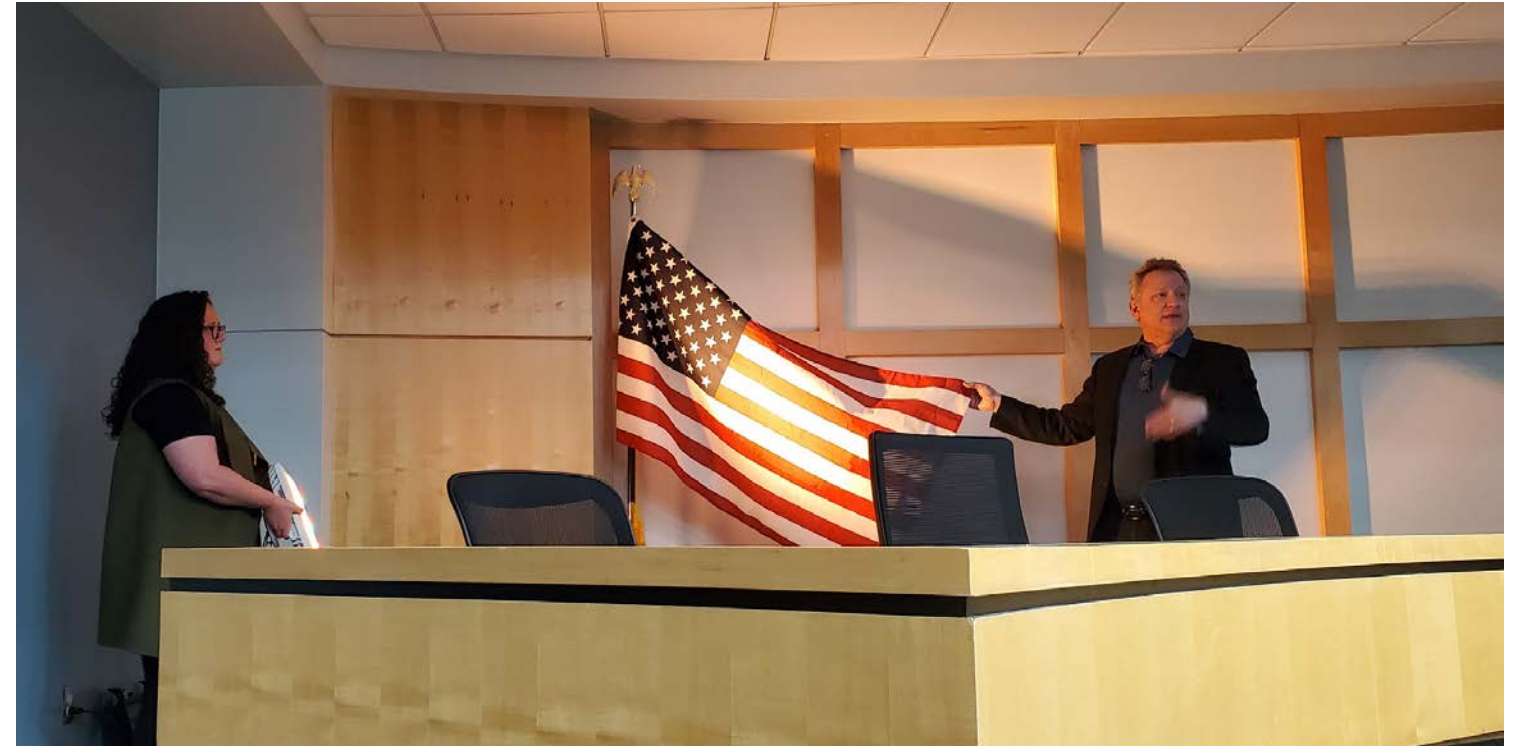
Clanton & Associates has previously utilized a demonstration kit to show five common CCT's for outdoor lighting and how they influence the appearance of a familiar object like the national flag. The five (5) color temperatures shown are 2200K, 2700K, 3000K, 3500K, 4000K.

- 2200K - This CCT is often encouraged near ecologically sensitive areas such as natural parks, waterways, or coastlines. Light sources of this temperature generally contain the least amount of disruptive blue light.
- 2700K - This CCT is being pursued as a standard outdoor lighting CCT by California. It is now a standard offering by many manufacturers.
- 3000K - This CCT has become very standard for outdoor lighting. It's often referred to as warm white.
- 3500K - This CCT is less standard for outdoor use but is available. Sometimes individuals struggle to distinguish it from a 3000K light temperature.
- 4000K - This CCT was standard when LED technology was new but is no longer recommended as a default outdoor CCT. Some residents tend to find this CCT too "blue" or too harsh for outdoor use at night.

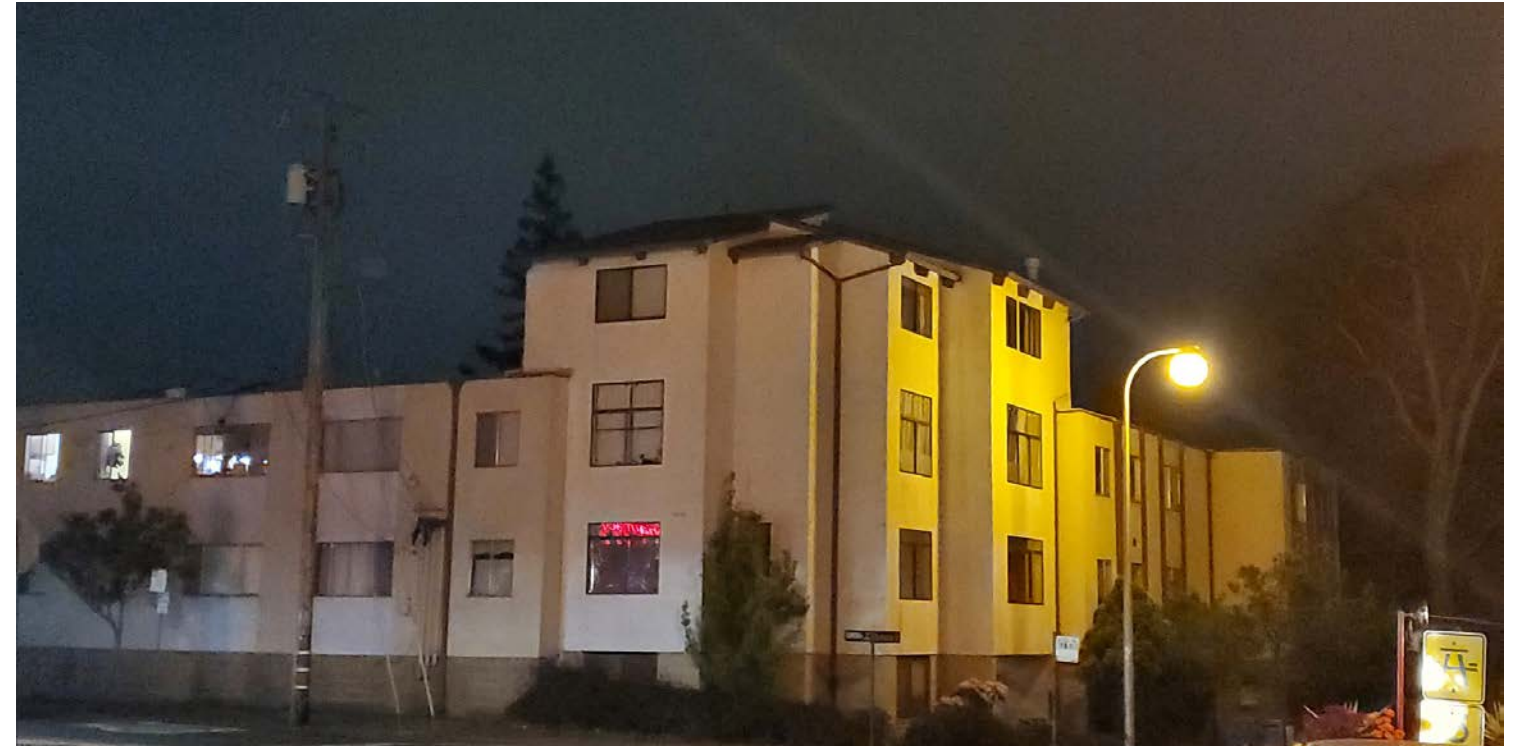
LIGHT TRESPASS FROM UNSHIELDED LUMINAIRE

Light trespass occurs when light is shining beyond the area intended to be lit. This can occur due to overlighting, using the wrong luminaire for the needs of the site, poor luminaire shielding, or poor luminaire placement. Even a well-controlled, fully shielded luminaire may cause light trespass if it is not located or oriented properly on a site. Topography and other unchangeable site conditions can easily lead to this.

Light trespass can be a significant neighborhood nuisance, resulting in disturbed sleep or loss of privacy for residents. Light trespass is also a waste of energy due to the amount of light being paid for through energy bills that is then missing its target. There are also negative environmental impacts from unmitigated light trespass. Light trespass from busier, denser areas into natural spaces can disrupt both plants and animals health and behaviors.

Light trespass can be addressed through using appropriate light levels for the area being lit, adding backlight shielding to existing luminaires if needed, and the use of luminaires with no measurable uplight.
