Subject: Arborist Survey Report – Pierce Street Pavement Rehabilitation and Bicycle/Pedestrian Path Project, Albany, California (ABY0901)

Pierce Street Pavement Rehabilitation and  
Bicycle/Pedestrian Path Project

Tree Map

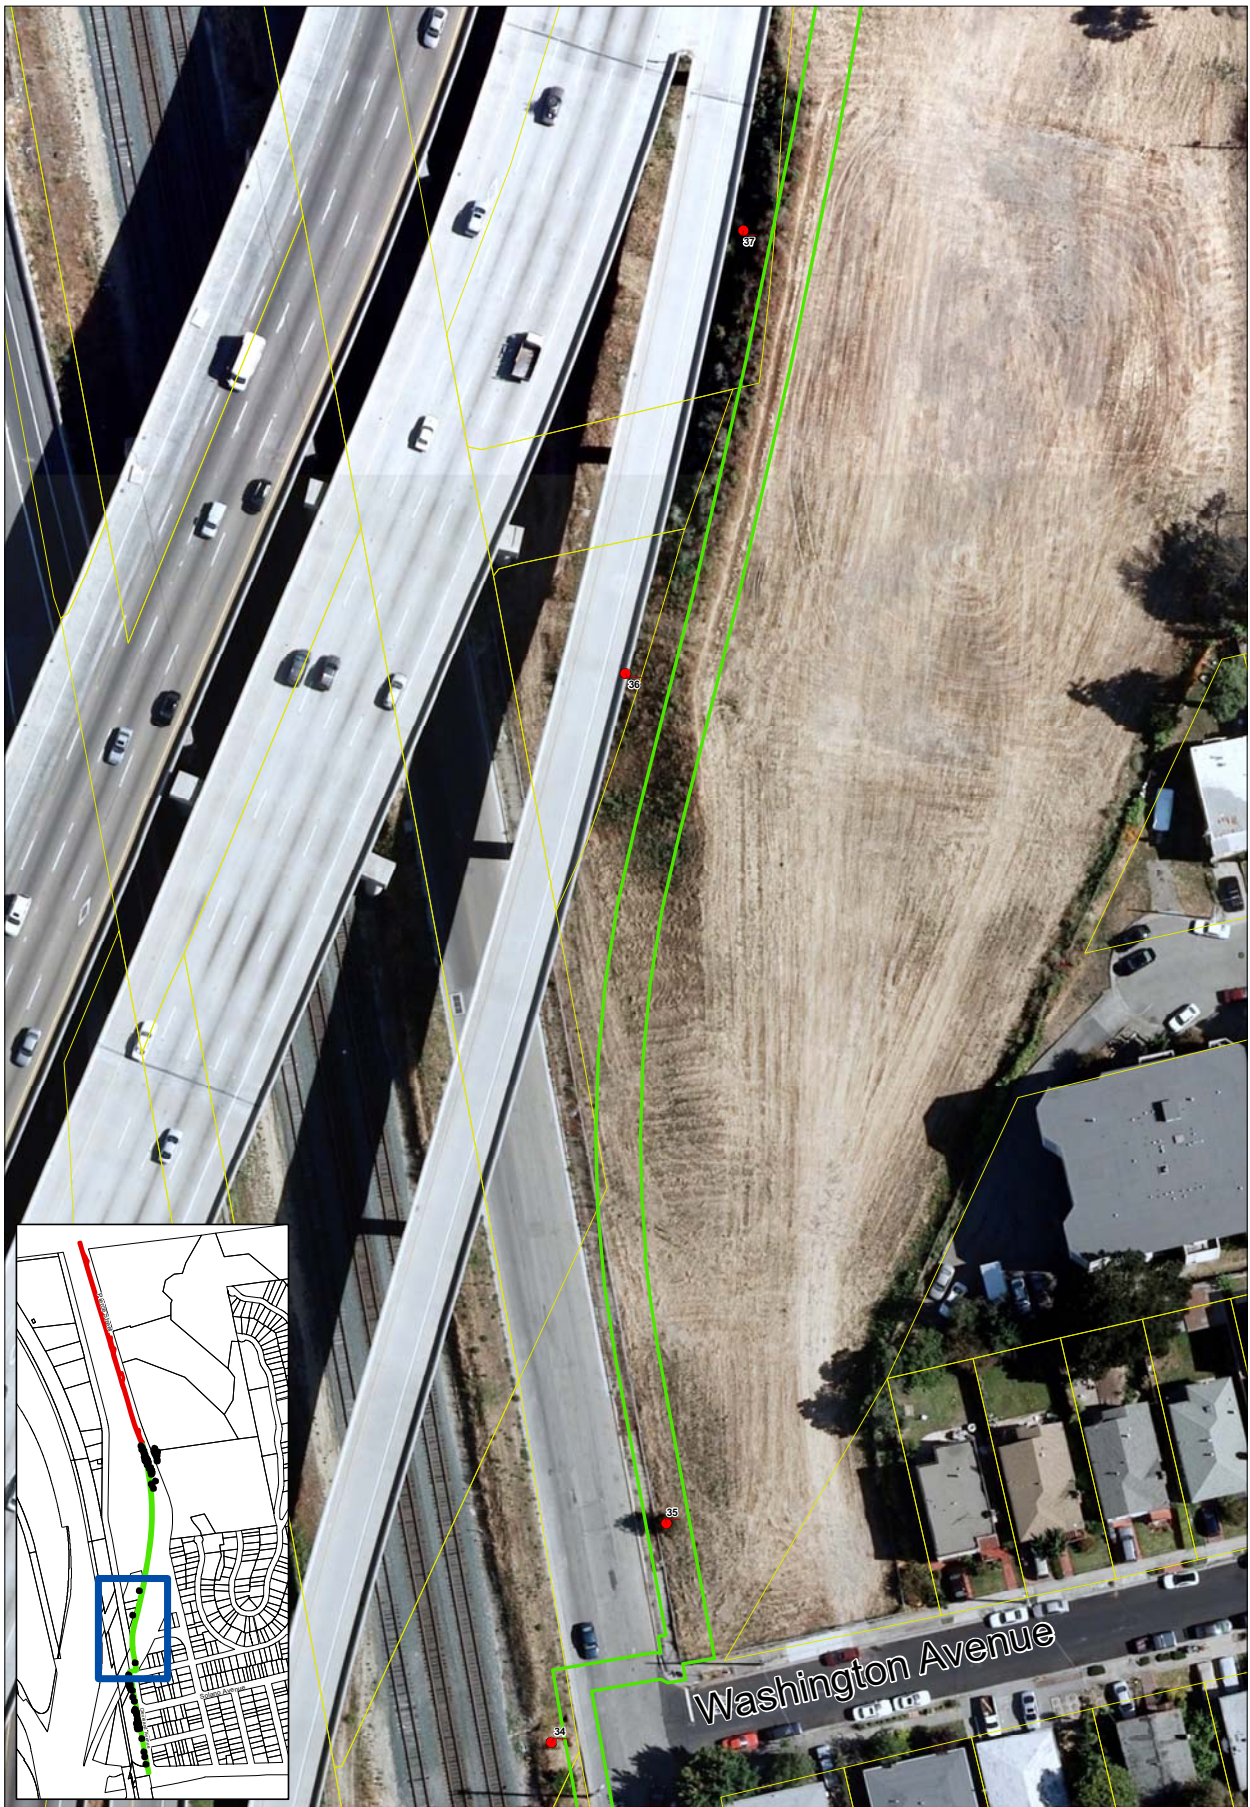
Tree Map

*Pierce Street Pavement Rehabilitation and  
Bicycle/Pedestrian Path Project*

This letter provides the results of the tree survey conducted for the Pierce Street Pavement Rehabilitation and Bicycle/Pedestrian Path Project in the City of Albany. The Draft Initial Study/Mitigated Negative Declaration (IS/MND) prepared for the project by LSA Associates, Inc. (LSA) (August 2009) includes a mitigation that requires preparation of a tree survey prior to construction of the project. The purpose of the tree survey is to identify and evaluate trees occurring within the proposed path alignment, which is divided into two segments: the Pierce Street segment (Segment I) and the Caltrans Property and Cleveland Avenue segment (Segment II). The tree survey generally covers the following portions of the project area: a section of Albany Hill located along the east side of Pierce Street, just south of the Gateview condominium complex (555 Pierce Street), the segment of the Caltrans property that generally parallels Interstate 80 (I-80), and the area along the west side of Cleveland Avenue (generally no further out than 20 feet from the edge of the proposed path alignment). The survey area is depicted in Figures 1a through 1d.

Details of the tree survey results are presented in the attached tree survey results table. The table lists each tree by number (shown in Figure 1a-1d) and provides the common and scientific name, diameter, and condition for each tree.

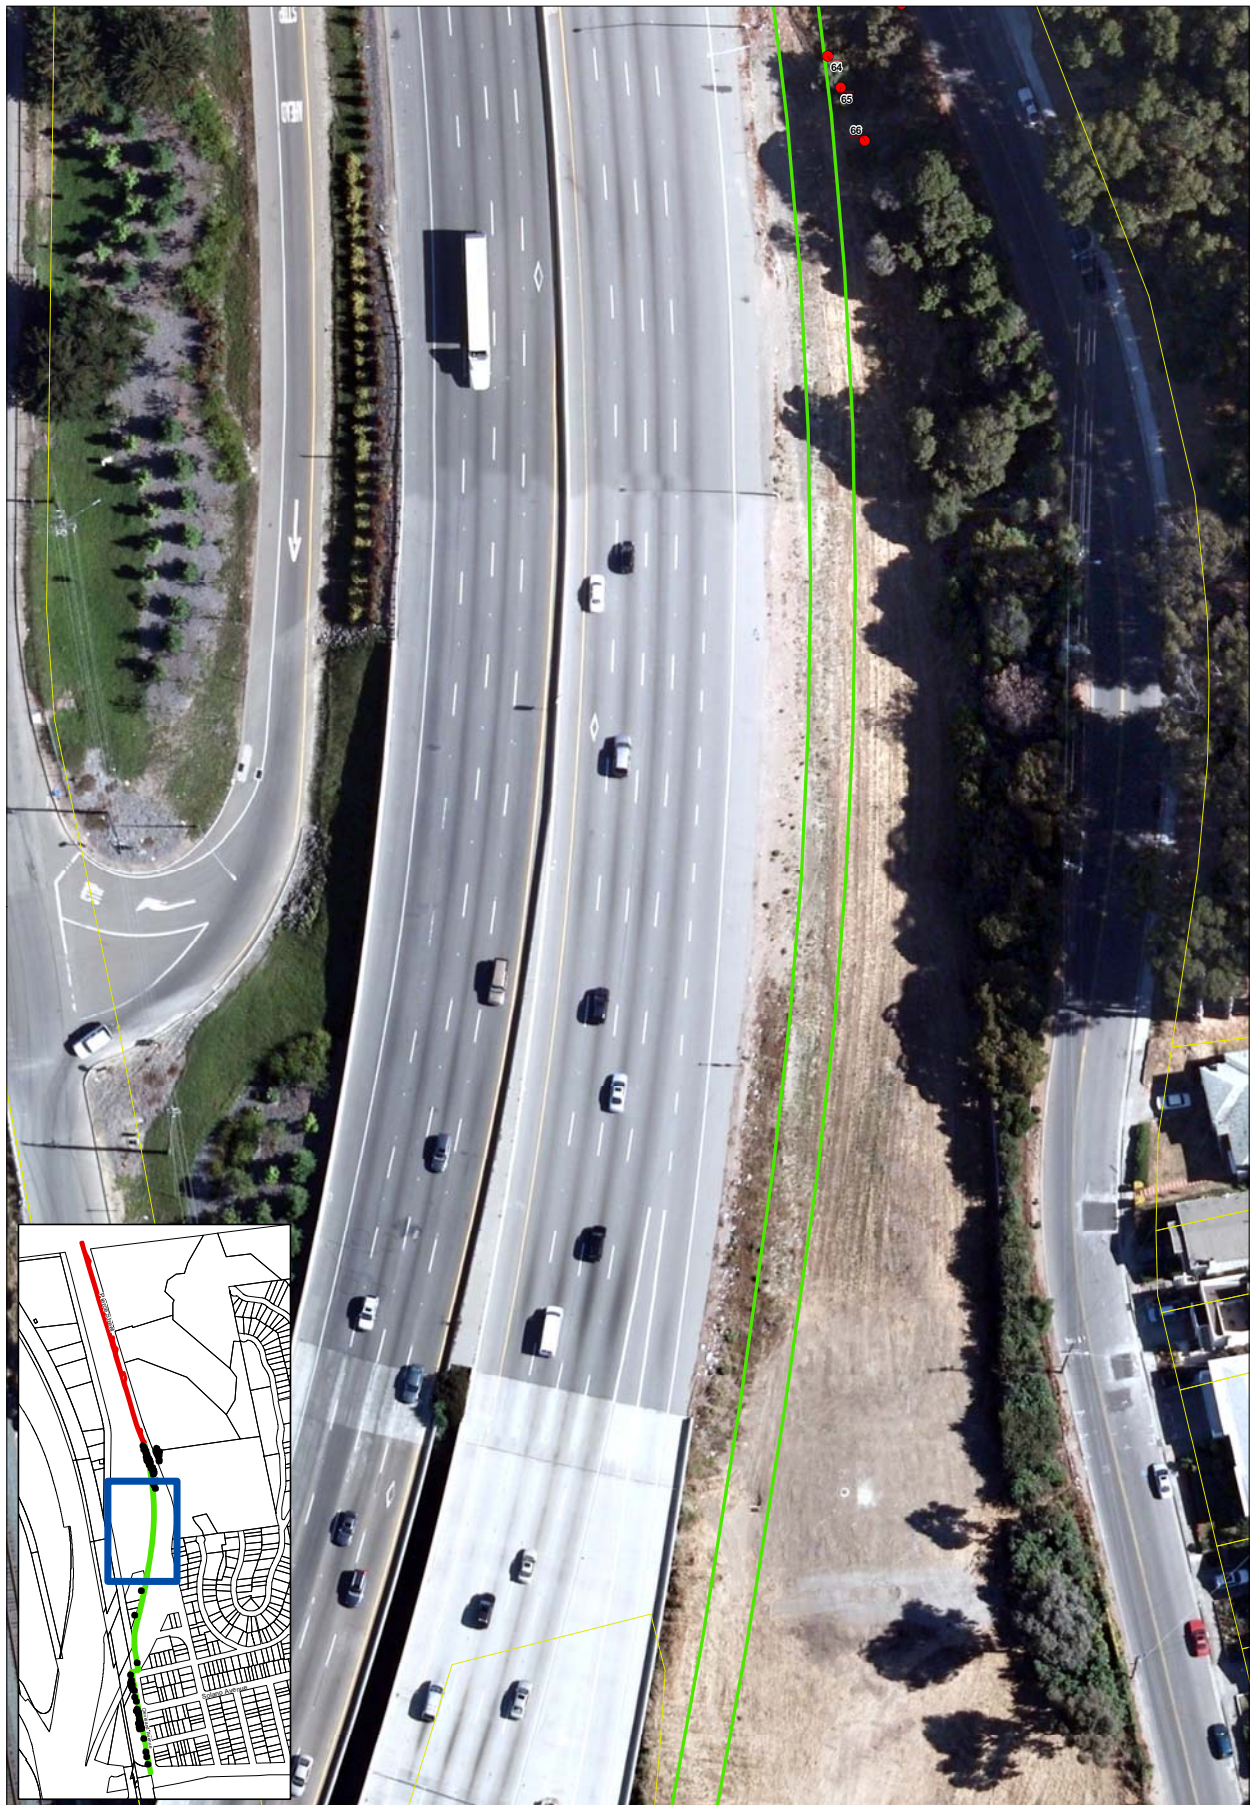
Tree Map

Pierce Street Pavement Rehabilitation and  
Bicycle/Pedestrian Path Project
