**CITY OF ALBANY  
PLANNING AND ZONING AGENDA  
STAFF REPORT**

**SUBJECT:**    **Discussion of Soft-Story Residential Building Policies.** Discussion of issues concerning soft-story residential buildings in the Albany, and possible programs to mitigate potential problems in the case of an earthquake.

# **The Apartment Owner's Guide to Earthquake Safety**

**A Handbook for Owners to Identify  
Seismic Hazards in Low Rise Apartment Buildings**

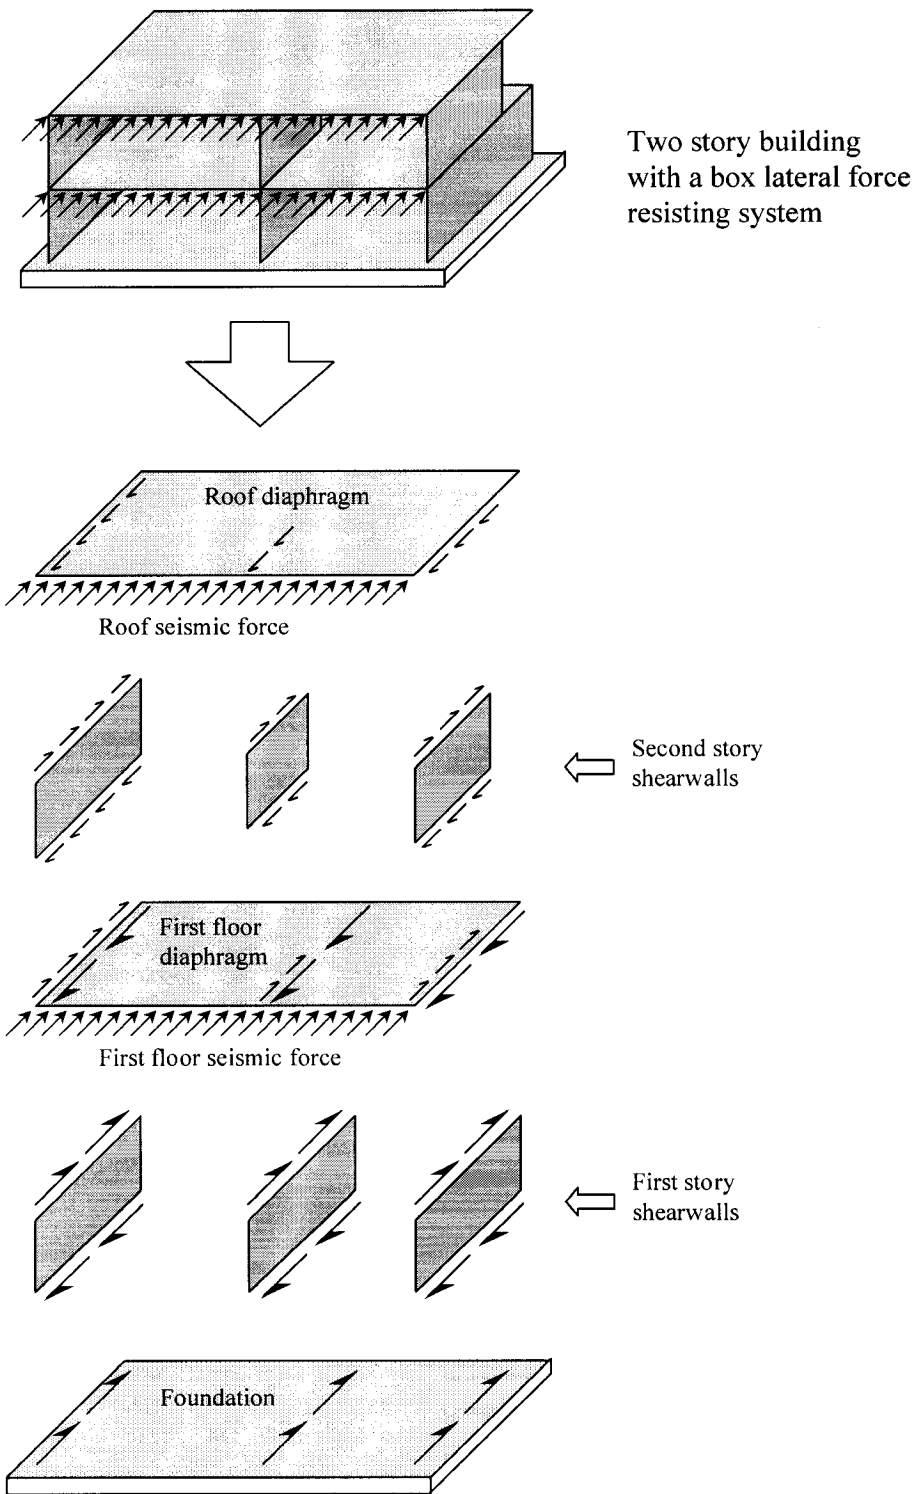
**Figure 2.** Seismic forces on the elements of a box structure

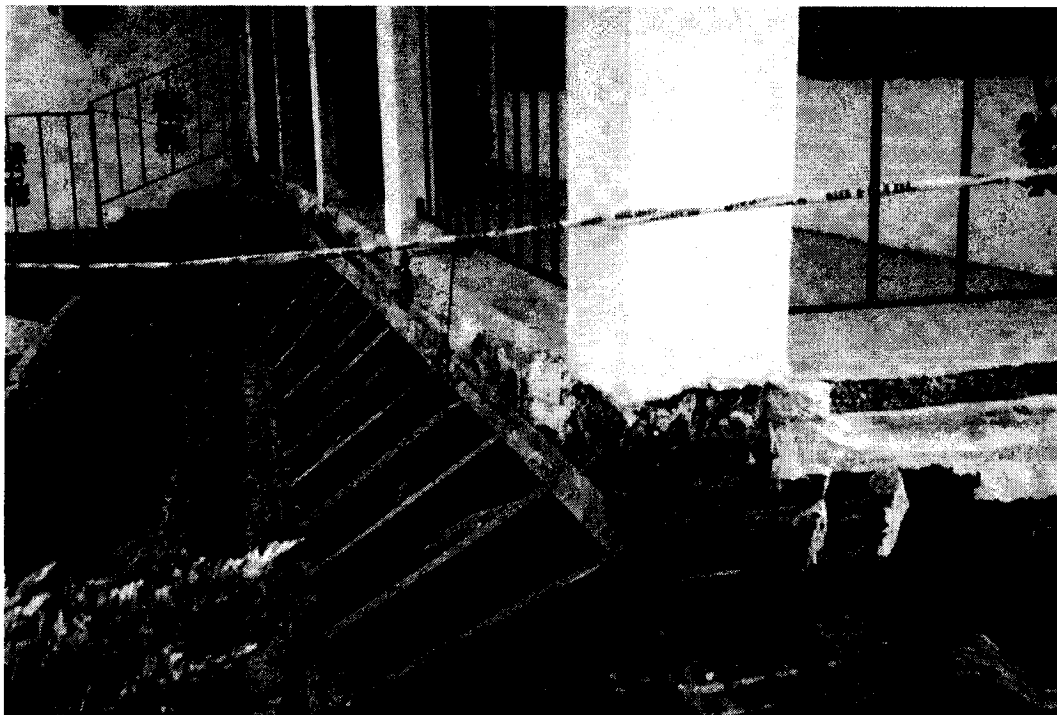
**Figure 5.** Cripple wall damage in the Northridge earthquake

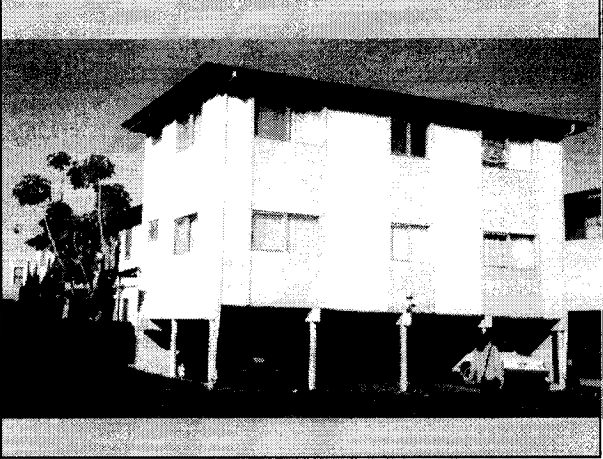
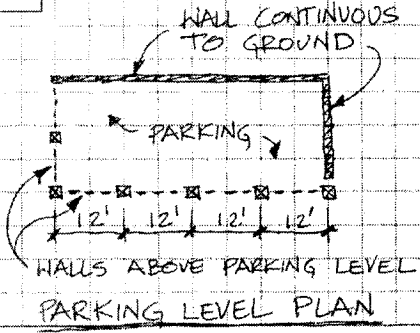
<p>PARKING LEVEL PLAN</p> </div> <div style="text-align: center;">   <p>SHORT SIDE VIEW</p> </div> </div>																											
<p>Comments</p> <p style="text-align: center; font-size: 1.2em;">FINAL SCORE <math>\Rightarrow</math> 1.7 &lt; 2</p> <p style="text-align: center;">DETAILED EVALUATION IS RECOMMENDED</p>

Figure 13. Example of completed Data Collection Form.

From the visual survey and data collection, the PMFs that apply to this building are circled on the Data Collection Form. The circled PMFs as indicated on Figure 13 are:

The Final Structural Score of 1.7 is less than 2.0 and it is noted in the comment section that for this building a detailed evaluation by a design professional is recommended.
