Albany Hill Creekside Master Plan

DRAFT: 1/12/12

City of Albany

Access and Circulation Albany Hill Creekside Master Plan 2012

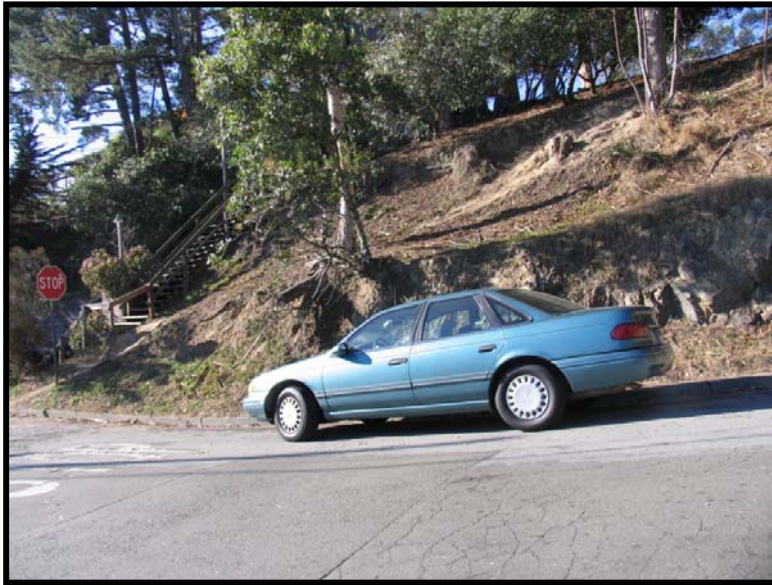
Steps at lower Taft on private property. New steps are being proposed on City owned property just north (or to the right of the privately owned steps.) #2 from the Access and Circulation recommendations.

1. In order to complete the main trail, it is recommended that an easement be secured through the 11 acre parcel that is currently privately owned. It should be noted that the draft Albany Active Transportation Plan also recommends the trail through the 11 acre privately owned parcel. A map of Albany Hill showing land ownership including the 11 acre privately owned parcel can be found on page 2 of the Vegetation Management Plan.
2. Currently, access to lower Taft does not exist except via steps located on a resident’s private property. The installation of steps on City owned property just north of the privately owned steps is recommended to prevent hikers from using steps belonging to the homeowner. A photograph is provided on page 10

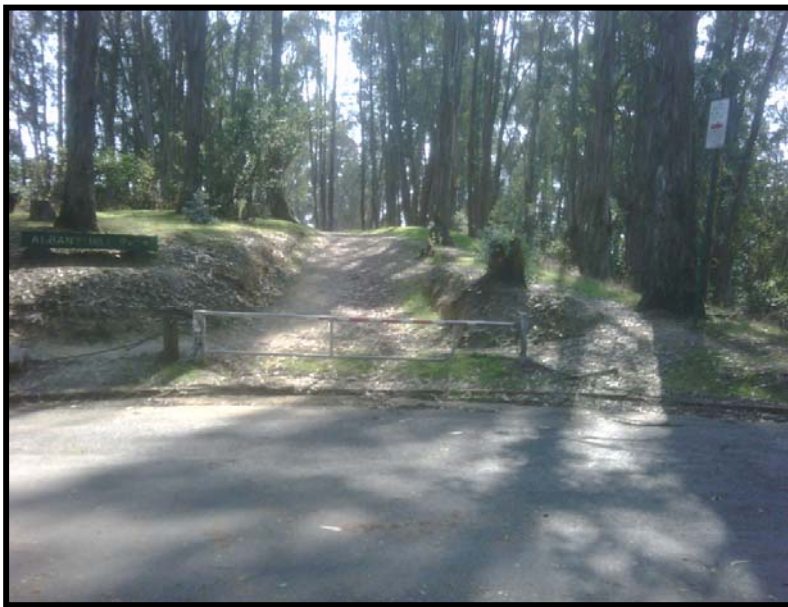
At the primary entrance at the top of Taft, install a ramp that has an ADA compliant grade to allow those with limited mobility an opportunity to enjoy the crest which hosts the best east and west views on Albany Hill. #4 from the Access and Circulation recommendations.

4. At the primary entrance at the top of Taft, install a ramp that has an ADA compliant grade to allow those with limited mobility an opportunity to enjoy the crest which hosts the best east and west views on Albany Hill. A photograph is provided on [page 10](#).

3. At the upper Taft entrance, a sign describing the trail difficulty including grade information should be placed at the beginning of the ramp that is recommended in the Access and Circulation section. Another sign warning of a grade change should be placed just before the cross where the trail becomes much steeper. The trail description signs will allow those with limited mobility an opportunity to decide if they are able to traverse the trail safely.

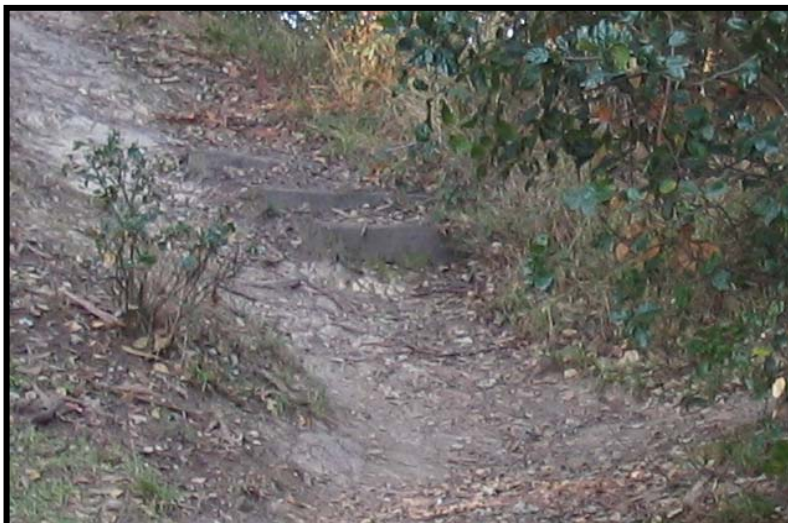
Steps off of Jackson. #6 from the Access and Circulation recommendations.

6. The existing steps closest to Jackson Street are too narrow and need to be removed and replaced. A photograph is provided on [page 10](#).
7. For the trail on the crest that runs parallel to Taft Street, install wooden beams that run adjacent to the fire trail that are set 30-40 feet apart. Since the current trail along the crest is a fire trail for vehicles, installing the beams adjacent to the fire trail at the steepest points of the trail will improve pedestrian circulation without impacting vehicle transportation. This type of wooden beam has been installed on the trail leading to the Madison entrance. A photograph is provided on [page 10](#).

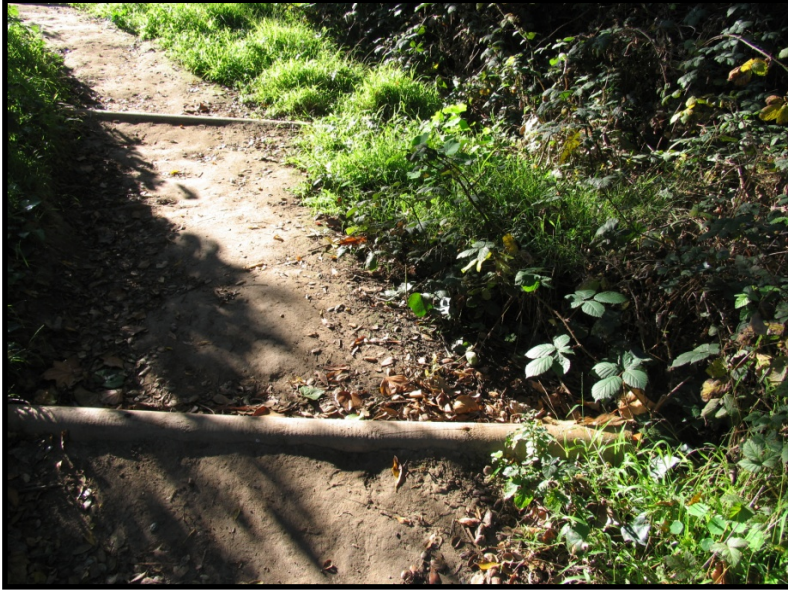
Logs on the Madison Trail. A similar installation is recommended on the steepest parts of the trail on the crest of the Hill. #7 from the Access and Circulation recommendations.

9. The existing steps and wooden beams leading to the Madison entrance are in good condition, but need to be monitored annually as part of the inspection program.

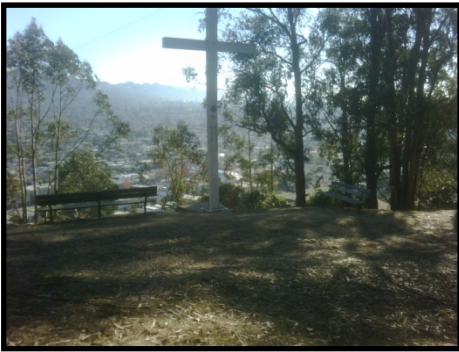
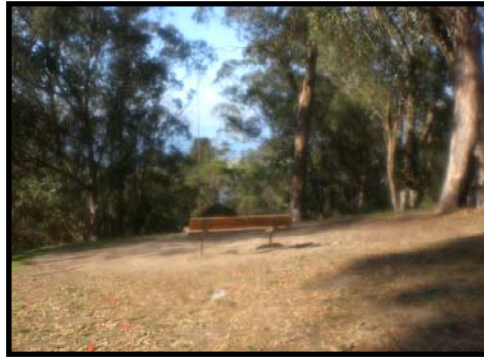
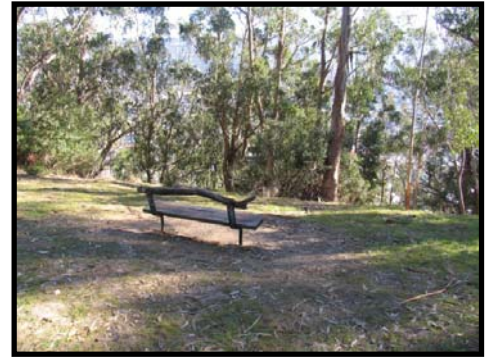
Current bench locations: east and north facing benches next to the cross, west facing bench near the center of the crest, and the east facing bench near the Taft entrance.

The most prominent viewing corridor is the trail running parallel to Taft Street along the Crest of Albany Hill. From the 1991 Plan, there were four suggestions for benches which have been installed, but need to be repaired and/or replaced. Photographs of the benches listed currently located on the crest are provided on [page 11](#).

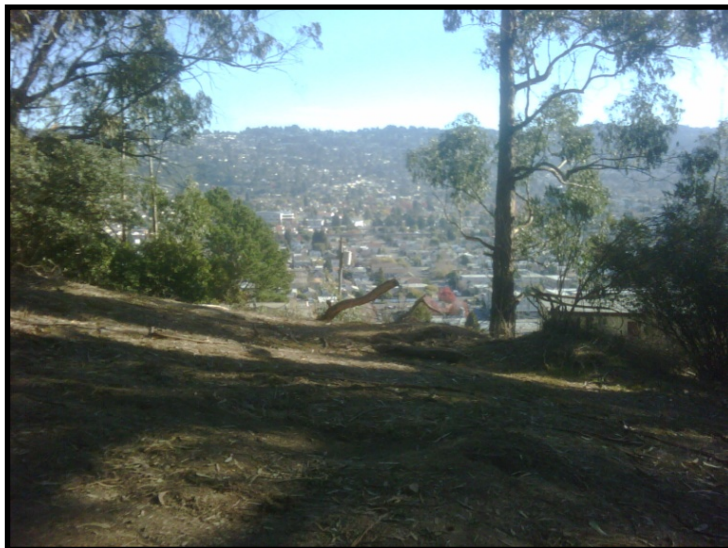
Recommended location for one or two additional east facing benches on the crest.

1. Views to these Bay Area landmarks should be maintained by controlling eucalyptus seedlings and by pruning view-blocking on existing Eucalyptus. Branches blocking views will need to be cut back approximately every two years.
2. All six of the existing benches need to be repaired or replaced as most of the back panels have been removed and the benches are covered with graffiti.
3. One or two additional benches should be installed along the crest trail facing east. There is an open area where the view is spectacular with no tree branches blocking the view. A photograph of this area is provided on [page 11](#).
