Vegetation Management at Albany's Creekside Park and relevant adjacent areas

Susan Schwartz, President, Friends of Five Creeks

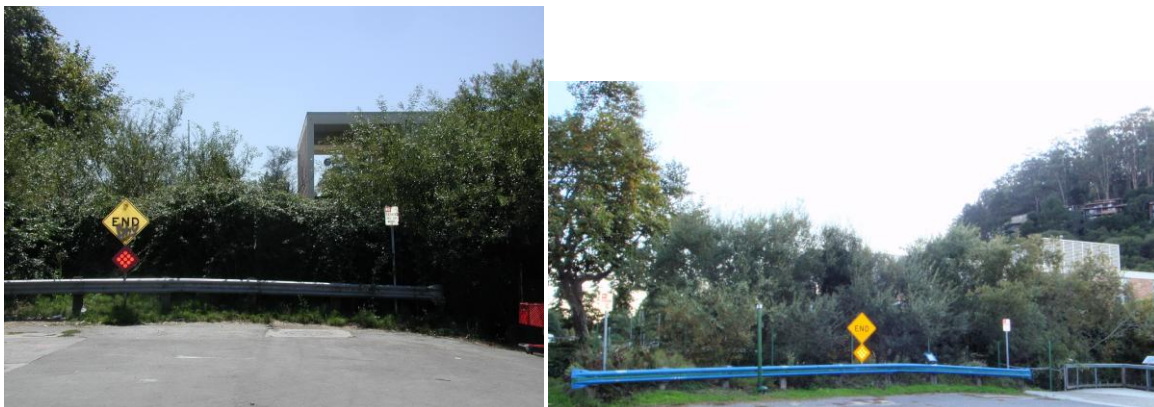
Left, blackberries at Adams Street, 2004. Right, after blackberry removal and planting of natives.

Downstream at Adams Street, some blackberries remain on the south bank (Orientation Center property). F5C continues to gradually shrink this patch, but any hired contractor should dig them, too. This is best done in late summer; erosion-control cloth should be in place in October.

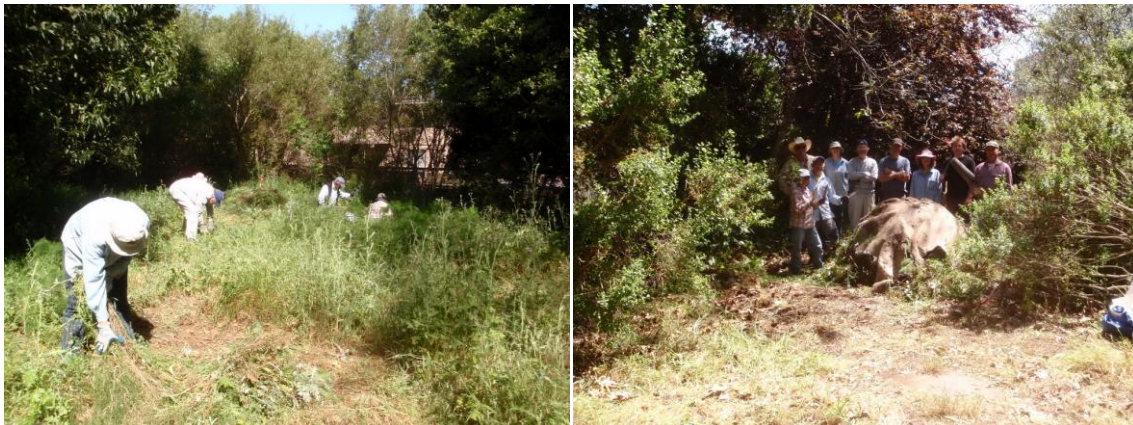
Weeding meadow east of Orientation Center, reachable only by fording creek.

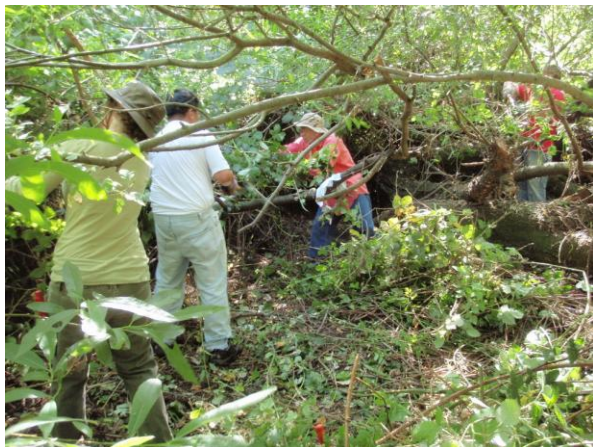
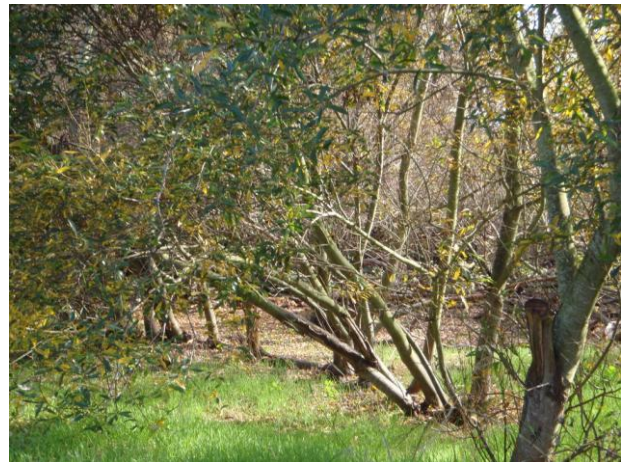
Left, clearing blackberries in Middle Creek willow grove, 2008. Right, grove after clearing, in fall.

Camping is a recurring problem that must be watched for, particularly on the southeast, where the adjacent blackberries limit visibility (see next section). F5C is not seeking to extend the cleared area up Middle Creek, largely due to poison oak. Although cape ivy seems to be eradicated, the blackberries must be cut and dug regularly to keep them from taking over again.

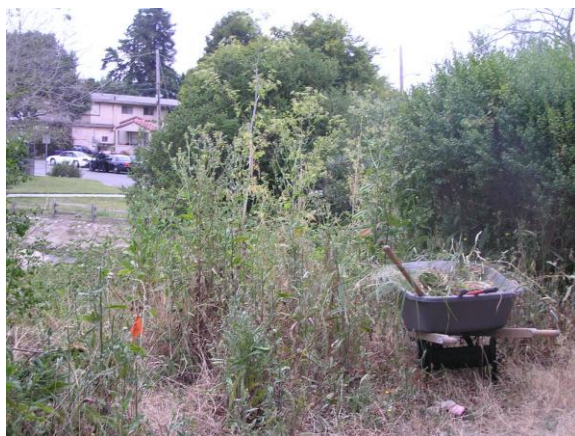
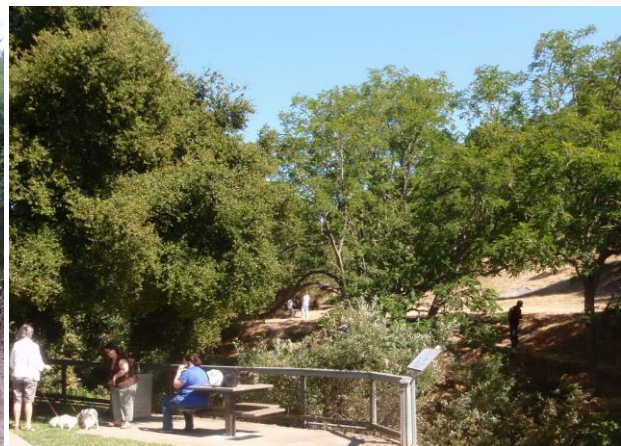
Ce *Left, weeds in Creekside Park meadow, 2006. Right, meadow from El Cerrito's Creekside Park, 2011.*

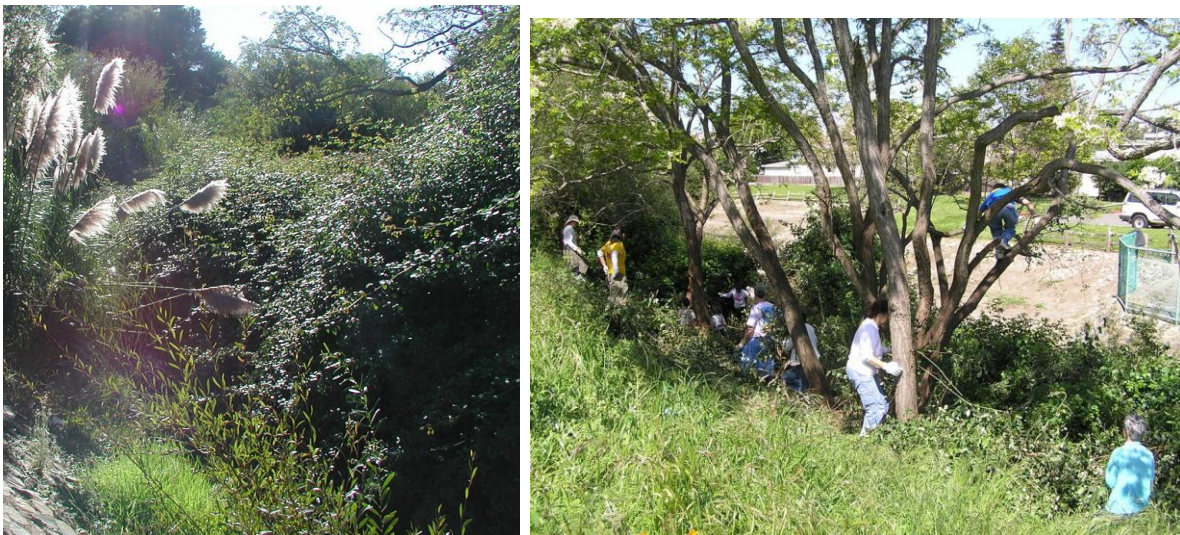
Left, Cerrito Creek at ford opposite Santa Clara in 2004. Right, F5C's first blackberry removal, same area, 2005. Blackberries were up to where the person in the tree is pulling them down.

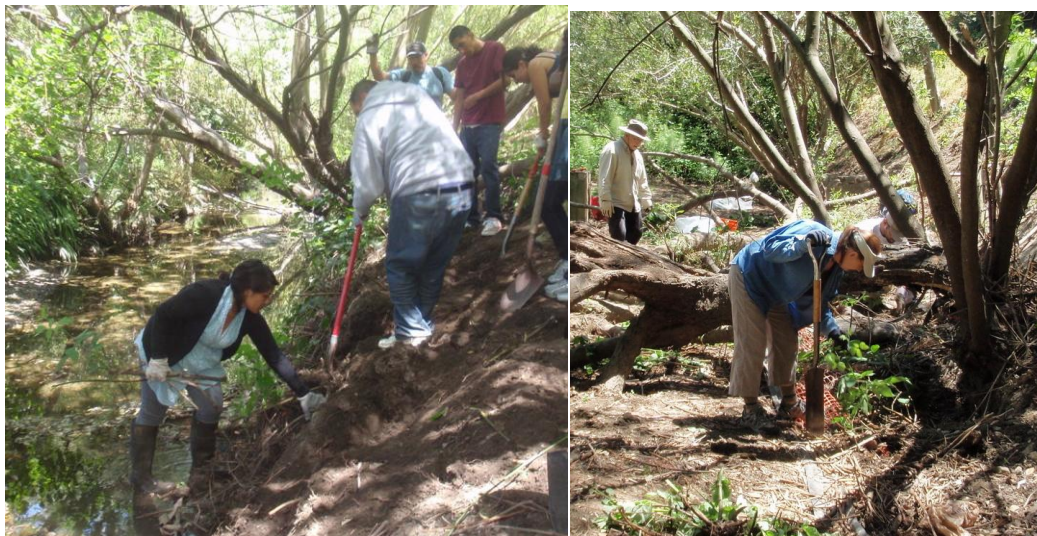
First and second rounds of digging roots of evergreen thornless blackberry. Other steps: initial cutting, putting down erosion control cloth, planting natives (several rounds), third and later rounds of digging.

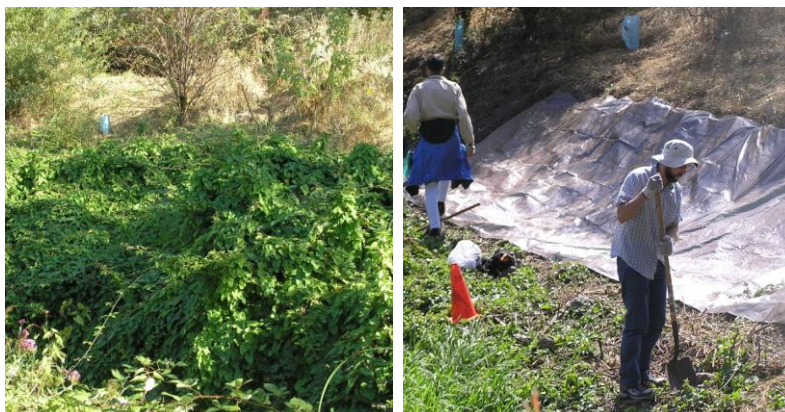
Waves of invasives can overwhelm even established vegetation.

Far left, in 2005 bindweed was overwhelming even blackberry in some areas. Left, tarps had to be kept on for three years to control it. Even now, it recurs.
